AIRCRAFT ACCIDENT INVESTIGATION AND INQUIRY BOARD

FINAL REPORT

RP-C511
KODIAK 100

TITLE: Incident involving a Kodiak 100 type of aircraft with Registry Number RP-C511 operated by WAIACO that had a bounced landing at Divilacan Airstrip, Divilacan, Isabela, Philippines, on December 5, 2020/1200H

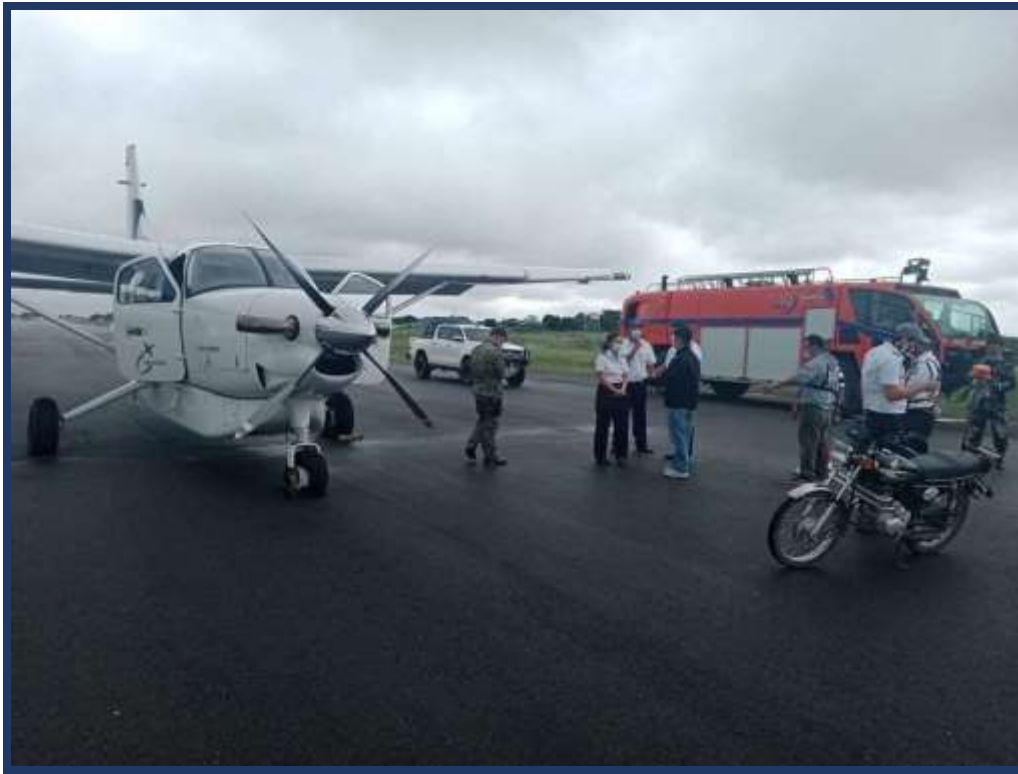
Figure 1: RP-C511 final resting point

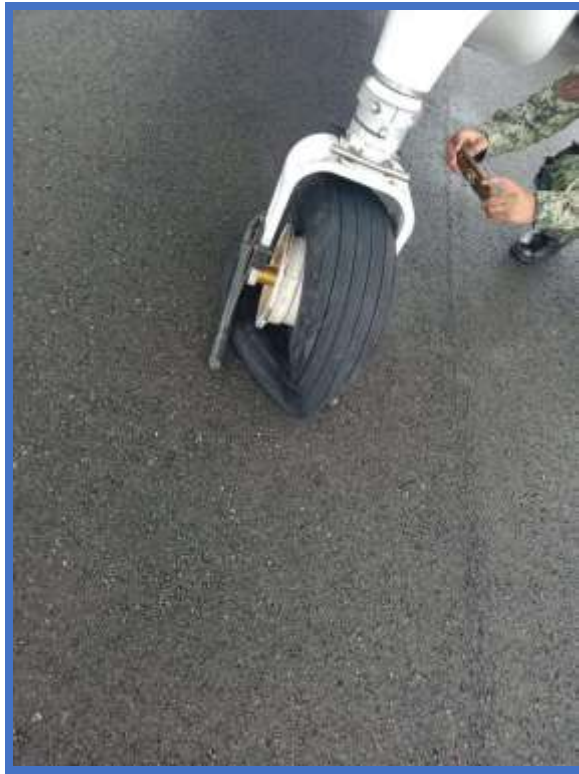
On final approach, the wind was observed from the aircraft Garmin 1000 navdata to be 8-10 kts right crosswind. Accordingly, the aircraft was fully configured for landing. Before touch down, the Pilot claimed the the aircraft was hit by strong gust of wind that resulted to a bounced landing on initial touchdown. Following a bounced landing, the aircraft landed again with its nose landing gear. The Pilot initiated a go-around and proceeded to Cauayan Airport Isabela as its alternate airport. Before landing, the aircraft flew over the Airport and the Pilot requested Cauayan FSS to check its nose landing gear for any damage. Cauayan FSS responded “looked OK for landing”. The aircraft landed utilizing runway 32 and came to stop in the middle of the runway between distance-to-go markers 2 and 3. The passengers disembarked at the runway and the aircraft was towed towards the ramp area. Visual inspection on the nose landing gear revealed deflated nose gear strut and tire (Figure 3).

Figure 3: Deflated nose gear strut and tire

- 3.1.11.** The aircraft sustained damaged on its nose landing gear following a bounced landing.

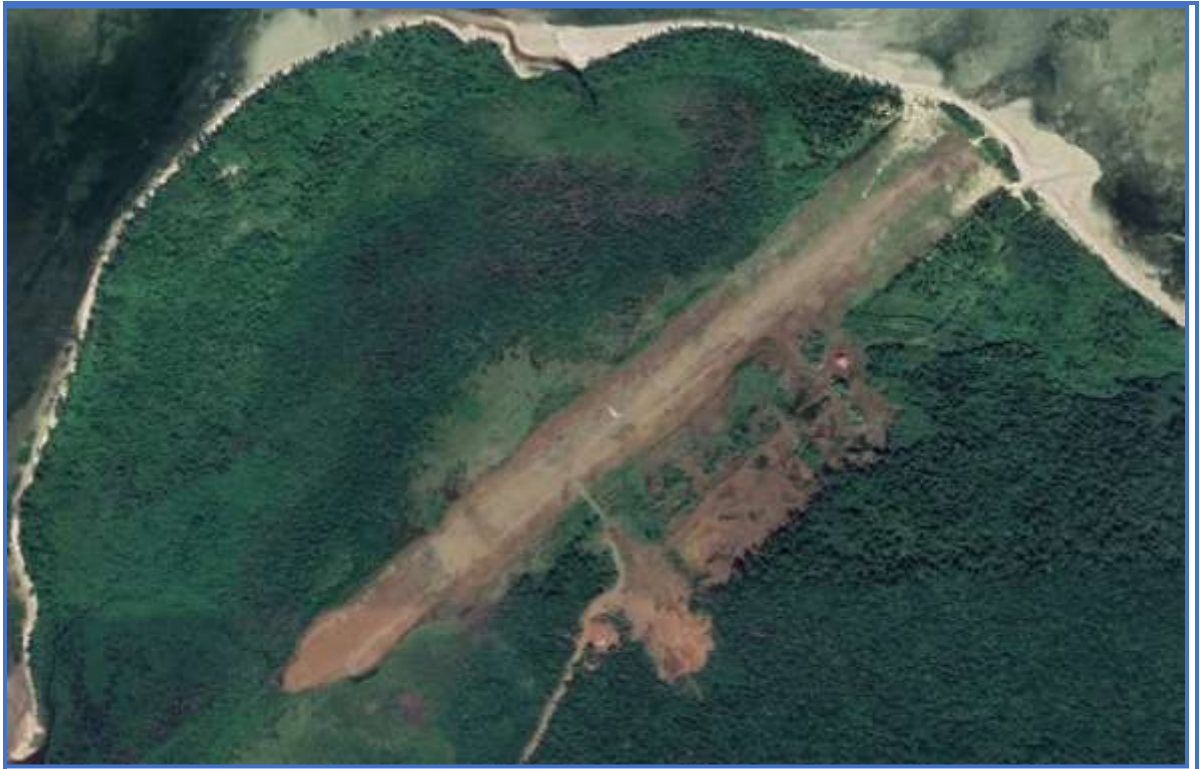
Investigation disclosed that the airstrip has no ground to air communication facility including basic guide to wind direction and speed like windsock to aid Pilots during landing. Verification with AANSOO revealed that Divilacan Airstrip has not undergone certification process from CAAP nor permit to Operate (PTO) was issued.

Figure 4: Divilacan Airstrip taken from google earth with imagery date of 12/24/2020
