## **AIRCRAFT ACCIDENT INVESTIGATION AND INQUIRY BOARD**

### **FINAL REPORT**

**RP-C8230**  
**TECHNAM P2010**

**TITLE:** Incident involving a Technam P2010 type of aircraft with Registry Number RP-C8230 operated by First Aviation Academy that had a nose wheel separation following a bounced landing at RWY 07, Subic Bay International Airport, SBFZ, Subic, Zambales Philippines on January 5, 2020/0917H

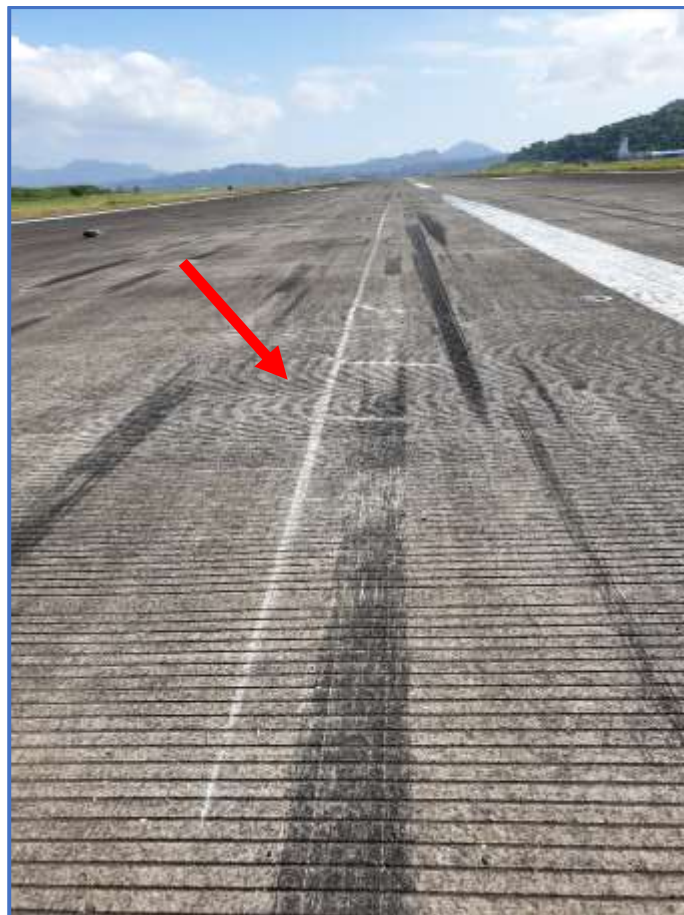
The runway sustained propeller strike marks and scrape caused by the broken nose landing gear strut.

Figure 1: Shows the propeller strike and runway scrape marks.

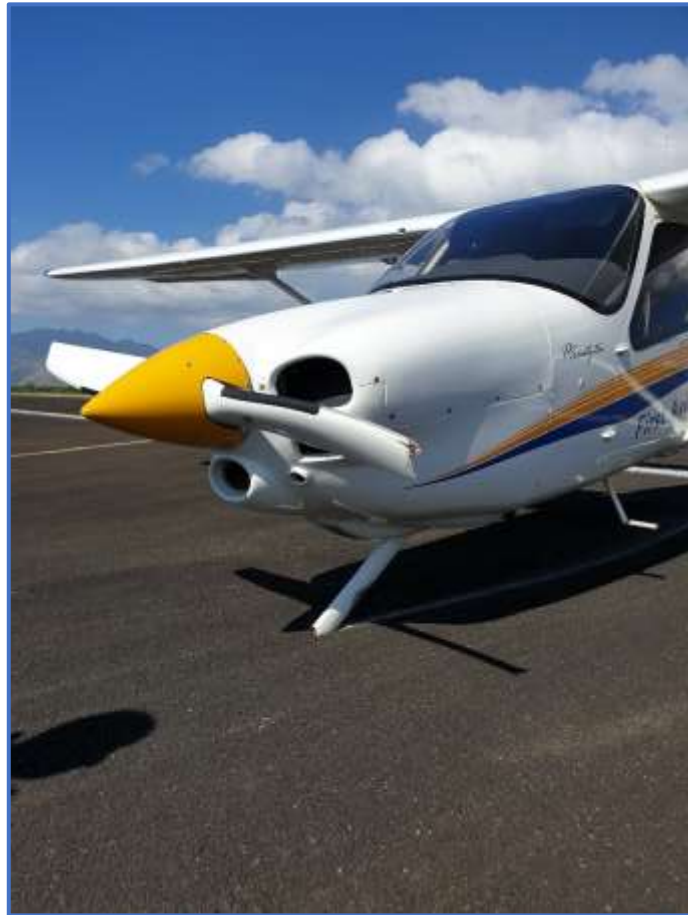
The aircraft final position was between intersection of runway 07 and taxiway Echo. The aircraft sustained damage on the Nose Landing Gear, both propeller blades, engine mount and shock absorber.

Figure 1: RP-C8320 after the nose landing gear separation from the strut assembly and propeller strike

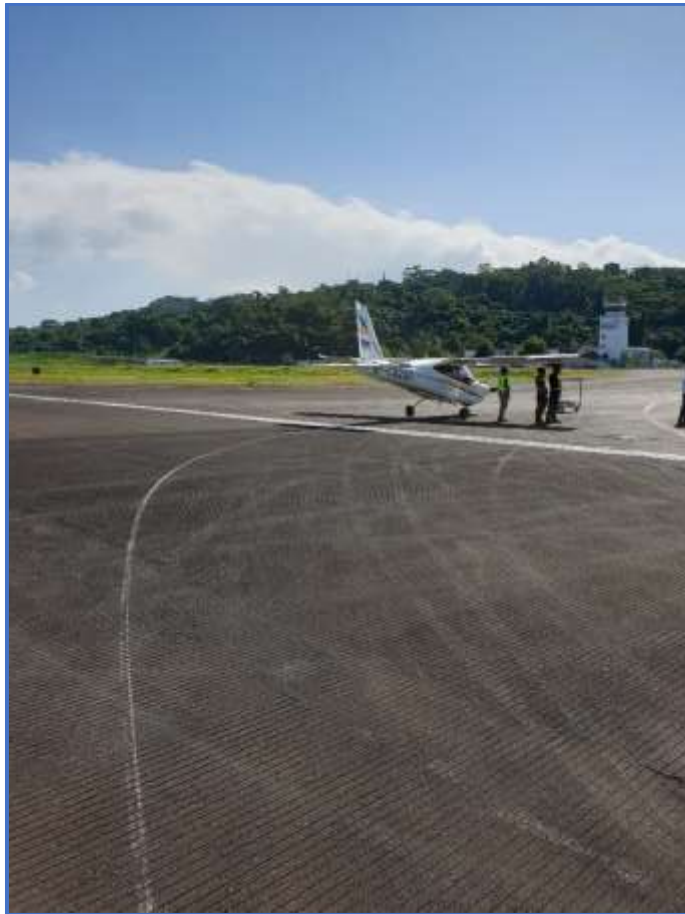
At around 0900H the SP took off for her first solo. She followed the normal traffic pattern until base and finals. The approach was also normal until the late stages. As the SP flared the aircraft, it touched down and bounced. Subsequently, there was a second bounce followed by the aircraft pitched nose down. The aircraft struck the runway with its nose wheel, the nose landing gear broke and the aircraft came to a stop on the runway.

The incident happened because the SP failed to do the proper porpoise/bounce landing recovery. It is evident by the nose wheel landing after the initial bounce. On the other hand, she could have initiated a go-around and attempt to land the aircraft again.

Figure 2: Shows the final position of the aircraft of taxiway echo.

4.1 The Student Pilot was subjected to re-training with emphasis to the following:

- a. Bounce/Porpoise Landing recovery
- b. Go-around After Series of Bounces
- c. Additional Landing Maneuvers to Ensure proficiency.
