FINAL REPORT

RP-R4861
AGCAT G-164B

OPERATOR: AIRTRAC AGRICULTURAL CORPORATION

DATE OF OCCURRENCE FEBRUARY 10, 2020

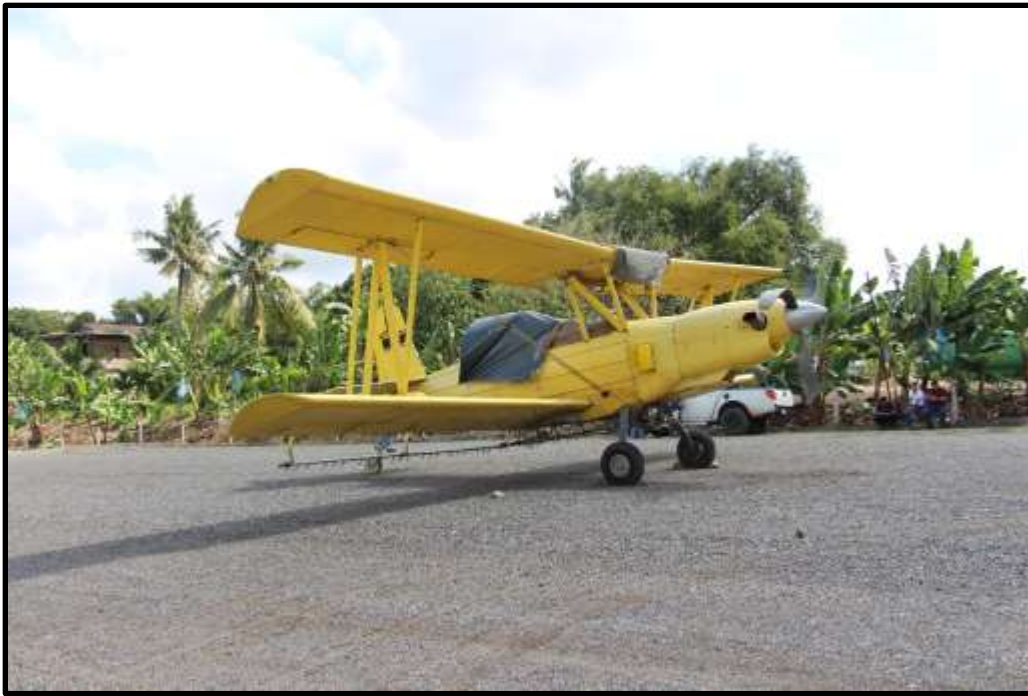
The Pilot was on a full stop landing after performing three (3) sorties of aerial chemical spray in the area. The aircraft landed almost 170 meters of the remaining runway. The pilot engaged the thrust reverse upon touchdown but as he applied full wheel brakes, the aircraft tilted forward resulting to propeller ground strike. The aircraft came to a complete stop with a heading of 180 degrees and coordinates of 07°13.49' N, 125°27.43' E. The pilot egress safely after performing engine shutdown. All of the three (3) propeller blades were bent at midspan. Visual Meteorological Condition (VMC) prevailed at the time of the event. Wind was reported to be at 360 degrees at 15 knots.

Figure 1. Aircraft's final resting point

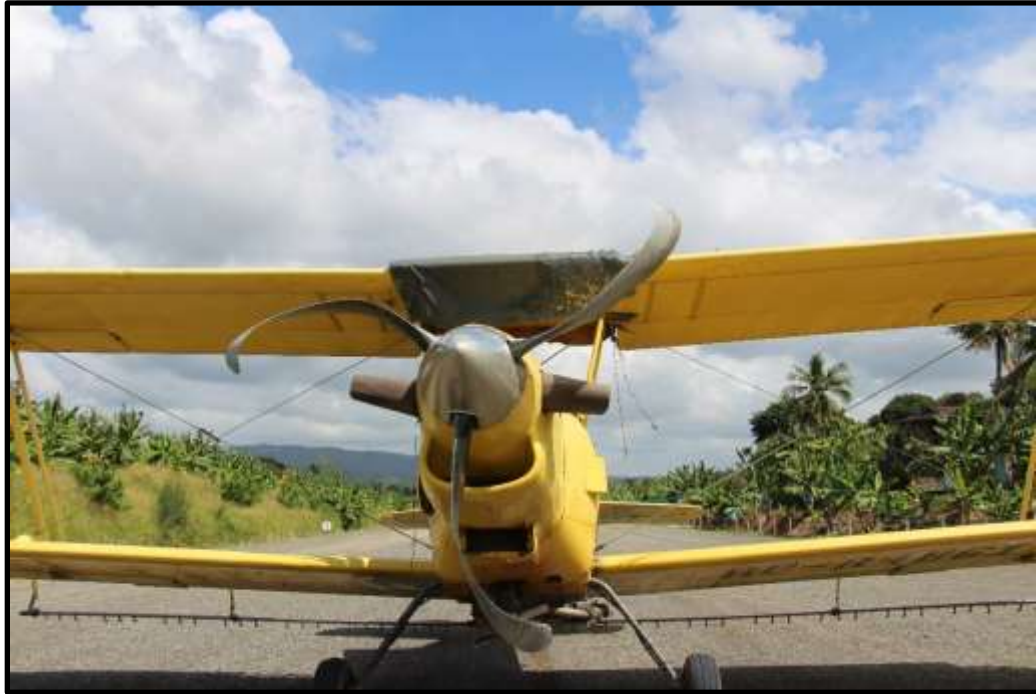
The aircraft came to a complete stop with a heading of 180 degrees and coordinates of 07°13.49' N, 125°27.43' E. All of the three (3) propeller blades were bent at midspan.

Figure 2: Propeller blades bent at mid span

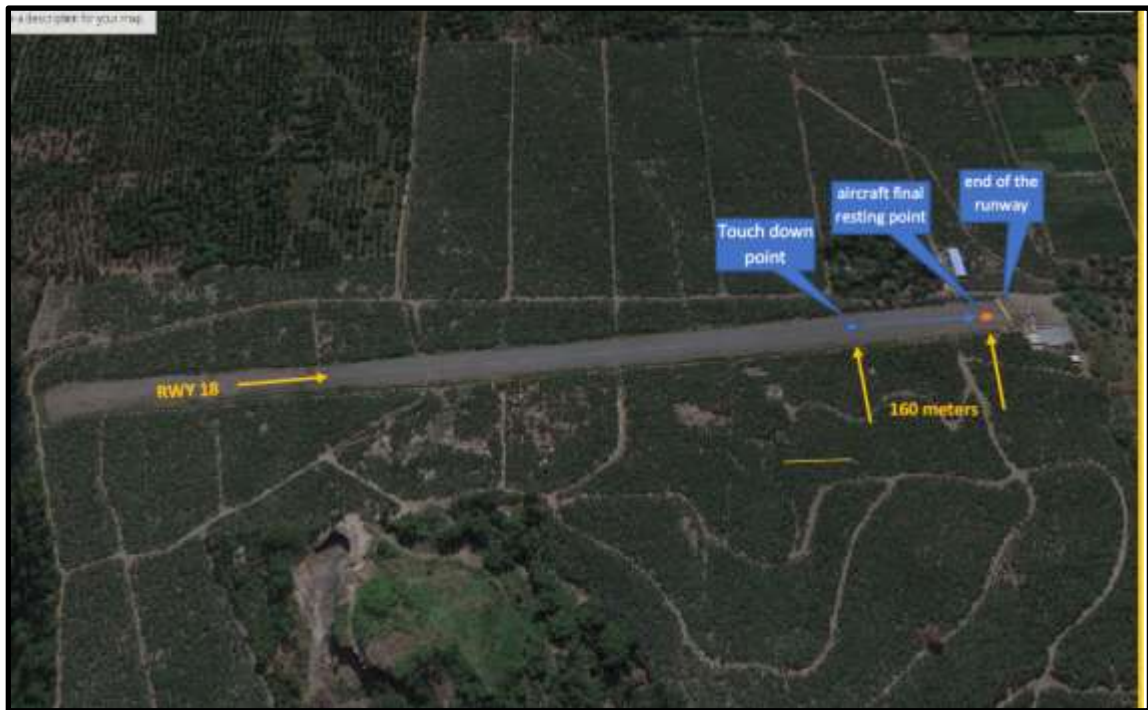
A pilot landing in a tailwheel aircraft is challenging in any wind condition. When there is a tailwind, landing safely is even more difficult. In this event, RP-R 4861 was making a landing with approximately 12 to 15 knots tailwind. It touched down hard almost at 1/4th of the remaining runway. It bounced twice, followed by the propeller ground strike after a nose over due to hard braking. As with any landing, maintaining aircraft control is the first priority, but in this case, the tailwind increases the aircraft's ground speed, and there is the problem of stopping the aircraft safely. A go-around should have been initiated during un-stabilized approach.

Figure 3: Approximate aircraft track

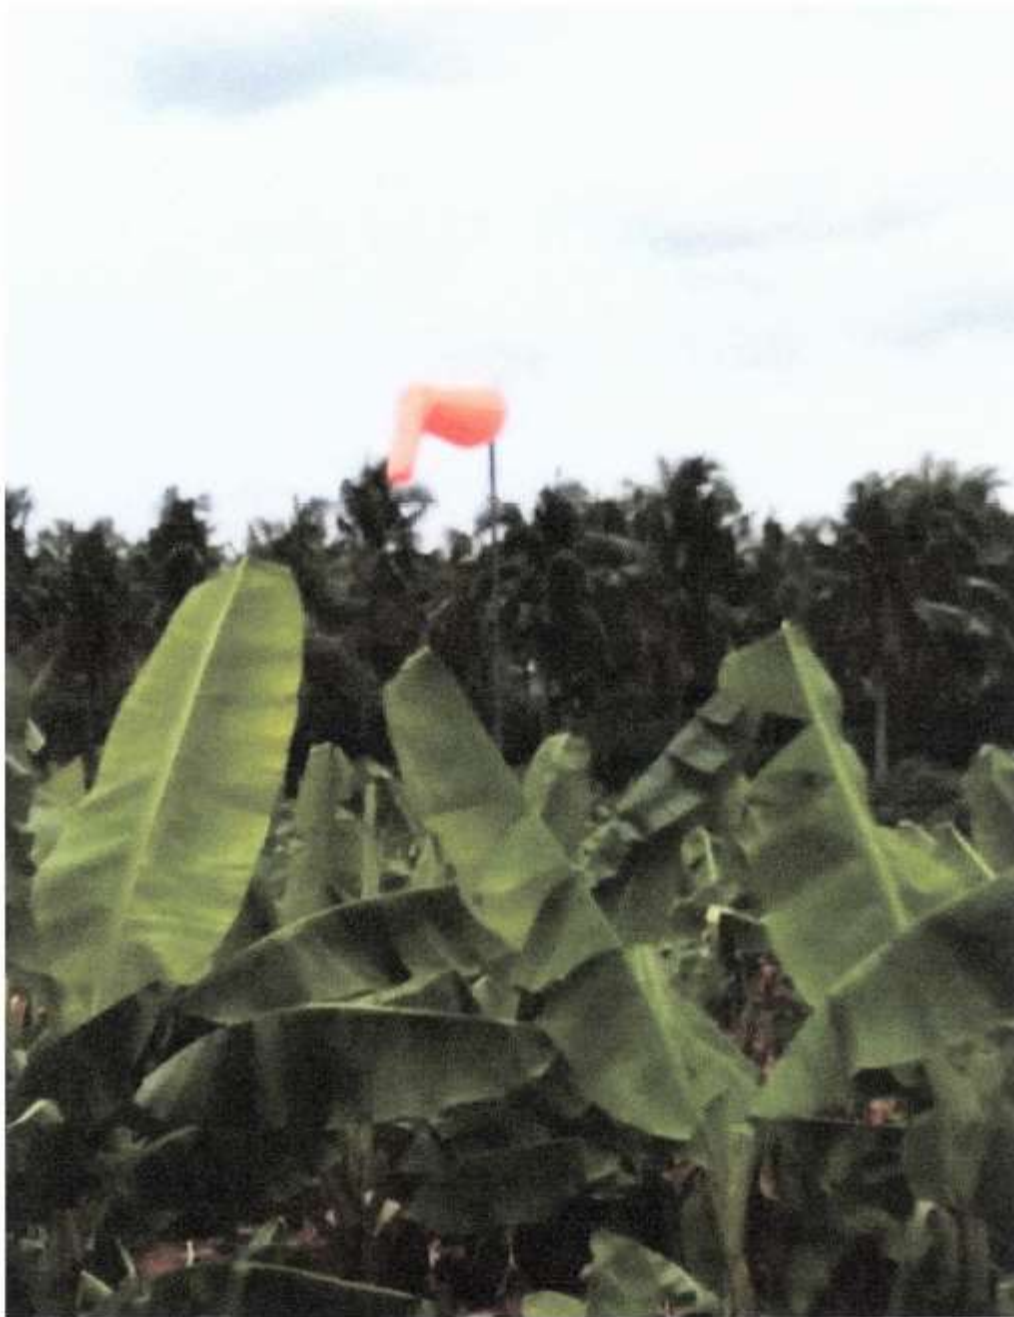
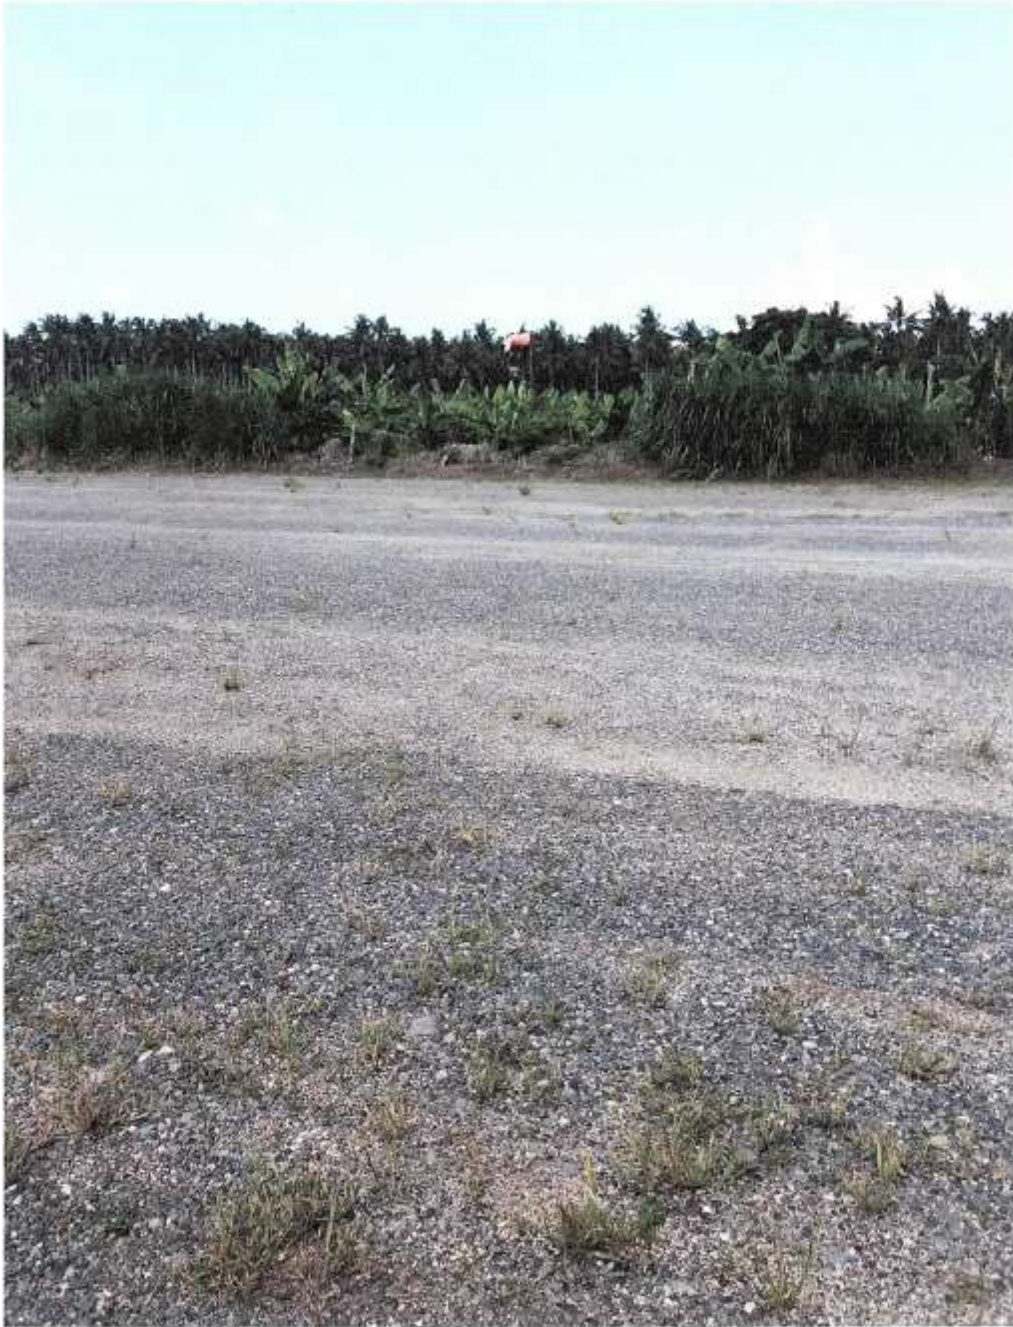
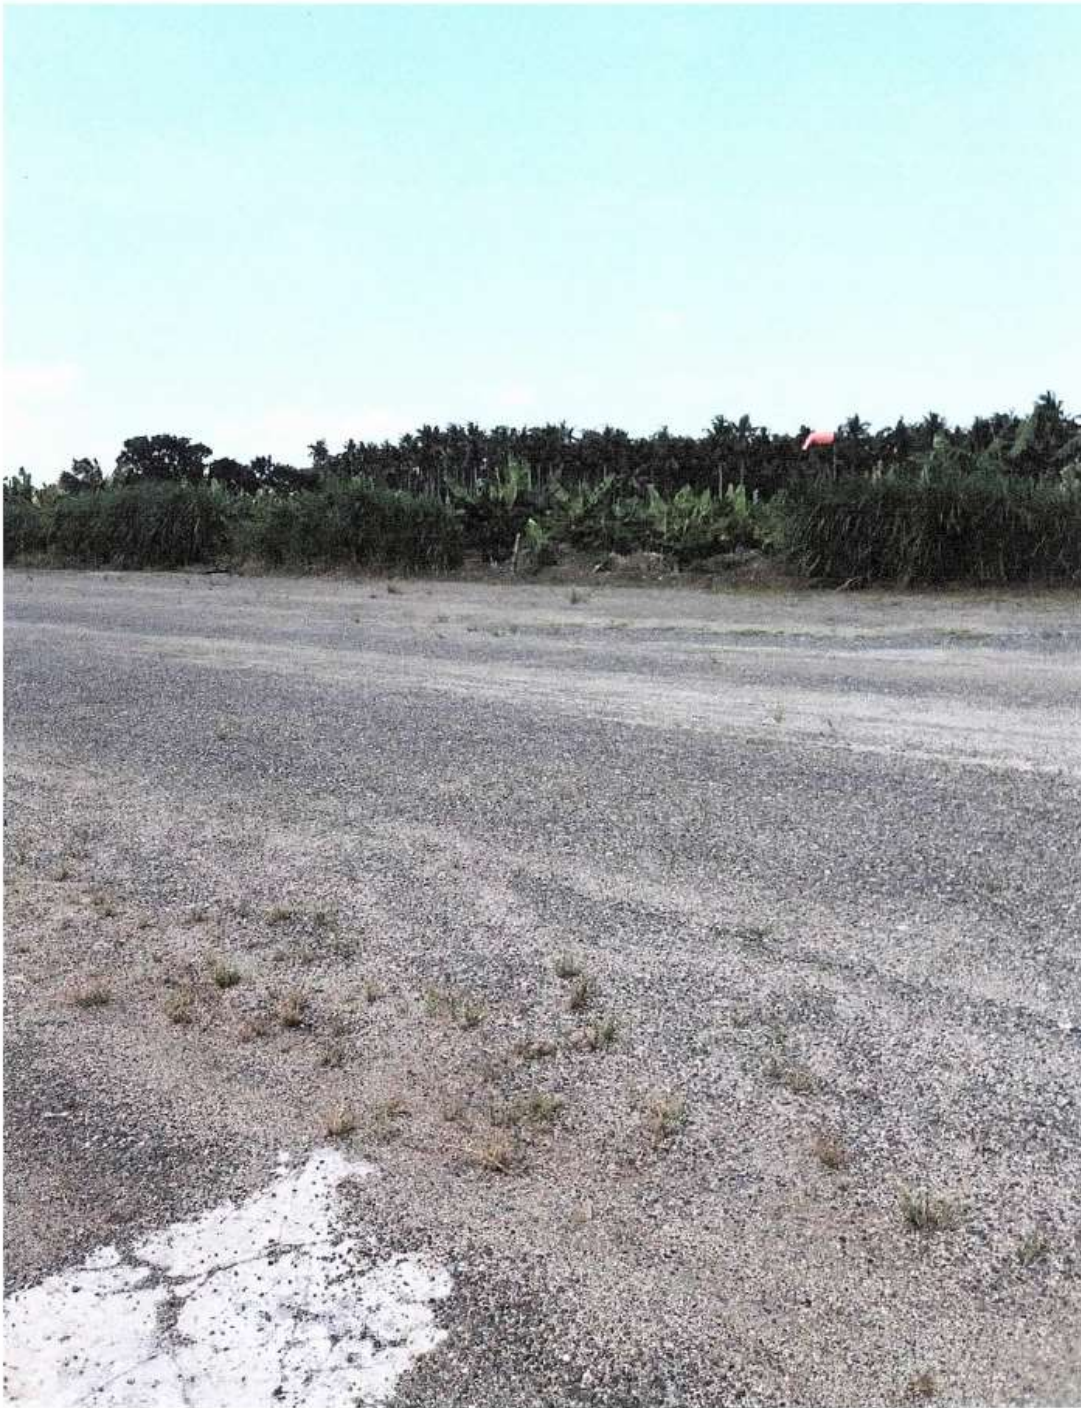
Attach is a 3 picture of the runway and the wind cone.

In compliance with your recommendation to install a wind cone in Dacudao Aerodrome after the incident of RP-R 4861 on February 10, 2020, Airtrac constructed a Wind Directional Indicator (Wind Cone) at runway 18 which abeam in the threshold of the runway 18 in order to monitor the wind condition in short finals and it was done on Aug 24, 2020.
