AIRCRAFT ACCIDENT INVESTIGATION AND INQUIRY BOARD

FINAL REPORT

RP-C1085

PA-38-112

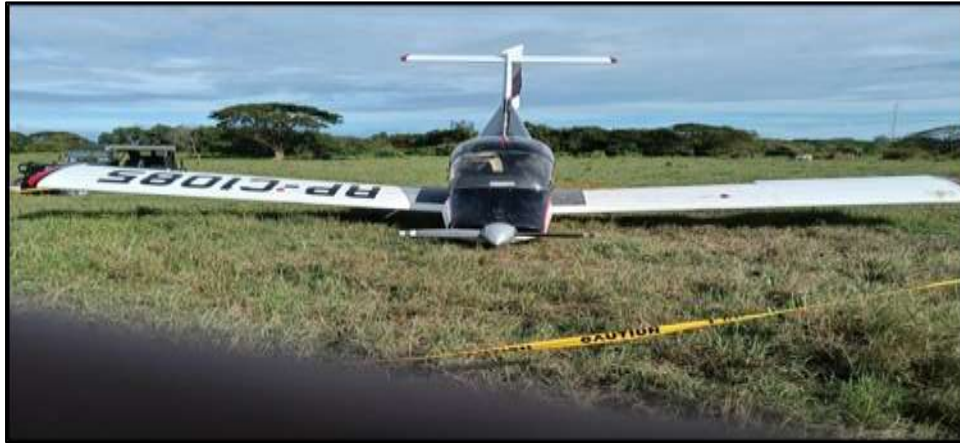
Figure 1 - RP-C1085 final position at the incident site.

The aircraft, upon touchdown on a grassy area, rolls for about 10 meters before coming to a complete stop. The soft and uneven terrain caused the nose landing gear to collapse, damaging the lower engine cowling and engine support.

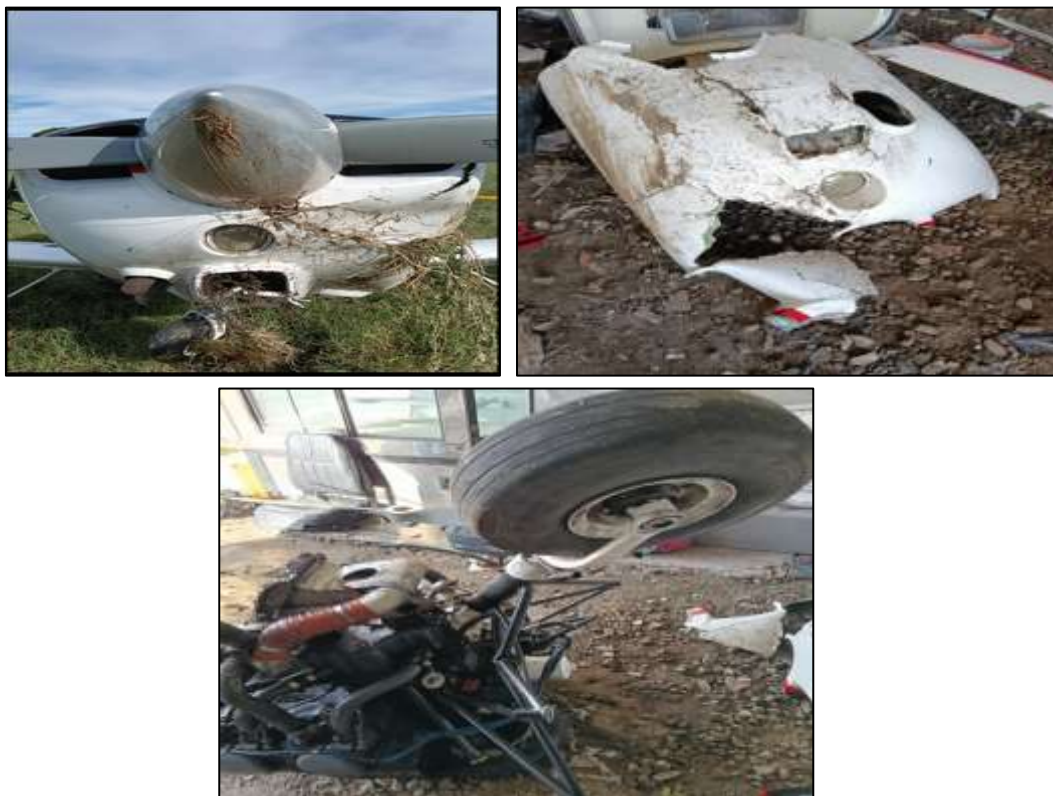
The aircraft sustained damaged on the Nose Landing Gear, engine cowlings, and engine supports.

Figure 2 - Damaged Nose Landing Gear (NLG), engine cowlings and engine support.

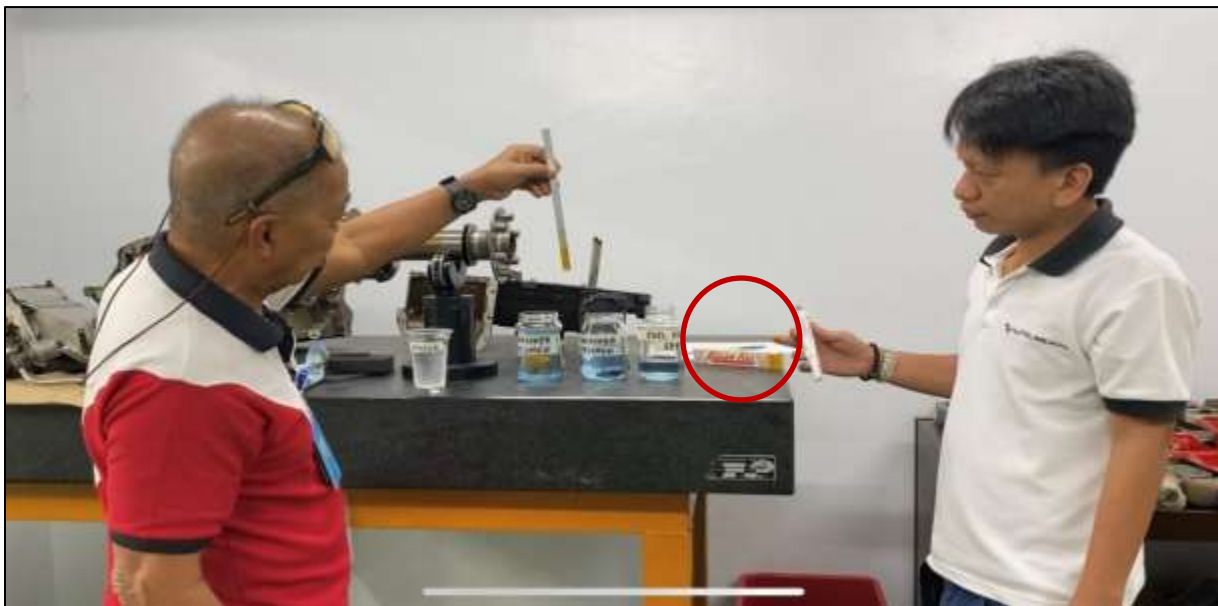
A sampling of fuel that was taken from the aircraft fuel tanks and carburetor assembly was placed on a clean/clear glass container and was tested for fuel contaminants using the Kolor Kut Water Finding Paste (Figure 4). The test results revealed negative fuel contamination.

Figure 4 - Testing the fuel with **Kolor Kut Water Finding Paste**.

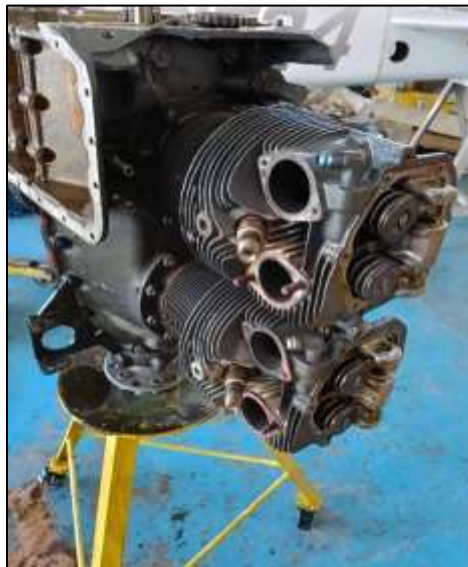
- a. The worn-out crankshaft bearing number 3 exceeds the normal clearance.
- b. The crankcase bearing holder is scratched due to the shrinkage of the third bearing.

Figure 5 - Engine teardown inspection.

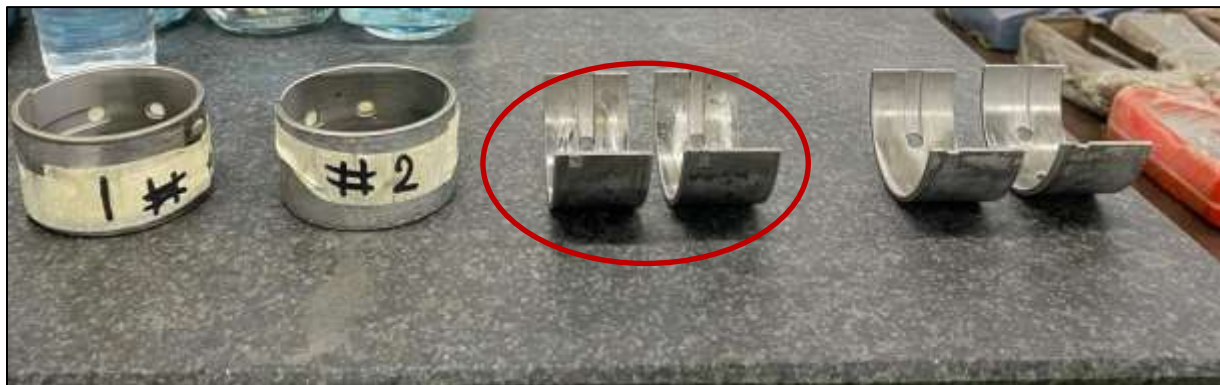
The finding that the number 3 bearing had worn out can likely be attributed to material failure since the three other bearings are still within the normal dimensions that likely made the engine come to a complete stop while in flight.

Figure 6 - Photo showing the four (4) bearings remove from the engine with #3 bearing showing differently.

- 5.1.1** Include in the pilot's handbook to monitor and record any unusual observation about engine parameter during flight.
- 5.1.2** Incorporate in the maintenance procedures manual the thorough inspection of engine during scheduled maintenance to detect any hint of material failure within the internal parts of the engine in compliance with Lycoming Maintenance Manual.
- 5.1.3** Adherence to Lycoming Service Bulletin and Service Instruction service documents related to bearings.
- 5.1.4** Ensure a high degree of cleanliness of the bearing areas and application of approved assembly lubricant during overhaul.

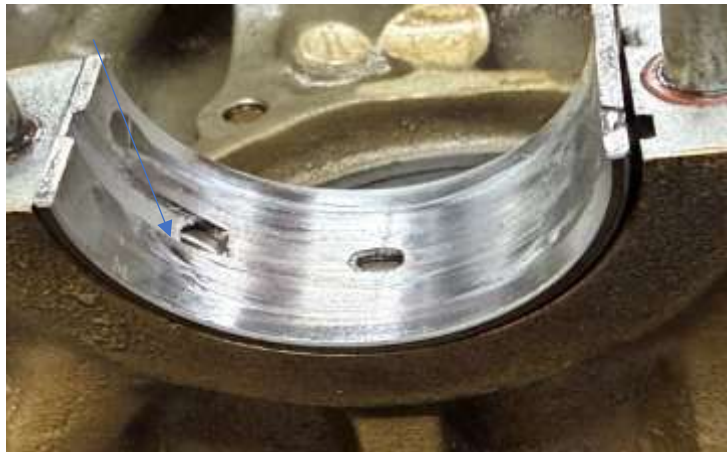
Figure 7 - The Crankcase bearing No.3 holder with scratches.

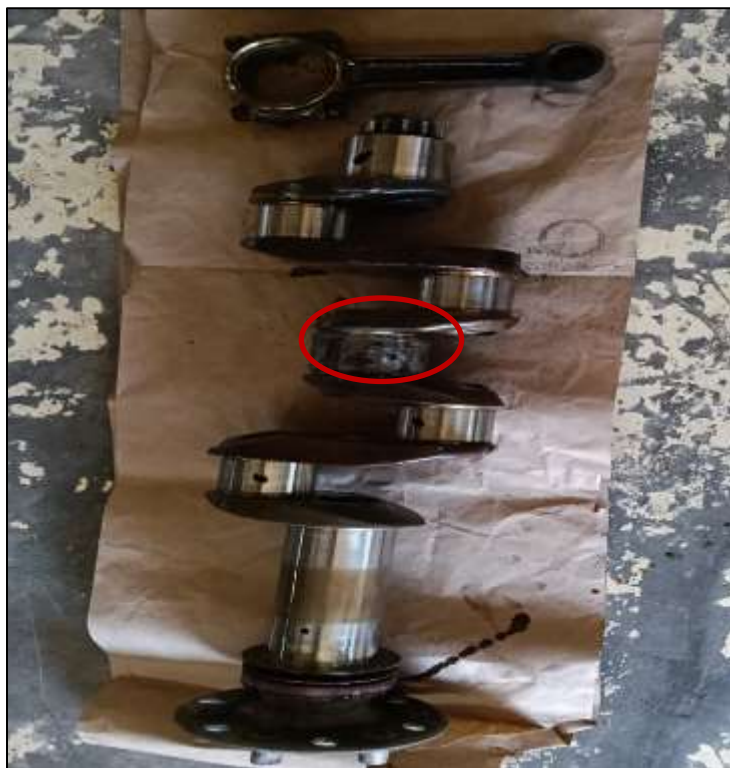
Figure 8 - Showing the #3 bearing still attached to crankshaft.

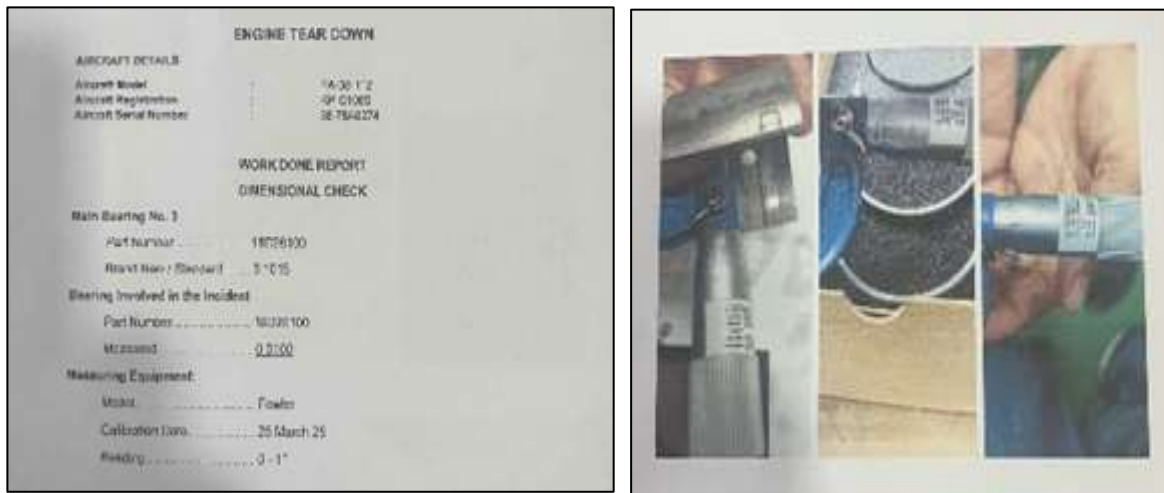
During the teardown inspection, the number 3 bearing showed damage, and when examined further, it revealed that its dimension was not within the normal parameters that likely caused the engine to fail.

Figure 9 - Dimensions of bearing #3 not within normal dimensions.

During the flight, the pilots reported intermittent sputtering sounds emanating from the engine before it ultimately ceased operation, indicating a probable mechanical malfunction. Although the worn bearing did not exhibit signs of overheating, initial indications suggest the presence of early-stage deterioration, which may have contributed to the engine failure.

- a. Worn-out number 3 bearing.
