AIRCRAFT ACCIDENT INVESTIGATION AND INQUIRY BOARD

FINAL REPORT

RP-C1762
CESSNA 152

TITLE: A serious incident involving a Textron Aviation Inc., Cessna 152 type of aircraft with Registry Number RP-C1762 operated by All Asia Aviation Academy, that resulted to a runway excursion during landing roll at Iba Community Airport, Iba, Zambales, Philippines on September 9, 2020 at about 1230H/0430UTC.

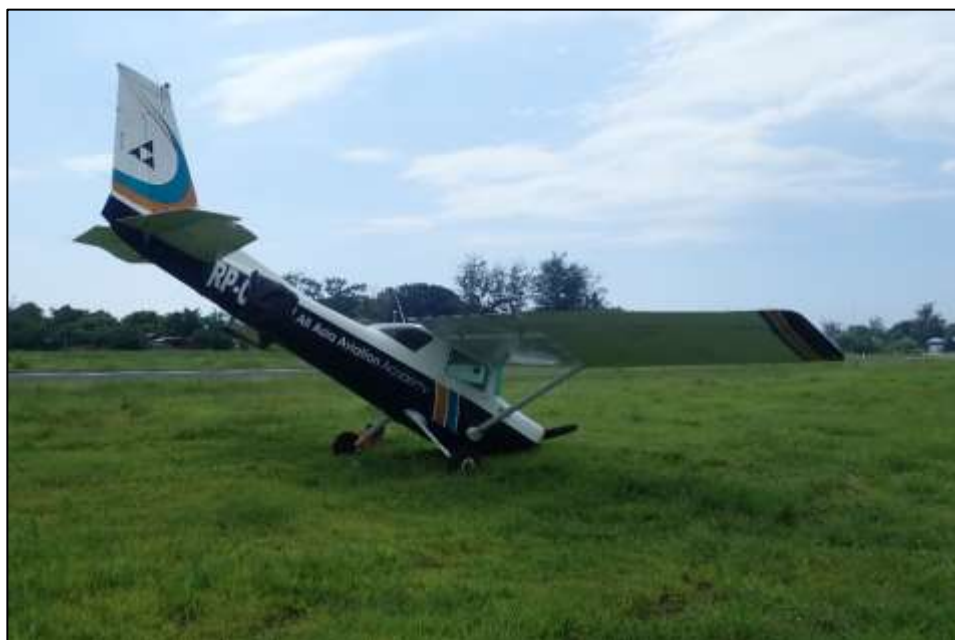
Figure 1 - RP-C1762 Final resting point.

The aircraft came to a complete stop in a nose-down position on soft ground, heading 330 degrees. Based on the tire marks on the runway, the aircraft landed to the right of the centerline. While on the landing roll, it veered to the right side of runway 32 (Figure 2). The aircraft continued to roll and departed the runway pavement into the grass field for another thirty meters (30 m) and subsequently collided with loose boulders that caused the NLG to collapse and subsequent propeller strikes (Figure 3-4). It traveled for another twenty meters (20 m) scrapping the ground and came to a complete stop and final resting point at coordinates 15.325778 N 119.969056 E.

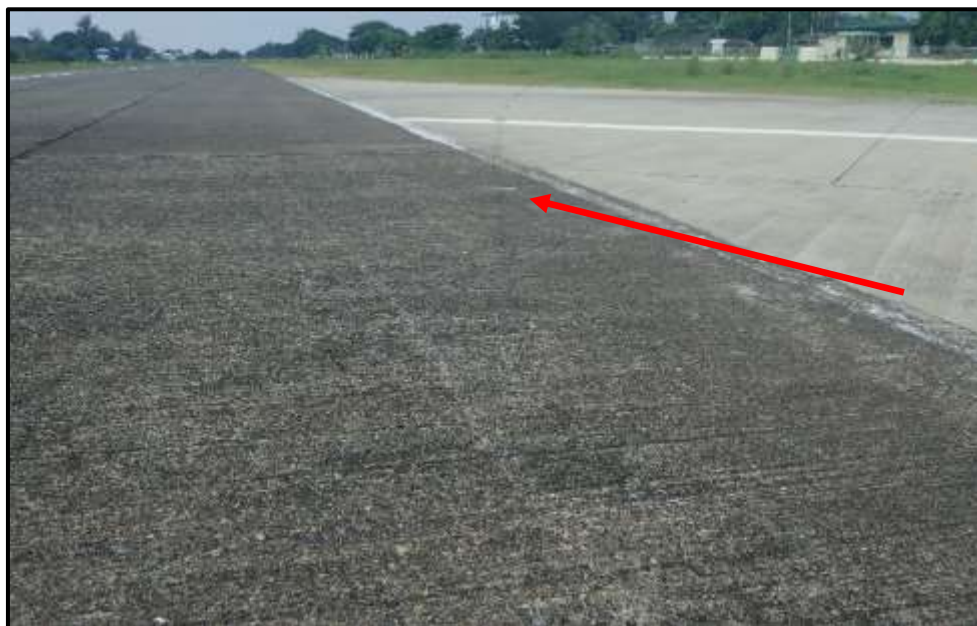
Figure 2 - Heavy tire marks leading outside of the runway.

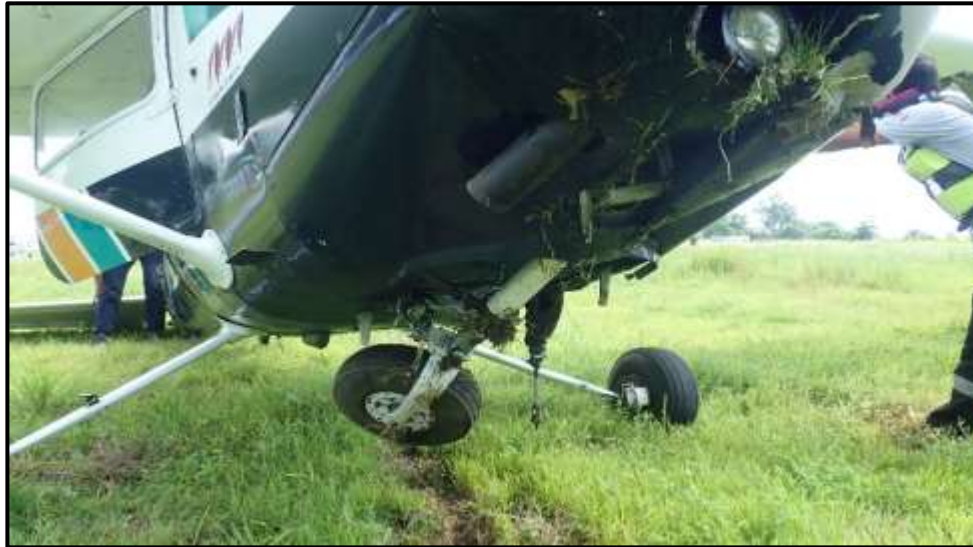
Figure 3 - Collapse nose landing gear.

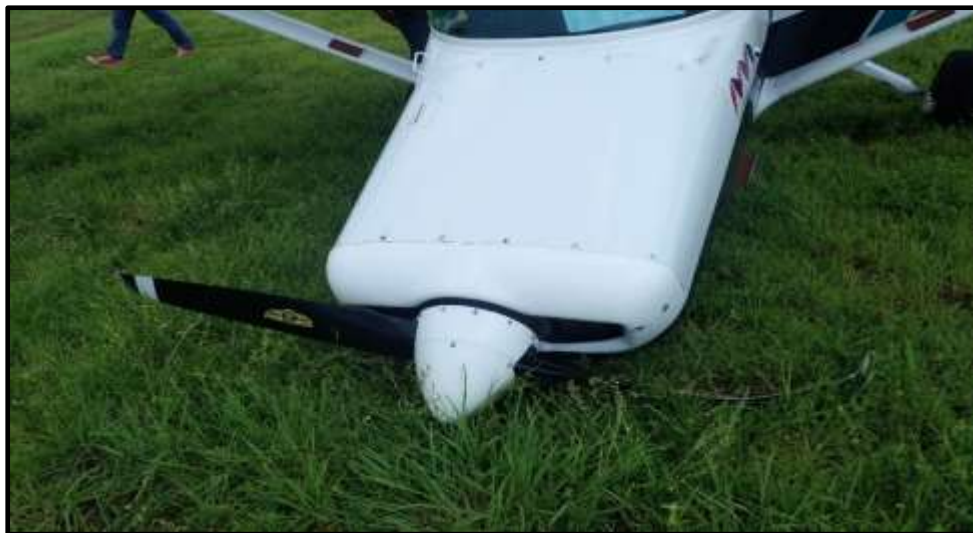
Figure 4 - Propeller ground strike.

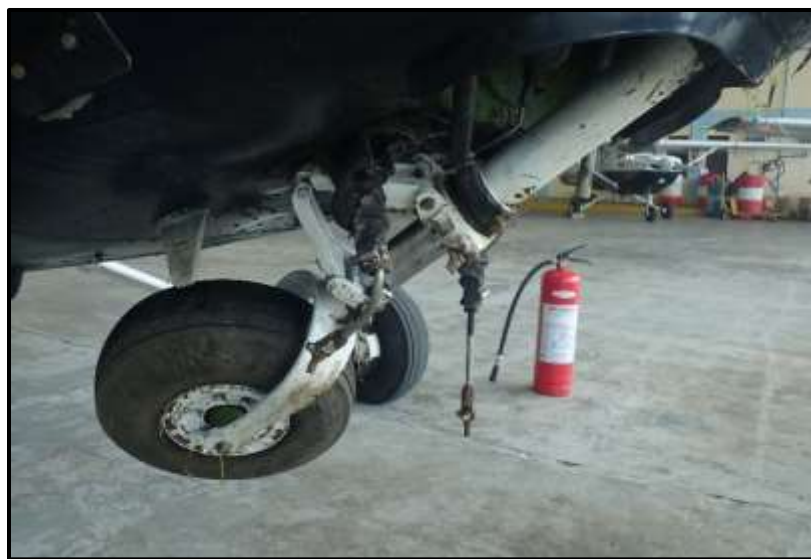
During the post-accident inspection, it was observed that the left-hand side of the nose landing gear (NLG) steering tube had sustained a fracture (Figure 5). Upon closer examination, it became evident that this fracture had occurred prior to the aircraft's contact with the loose boulder on the runway. The fracture was not a direct result of the ground impact but instead appears to have developed progressively over time due to operational stress.

Earlier in the day, the aircraft was engaged in a series of training flights that included multiple touch-and-go landings, particularly during the leg to RPUG. While no nose wheel shimmy or abnormal steering behavior was reported by either the pilots or the maintenance crew during pre- and post-flight checks, the repeated stress loads on the steering mechanism, particularly during touchdown and ground roll that likely contributed to the gradual propagation of a crack in the left-hand steering tube.

Each touchdown would have subjected the nose gear to compressive and torsional forces, and over several cycles, these forces may have initiated metal fatigue in the steering tube, especially if a pre-existing microfracture or material flaw was present. As the crack incrementally expanded with each subsequent landing, the structural integrity of the left-hand steering tube was progressively compromised.

On the final leg of the flight to RPUI, the aircraft executed a full-stop landing. It was during this landing that the left-hand steering tube suffered complete failure, likely at a weakened point due to accumulated fatigue damage. With the left-side tube

fractured, only the right-hand steering tube remained intact, resulting in a loss of balanced steering input. Consequently, the steering assembly was no longer centered, causing the aircraft to involuntarily veer to the right during the landing rollout. This deviation ultimately led to the aircraft exiting the runway surface.

Figure 5 - The damaged NLG left steering tube.

This sequence of events underscores the critical importance of closely monitoring the NLG steering tubes, especially after multiple hard landings or extended training operations involving repetitive touch-and-go procedures. Since the initial signs of failure were not visible during routine inspections or noted by the flight crew, it suggests that fatigue-related damage can remain hidden until the point of structural failure. Therefore, a more detailed inspection protocol should be considered for steering tubes during frequent-use training operations or after any suspected nose gear-related anomalies.

- a. To ensure that the operator, All Asia Aviation Academy, includes in their company maintenance program the detailed mechanical and structural assessment of the nose landing gear steering tubes every 100 hours or as necessary.
