# **AIRCRAFT ACCIDENT INVESTIGATION AND INQUIRY BOARD**

## **FINAL REPORT**

### **RP-C7202** **AVION TRANSPORT REGIONAL ATR 72-212A**

Type of Occurrence : Runway Side Excursion

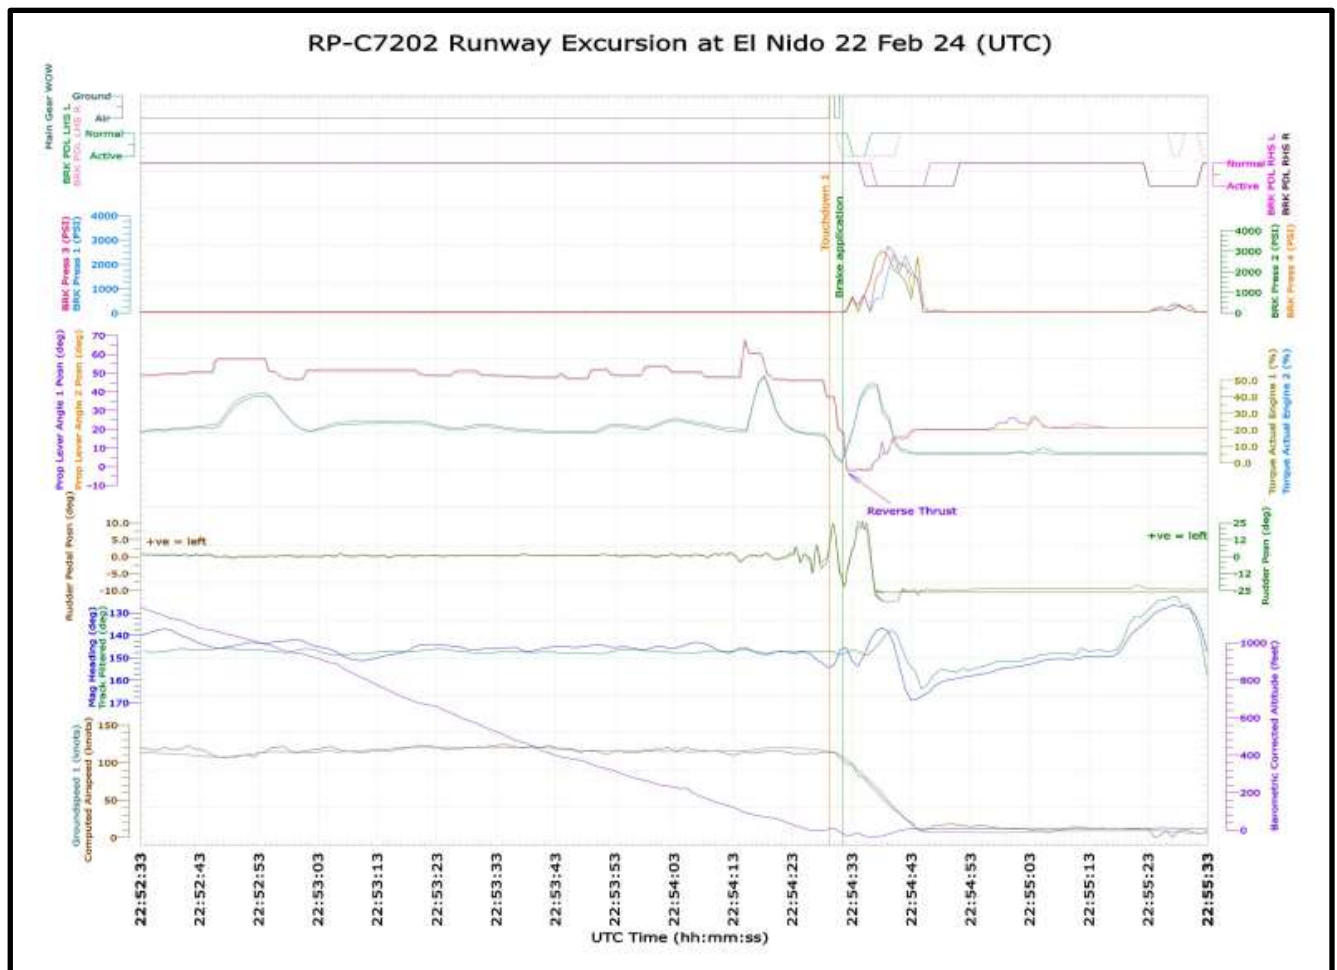
At 22:54:44 UTC, the aircraft was back within the runway centerline at approximately 1,000 meters from the threshold of runway 15. Aircraft heading at this time was 169°, ground speed of 22 knots, and PL angle of 5° (TQ = 12%). A nose down effort on CM2 was noted to be released during this time.

Figure 3 – DFDR readout of RP-C7202 runway excursion.

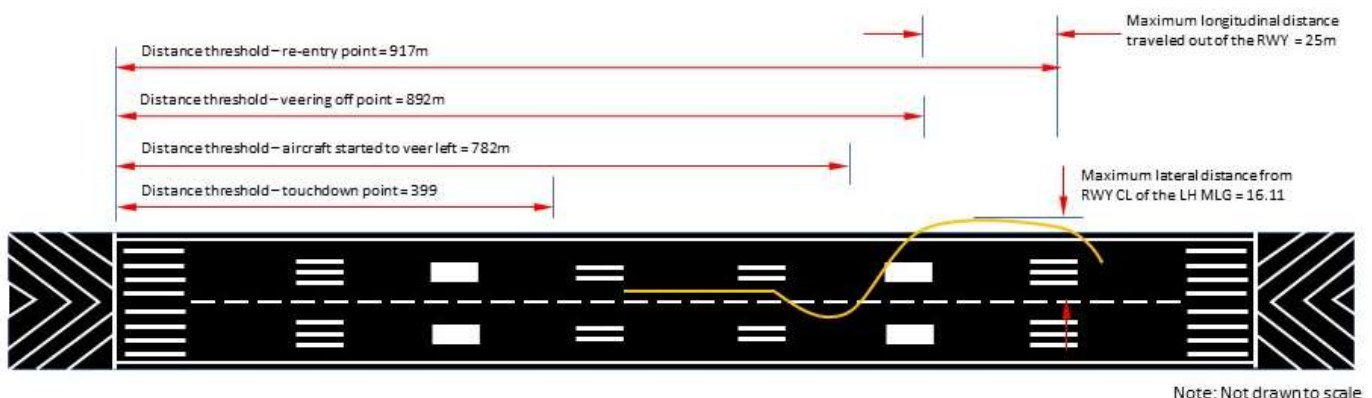
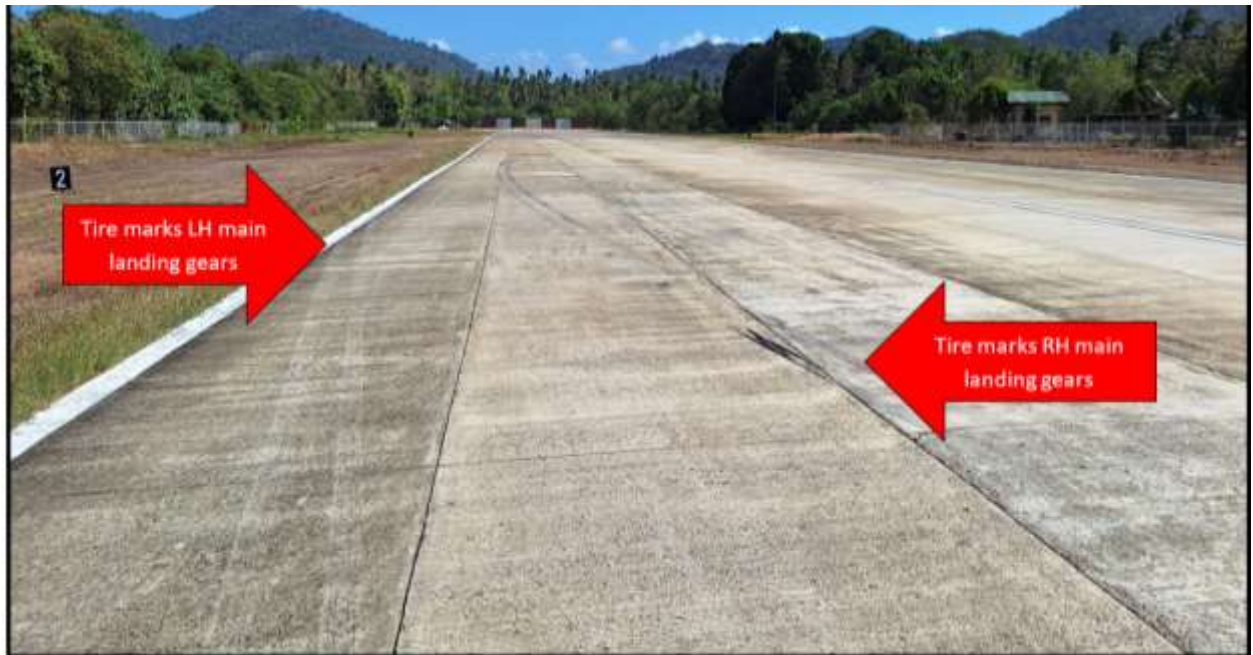
A post-incident runway inspection revealed evidence of hard braking by the right main landing gear. Similarly, tire marks indicated that the aircraft started to veer to the left side of the runway centerline, approximately 383 meters from its touchdown point. Additionally, traces showed that the aircraft's left main landing gear exited the paved portion of the runway approximately 493 meters from its touchdown point, at coordinates 11° 11' 56" N, 119° 25' 7.4" E. The left main landing gear spent approximately 25 meters in the grassy/unpaved area before returning to the concrete surface of the runway at coordinates 11° 11' 55" N, 119° 25' 7" E. Furthermore, the left main landing gear was out of the paved portion of the runway, approximately 16.11 meters from the runway centerline.

Figure 4 – Tire marks indicating the aircraft LH main landing gears exited the runway and evidence of hard braking actions on the RH main landing gear.

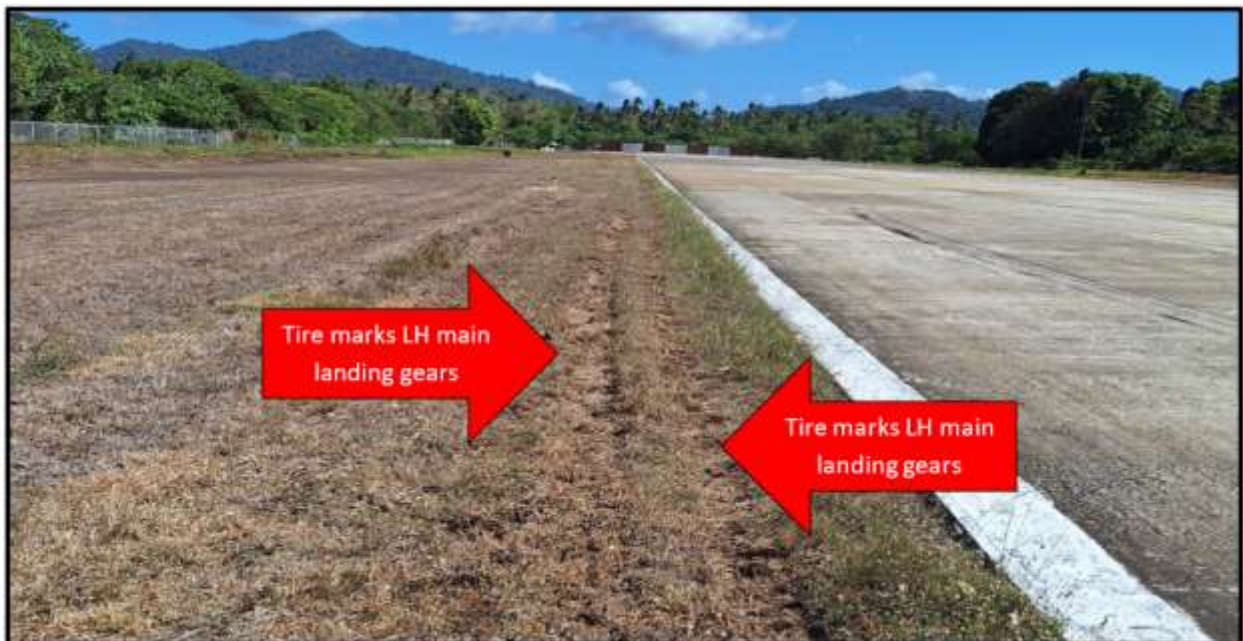
Figure 5 – Off runway tire marks.

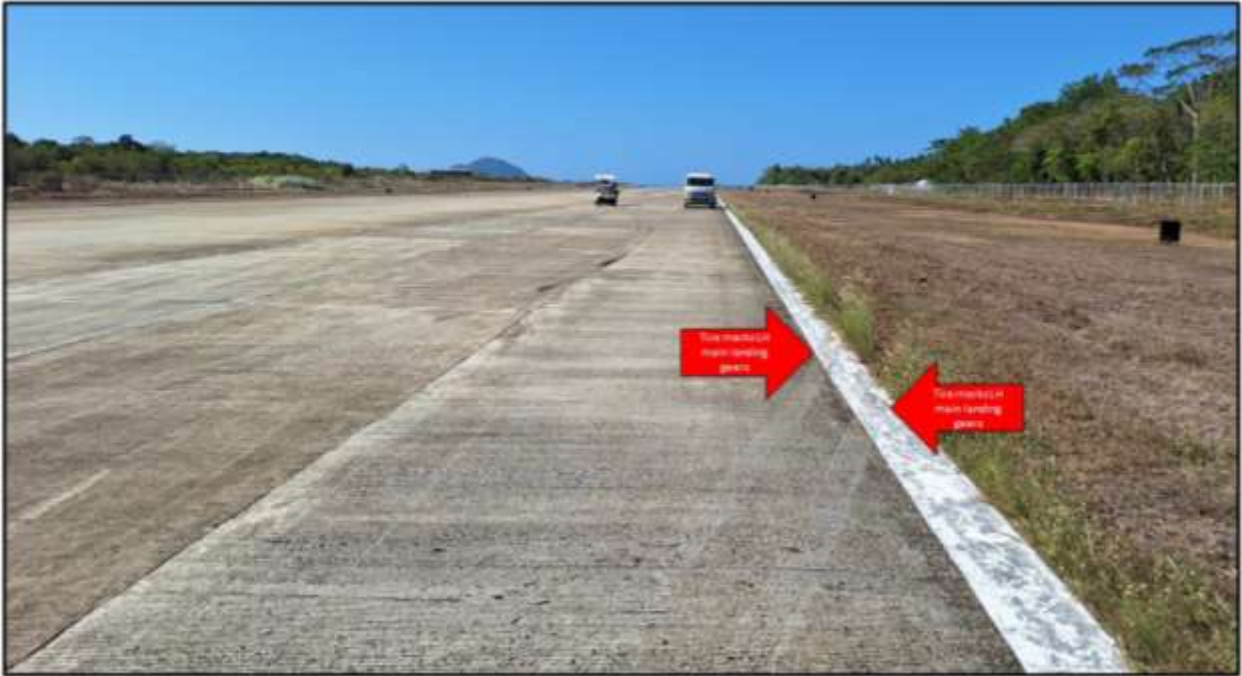
Figure 6 – Tire marks of the aircraft re-entering the paved portion of the runway.

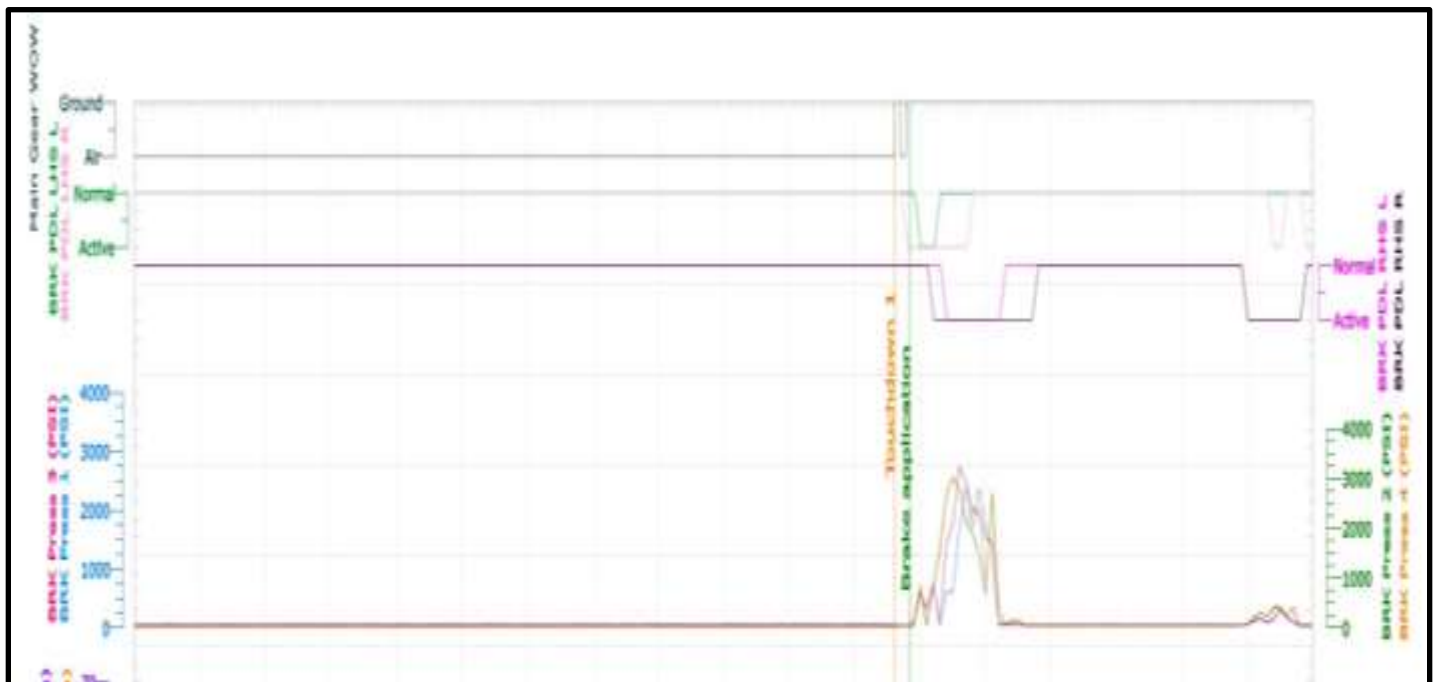
Figure 10 – Braking actions by the flight crew during the landing roll.

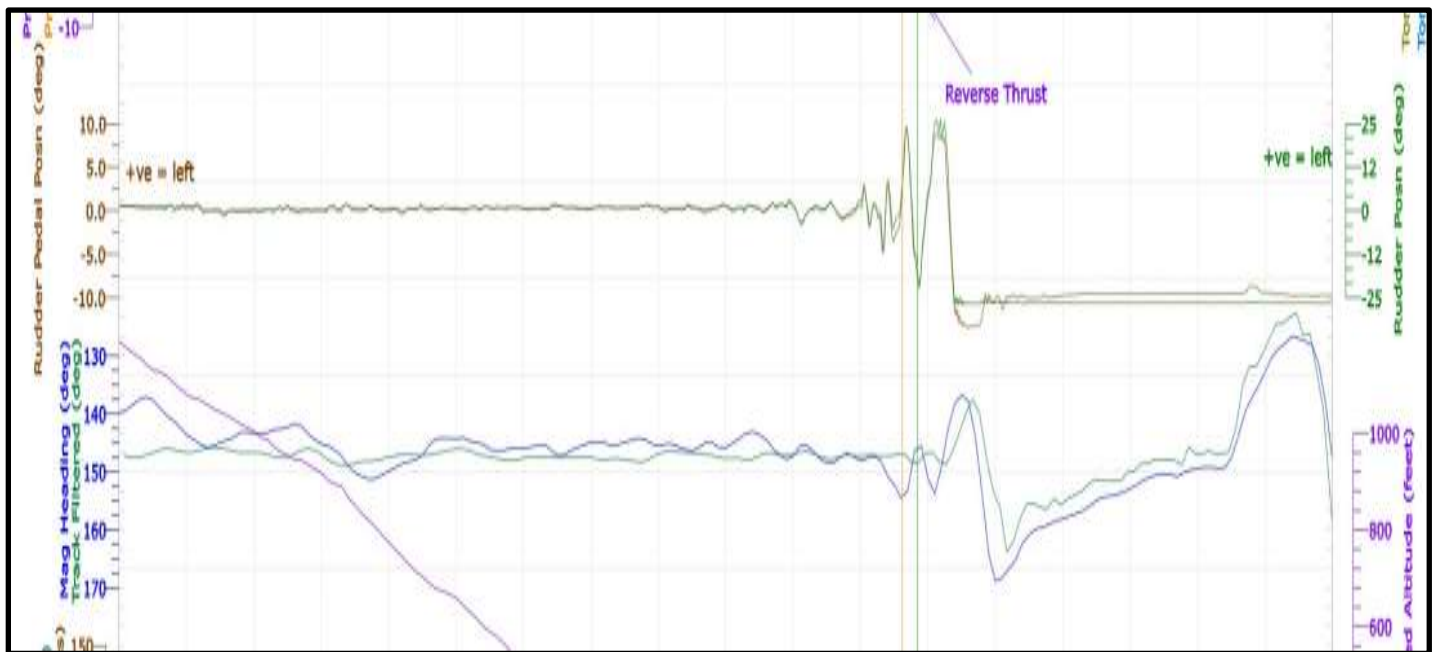
Figure 11 – The aircraft heading and rudder pedal inputs based on DFDR.

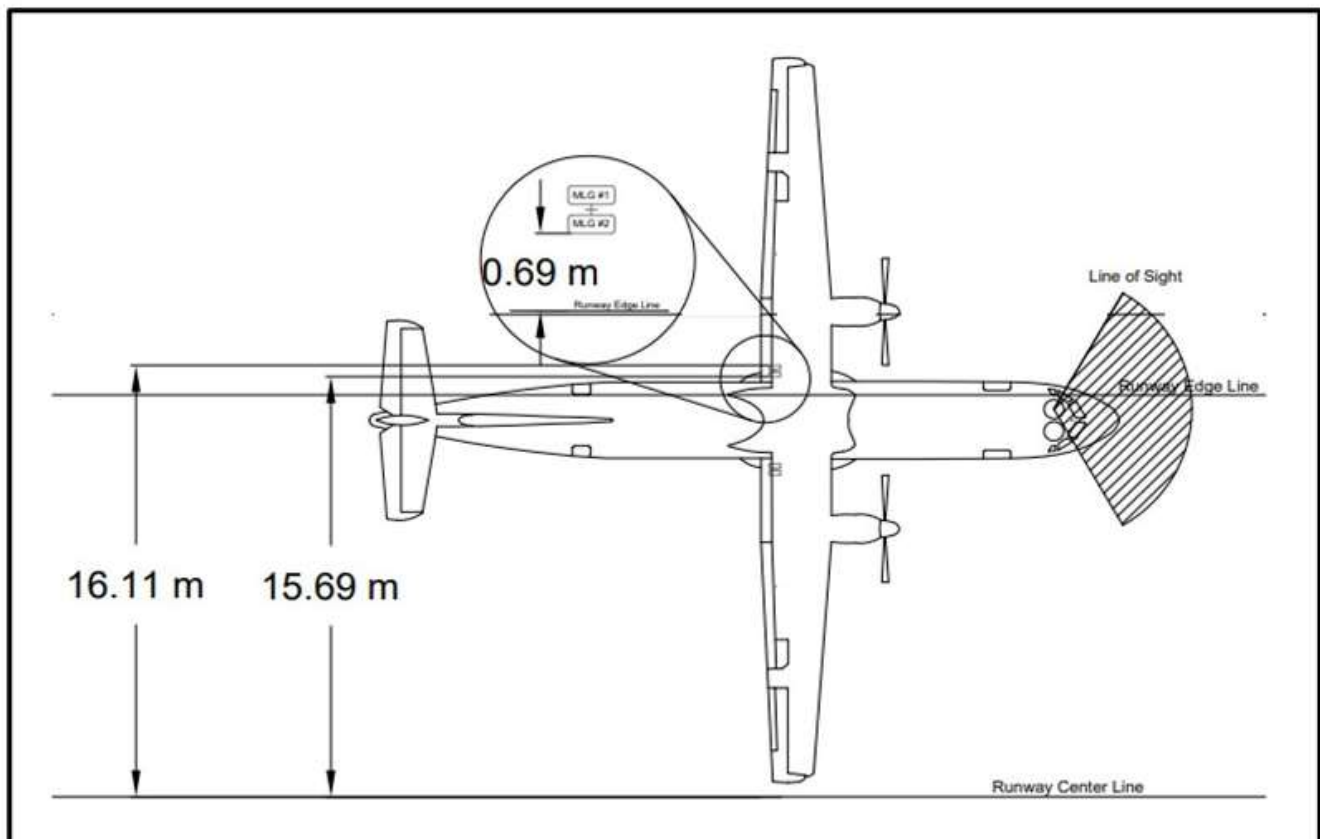
Based on the on-site investigation, only the left-hand (LH) main landing gear tire marks were visible on the grass outside the runway, indicating that the aircraft's runway excursion was less than 2 meters, based on the lateral distance between the main landing gear and the nose landing gear.

Figure 12 – Plotted tire track indicating the aircraft position from the runway centerline.

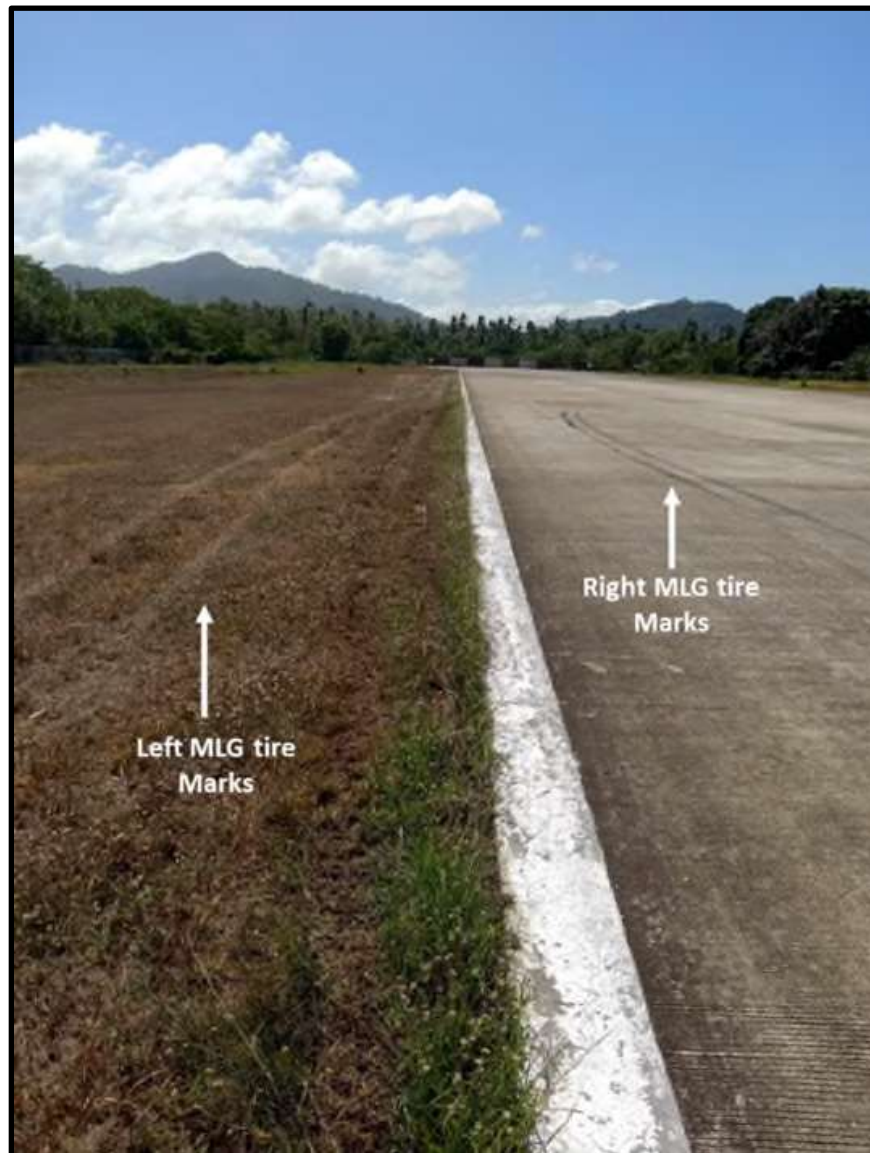
Figure 13 – Aircraft tire marks on the incident site.

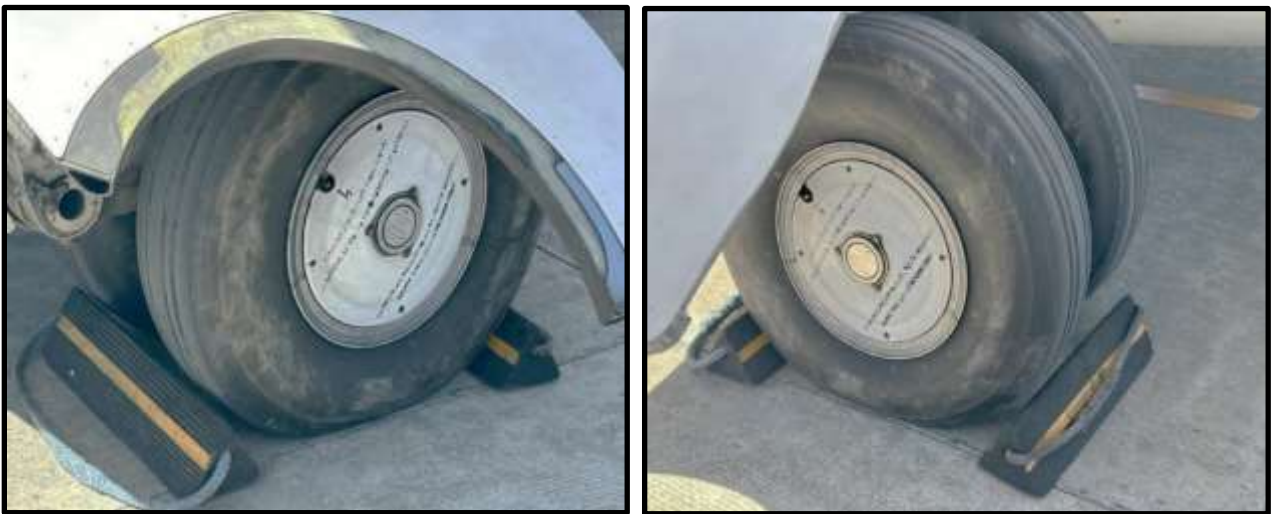
Figure 14 – LH MLG tires after flight ATX-126, which was the 3<sup>rd</sup> flight following the incident.

- 3.1.10** The flight crew and maintenance personnel failed to diligently assess the actual condition of the left main landing gear tires during their walkaround inspection. This indicates that the inspection was not conducted thoroughly, missing critical signs that could have highlighted the aircraft's condition after landing.

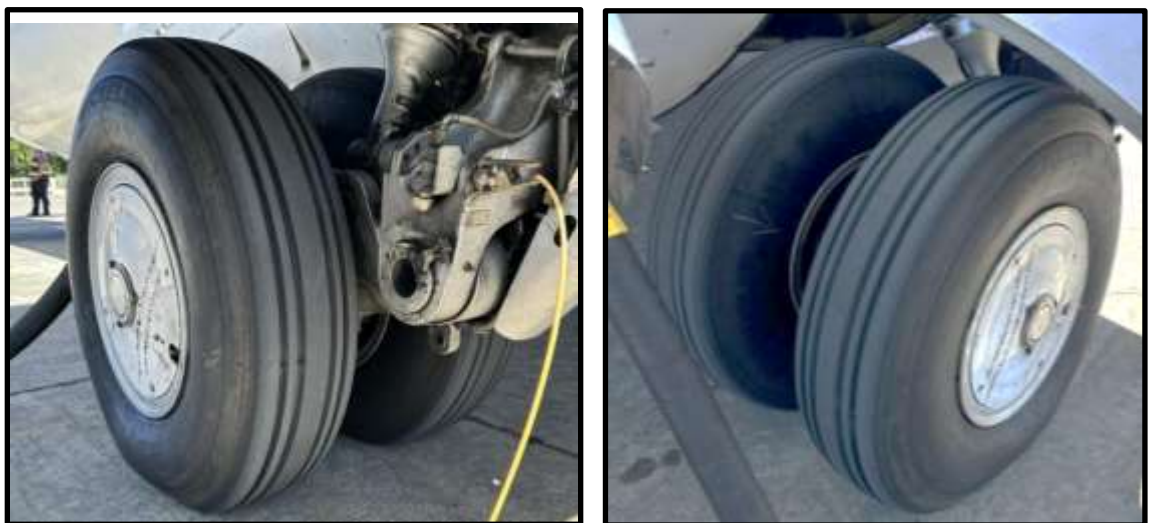
Figure 15 – RH MLG tires after flight ATX-126, which was the 3<sup>rd</sup> flight following the incident.

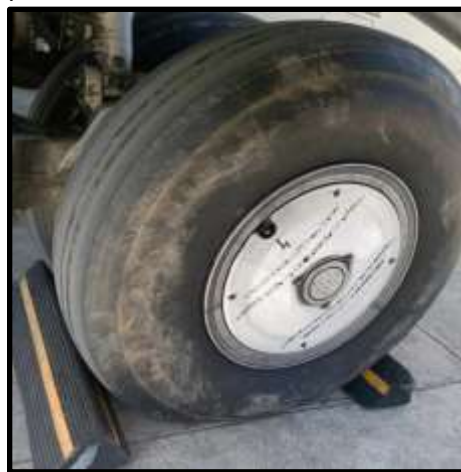
Figure 16 – MLG tires that encountered a runway excursion

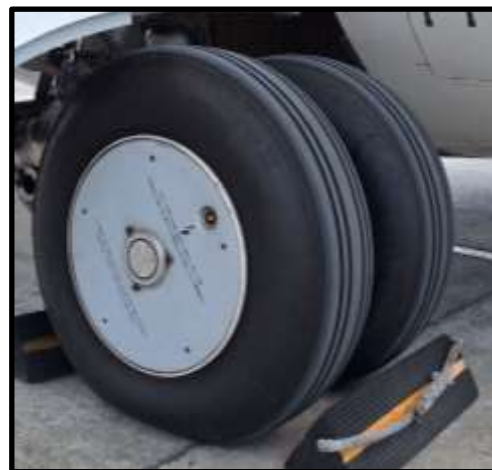
Figure 17 – MLG tires that did not encounter a runway excursion
