AIRCRAFT ACCIDENT INVESTIGATION AND INQUIRY BOARD

FINAL REPORT

<u>RP-C189</u> ROBINSON HELICOPTER COMPANY R44 II

PLACE OF OCCURRENCE: SITIO BABAHAGON, LANTAPAN, BUKIDNON, PHILIPPINES

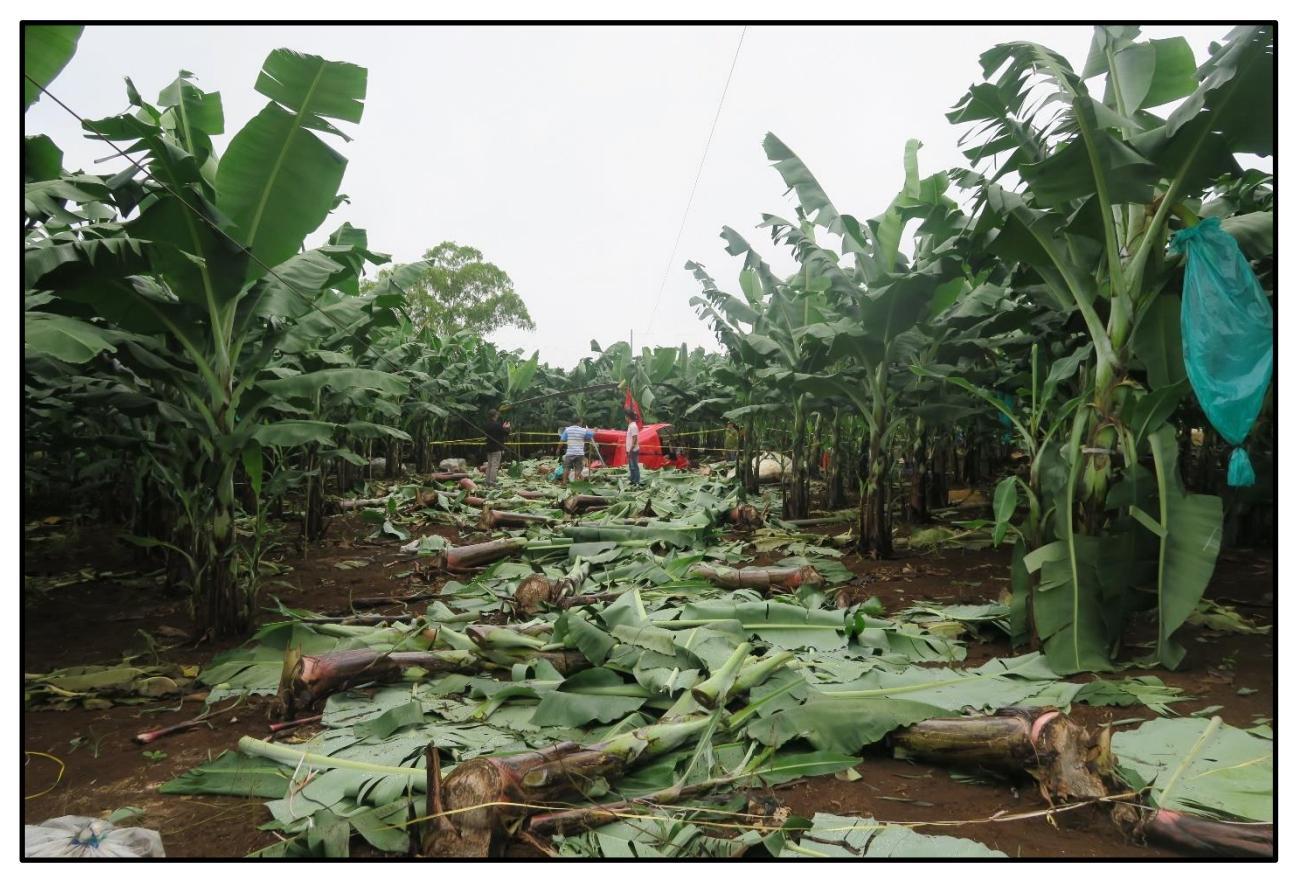
Damage to at least twenty (20) or more banana crops were noted at the accident site.

Figure 1 - Damaged banana crops at the accident site.

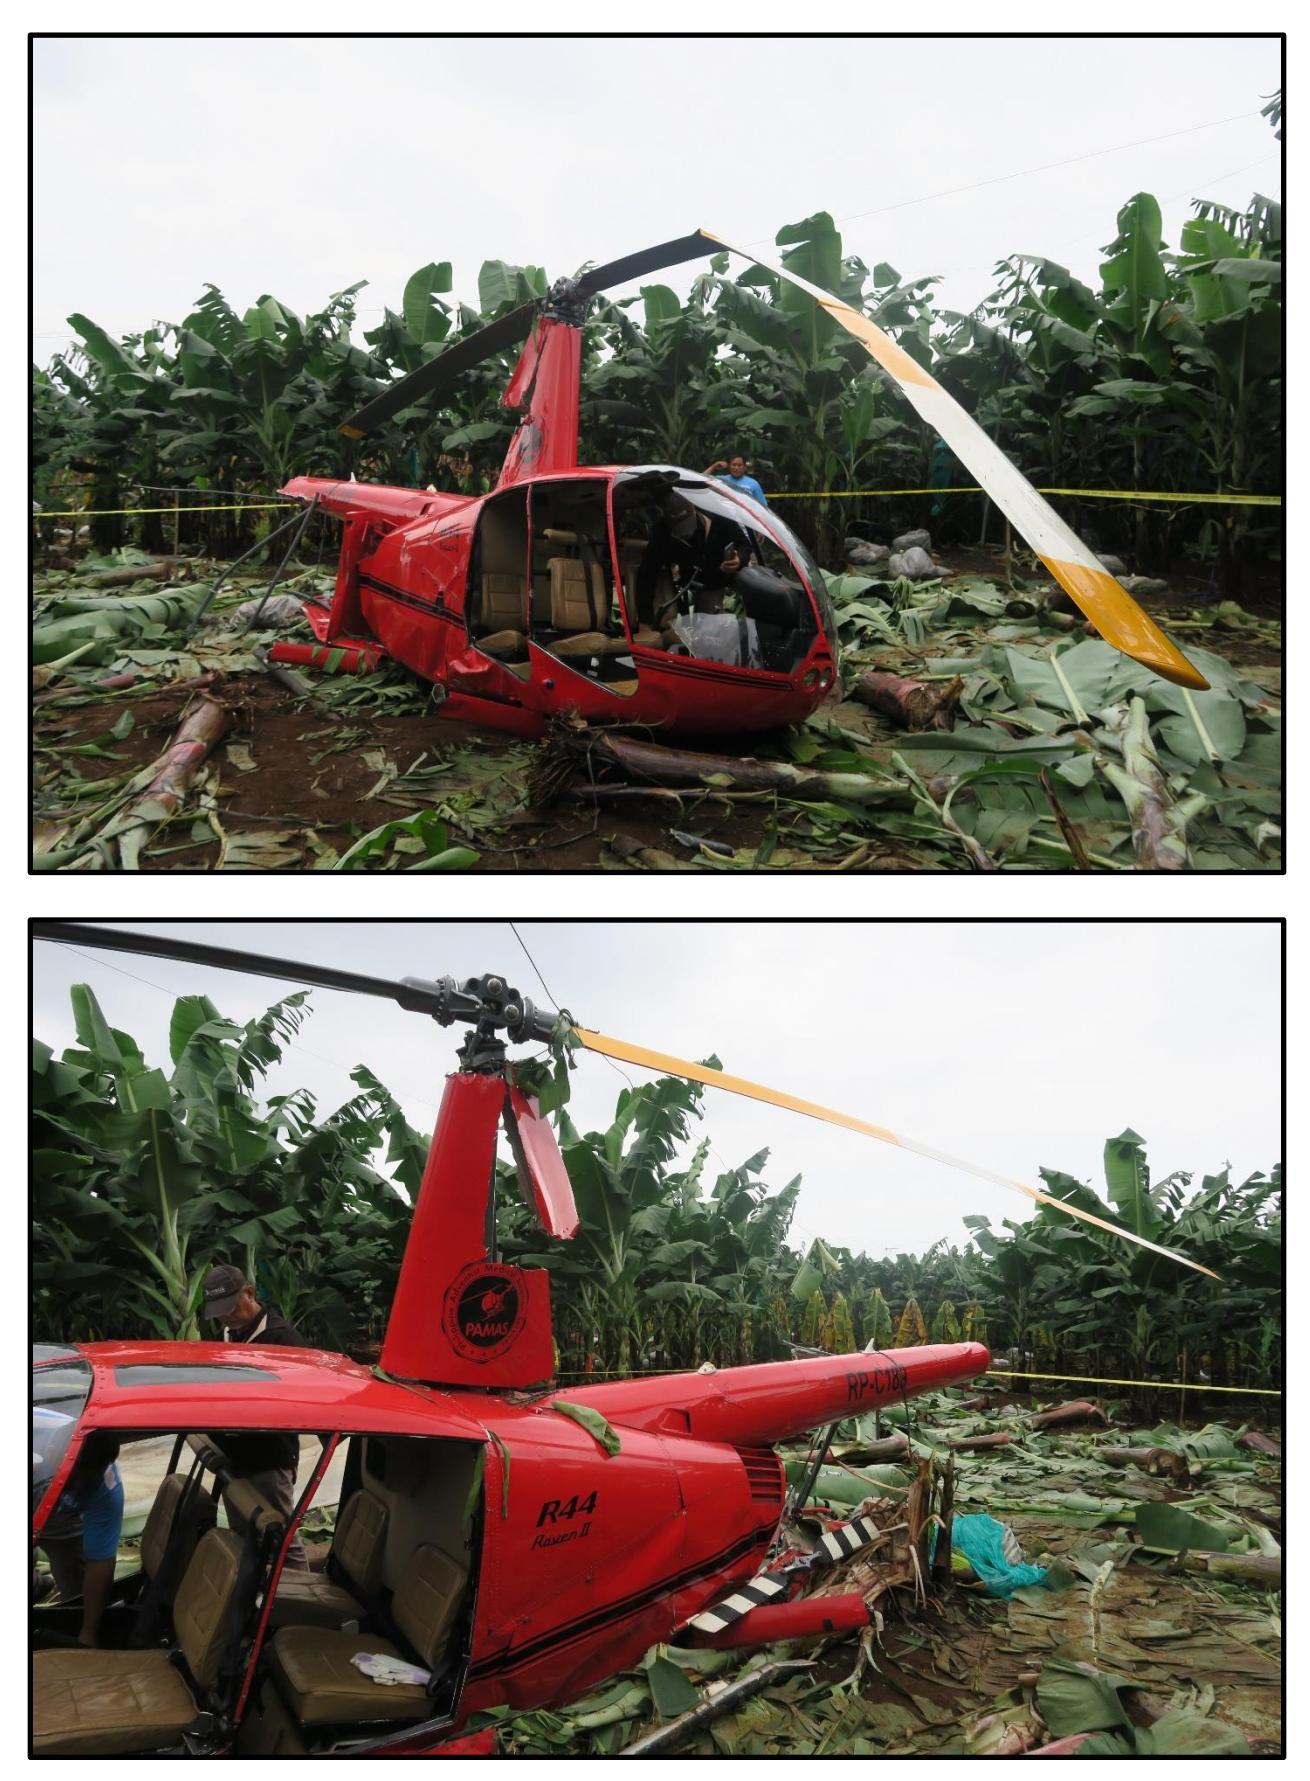
The aircraft wreckage (Figure 2 and 3) was found inside a banana plantation specifically at coordinates 7° 59' 48.8" N, 125° 03' 5.8" E and with a general heading of 321° NW. The site was approximately 2.51 kilometers from the PAMAS airstrip.

Figure 2 and 3 – The aircraft wreckage.

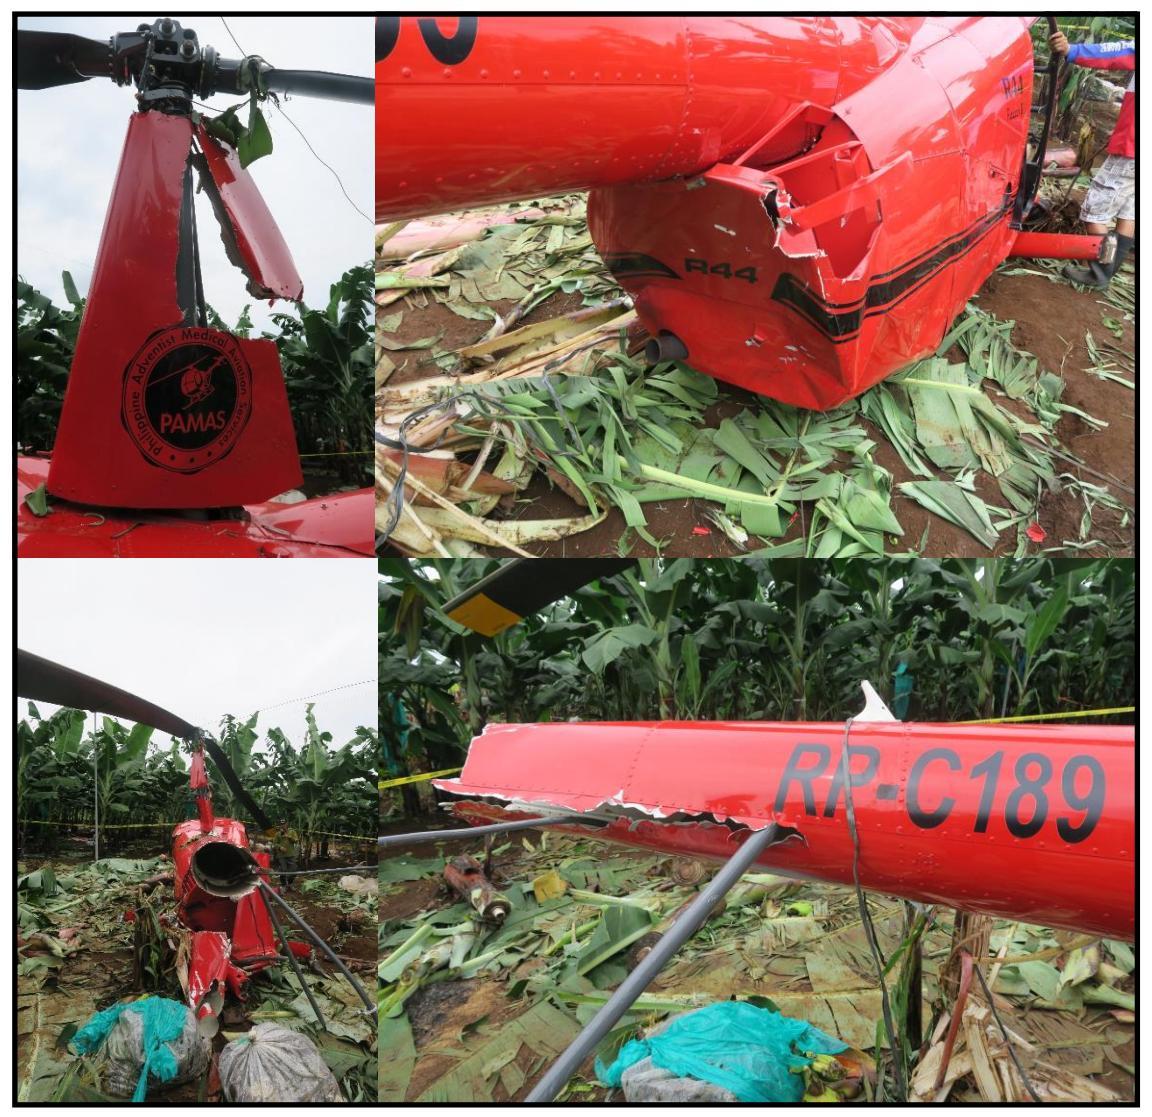
Inspection of the crash site revealed that the aircraft incurred substantial damage to its structures and flight controls (Figure 4) upon impact with the vegetation (banana trees) and the ground.

Figure 4 – Damages incurred by RP-C189.
