AIRCRAFT ACCIDENT INVESTIGATION AND INQUIRY BOARD

FINAL REPORT

RP-C1906 TEXTRON AVIATION INC. 172M

DATE OF OCCURRENCE: OCTOBER 30, 2024

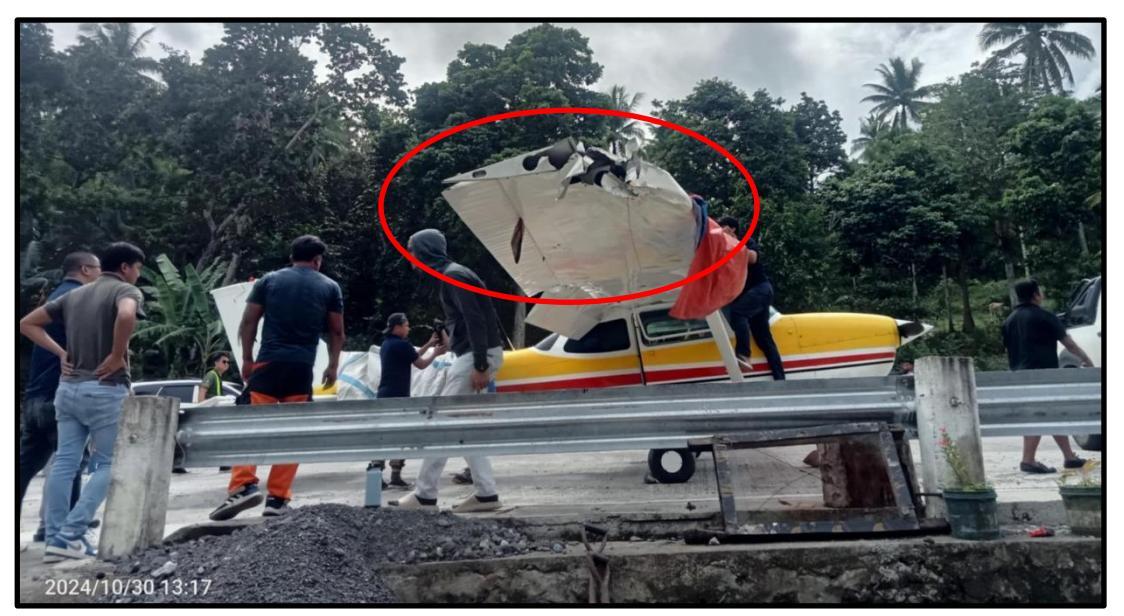
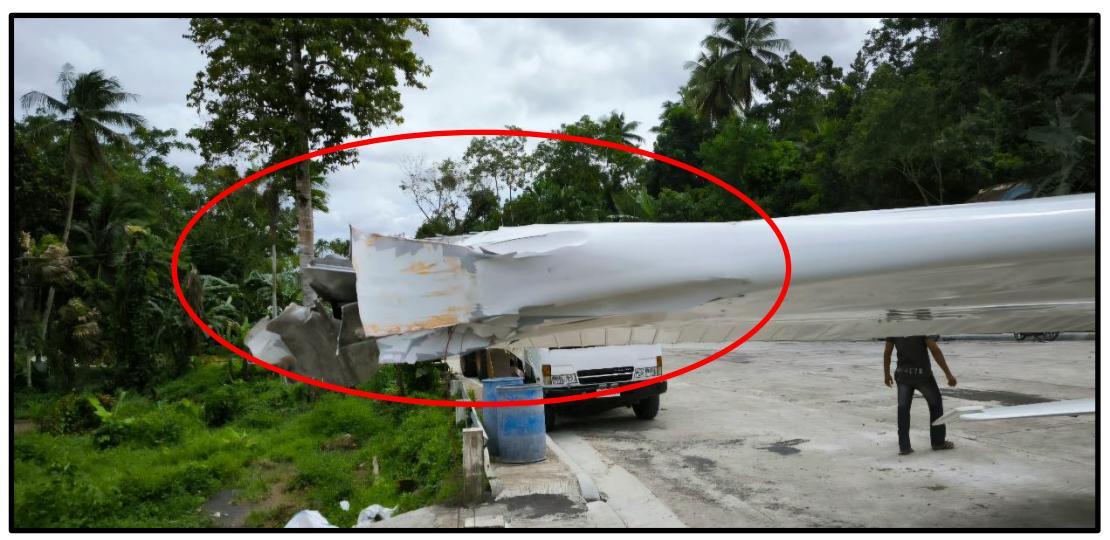
Figures 1 and 2 – Damage on the aircraft's right-hand wing tip.

The aircraft sustained damage to its right wingtip cap, leading edge, and flaps. Additionally, a leak was detected in the right-wing fuel tank, and the right-side passenger window was broken. These damages were caused by the aircraft's contact with heavy equipment parked at the landing site.

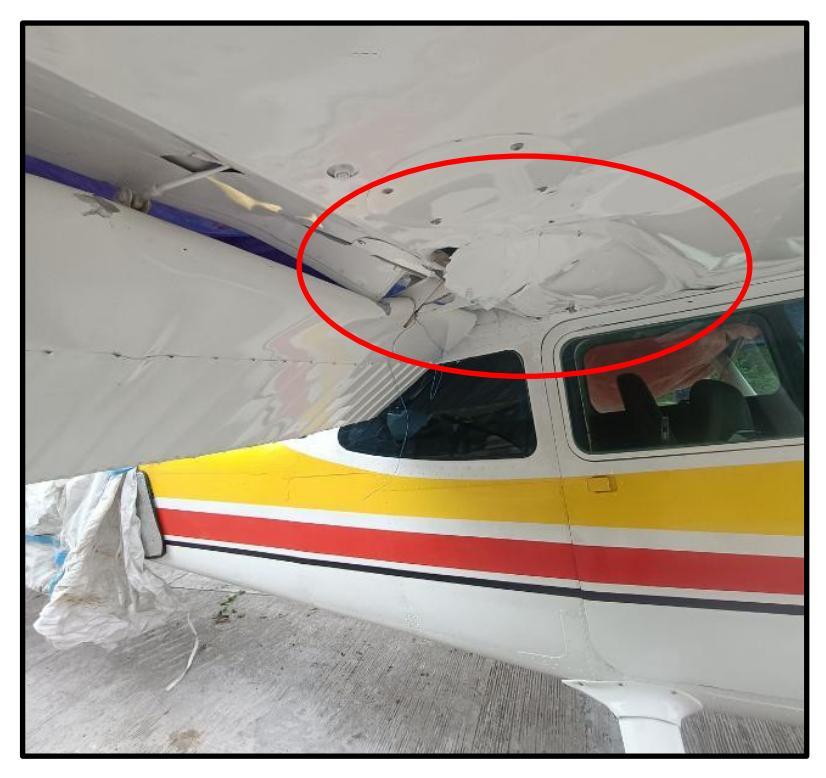
Figure 3 – Damage on the aircraft's right-hand wing root.

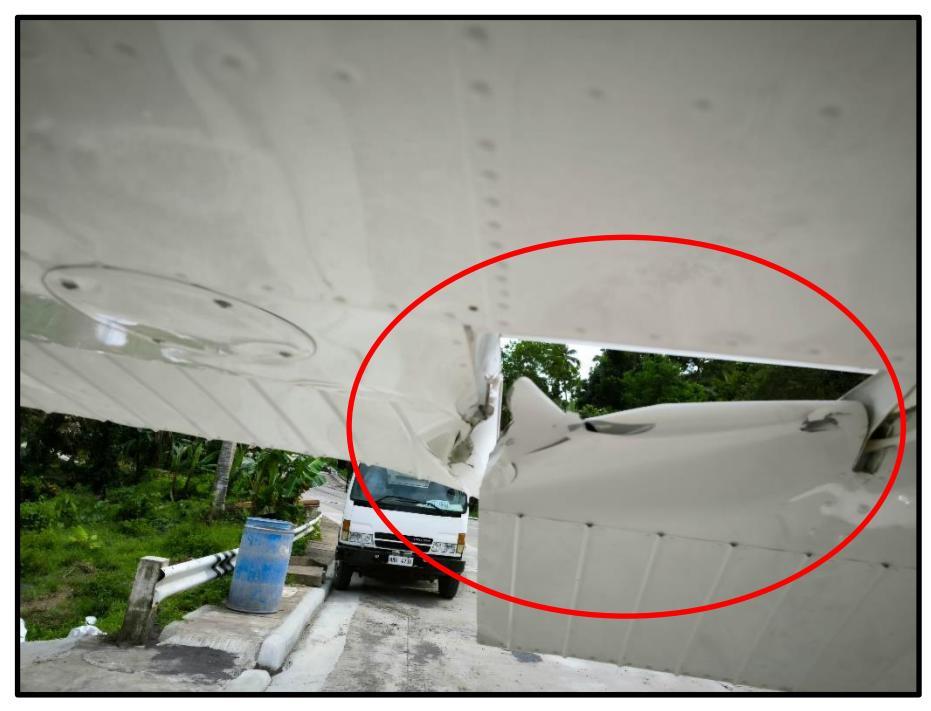
Figure 4 – Damage on the aircraft's right-hand wing flaps.

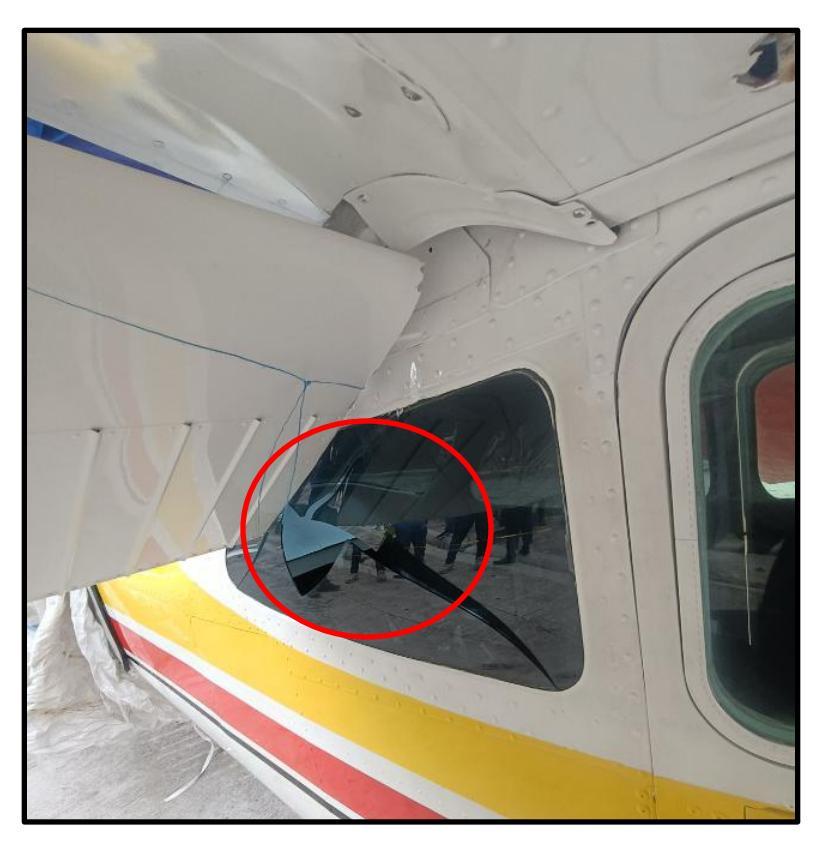
Figure 5 – Broken right-hand side passenger window.

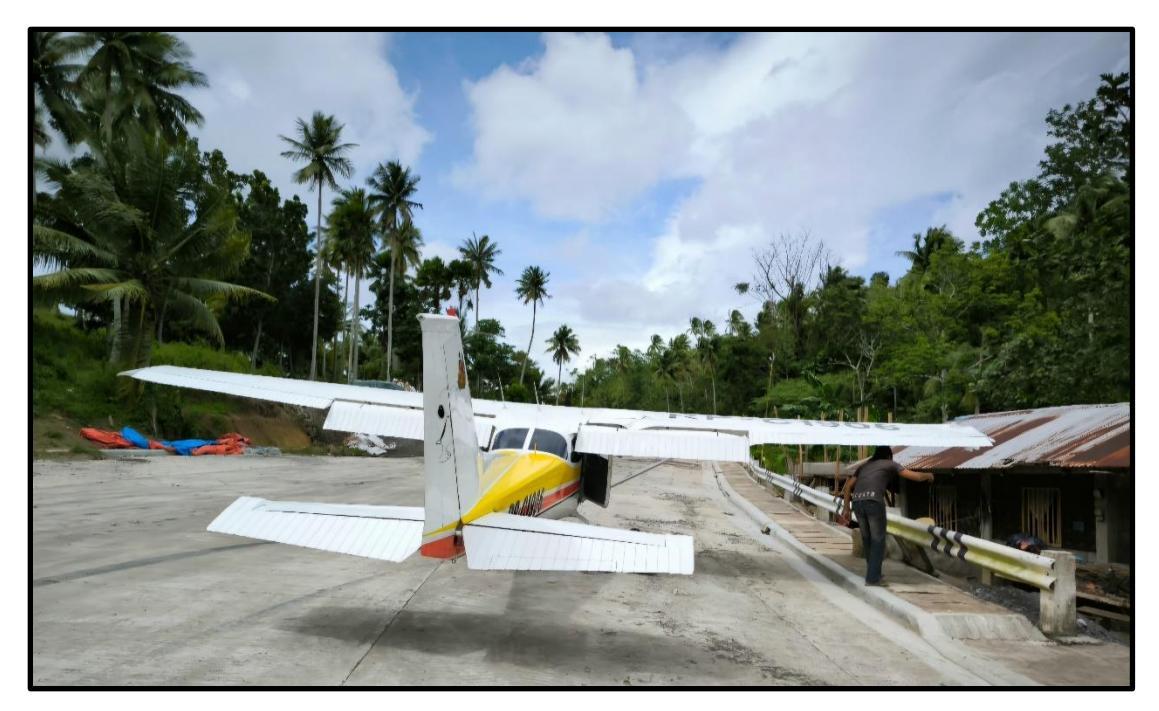
Figure 6 – The aircraft at its final stopping point.

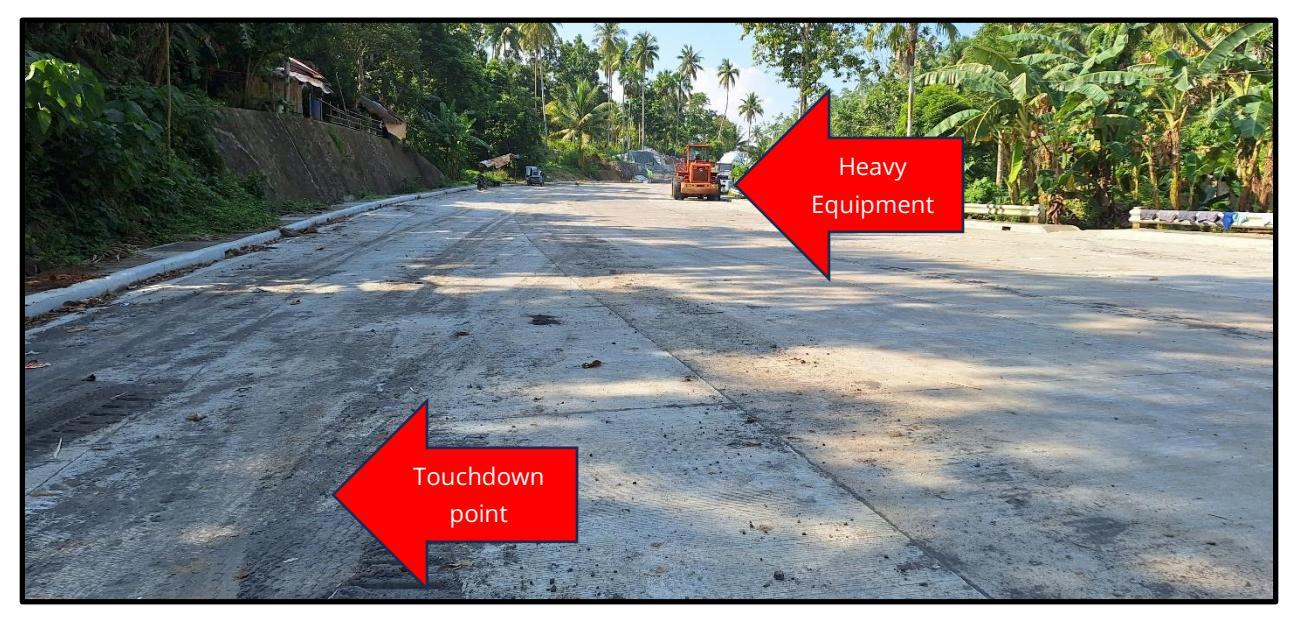
The pilot managed to land the aircraft on a newly constructed road, carefully maneuvering it away from electrical cables and bystanders in the area before it finally came to a full stop after its right-wing tip made contact with a part of the heavy equipment parked along the road.

Figure 7 – The aircraft's touchdown spot and the heavy equipment parked at the side of the road.

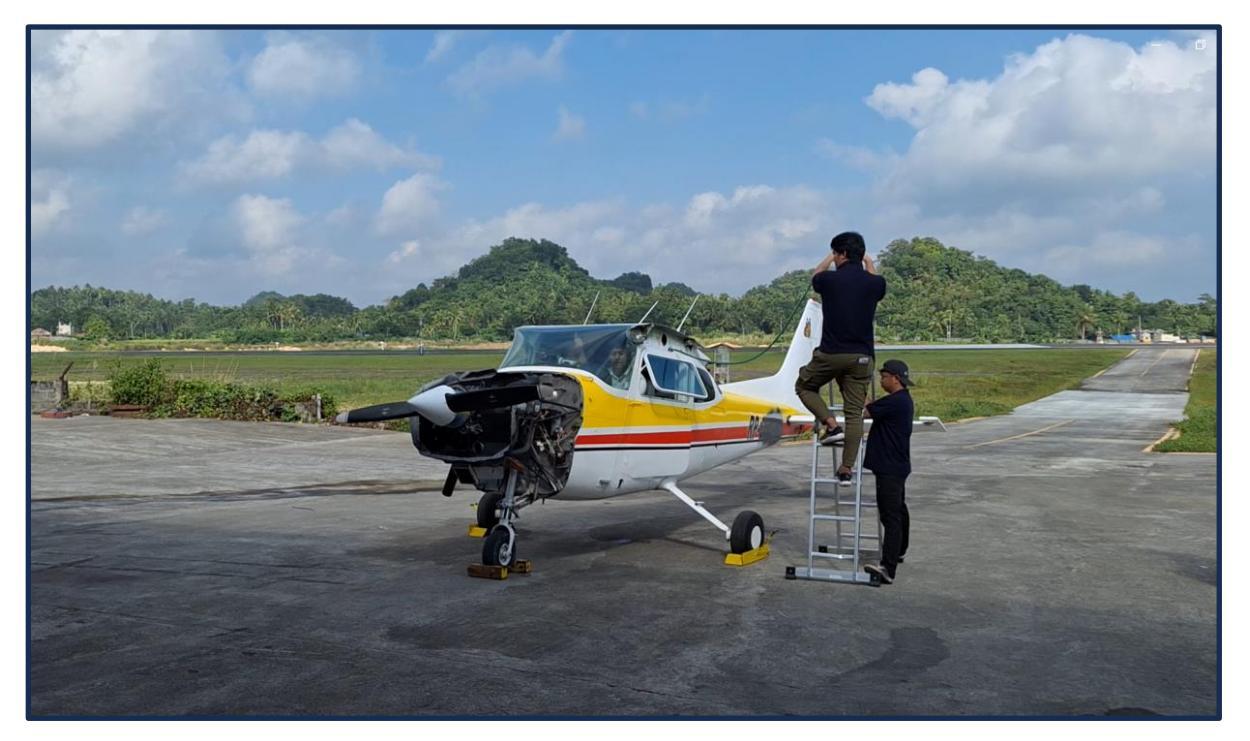
The first test involved conducting a ground run of the engine to replicate the scenario encountered during the incident flight. Various engine power settings were performed to evaluate engine performance. During this test at varying engine rpm, parameters such as oil pressure, oil temperature, and suction were all observed to be within normal limits. However, the engine showed rough performance at 1,700 rpm during magneto checks, especially when operating on the left magneto alone. Despite this, the rpm drop remained within the recommended allowable range for the specific engine type and model.

Figure 8 – The aircraft during engine run-up at Hi-Tone's hangar located beside BIA.

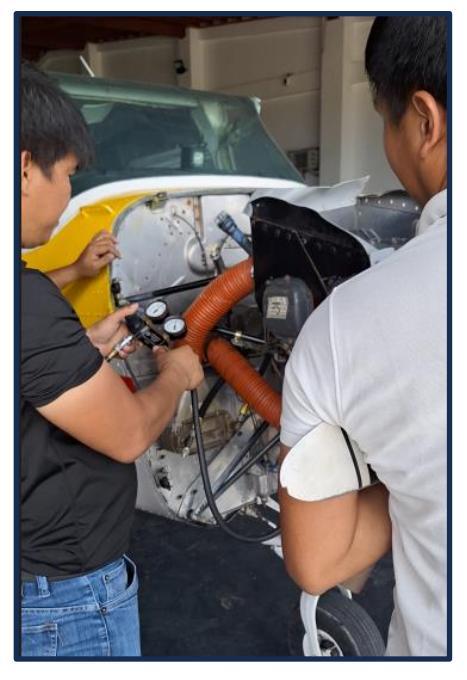
After the engine ground run, hot compression checks were performed on the engine's four (4) cylinders to evaluate their condition and the state of other internal components. The test results indicated that the engine components were functioning within Lycoming's specified acceptable limits.

Figure 9 – Hot compression checks on the aircraft engine's 4 cylinders.

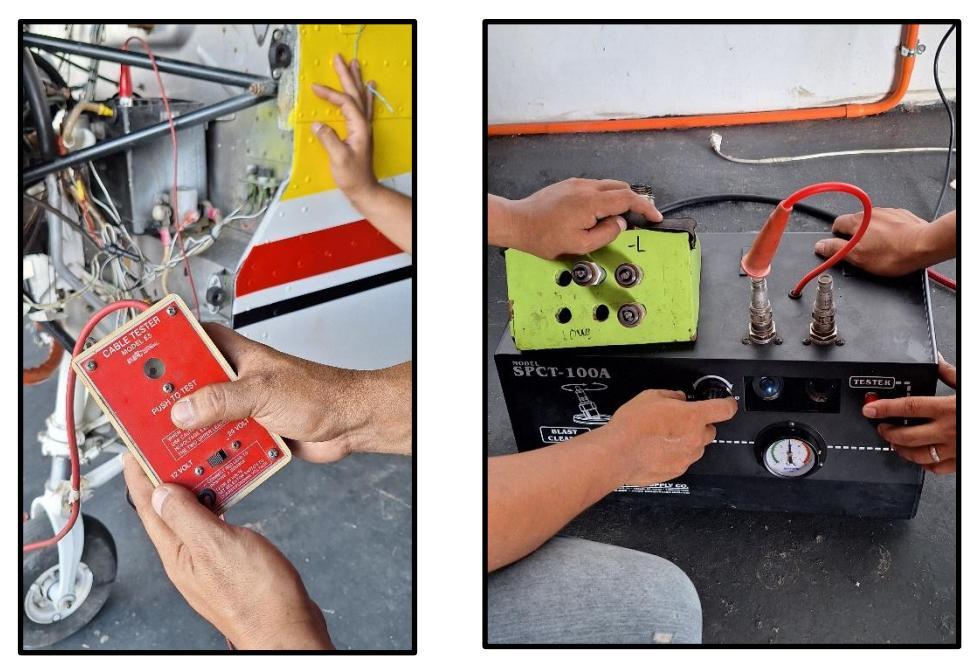
AAIIB-2025-054 Final Report RP-C1906, Textron Aviation Inc. 172 M An engine ignition harness test followed the compression check to ensure all components were functioning properly. The test began with a visual inspection to identify any physical damage to the wiring or loose connections. A performance check followed, which revealed that both the upper and lower harnesses of the no. 4 cylinder had failed, while the harnesses for the remaining cylinders were functioning correctly.

Taking into account the findings from the engine ignition harness test, a spark plug test was subsequently conducted using a spark plug tester to evaluate the condition and performance of the spark plugs. During the test, it was observed that the lower spark plug on cylinder no. 4 produced only a weak spark, while the rest generated adequate sparks.

Figures 10 and 11– Tests conducted on the engine ignition harness and spark plug.

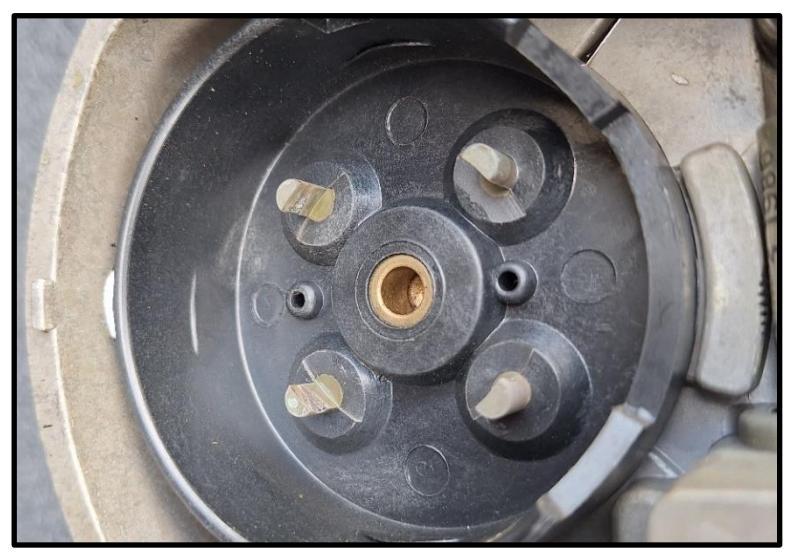
The next test involved inspecting the magneto. Only the left-hand (LH) magneto was removed from the engine, as the previous tests indicated only discrepancies or inconsistencies with the left magneto and cylinder no. 4. A spark test was performed on the magneto harness mounting, revealing a weak spark on the no. 4 connector, while the rest produced a significant spark. The magneto was then disassembled to inspect its internal components for signs of wear and tear, damage, misalignment, or the presence of deposits or debris that could hinder its operation. The inspection revealed significant erosion on the no. 4 distributor block contact point, which might have affected its ability to produce sufficient spark.

Figure 12– LH magneto distributor block.

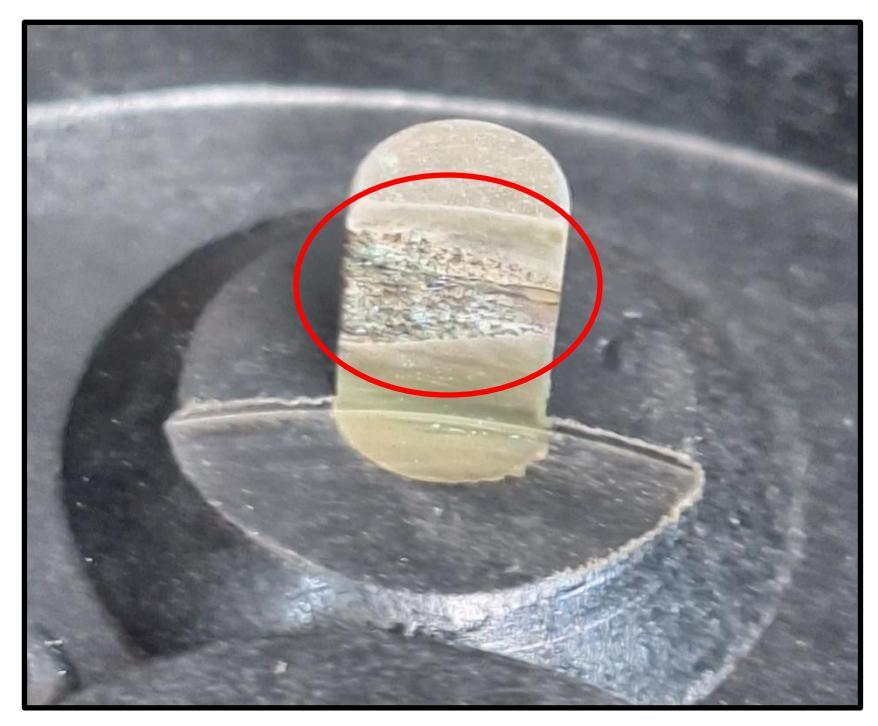
Figure 13– Noted significant erosion on the no. 4 distributor block contact point.

- 3.2.1 Primary Cause Factors
 - a. Magneto failure due to significant erosion on the no. 4 distributor block contact point, reducing its ability to produce a sufficient spark and likely contributing to the engine's poor performance.
- 3.2.2 Contributory Cause Factor
 - a. Current maintenance procedures do not require internal inspection of the magneto's components unless the 500-hour inspection threshold was met or special inspection was required.

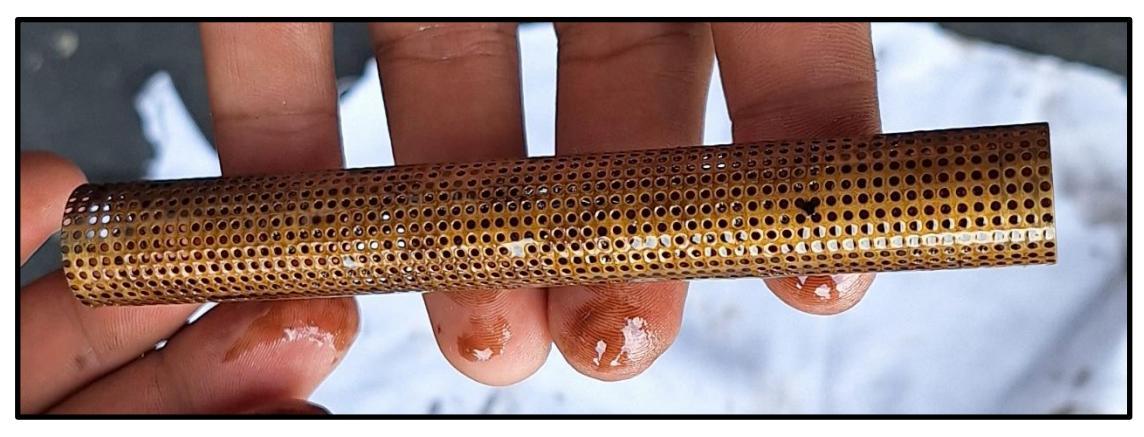
In addition to the above tests, oil and fuel checks were performed to identify possible contaminants that could have affected the engine's performance. For the oil check, samples were drained through the oil sump. No contaminants were found, even on the oil sump filter screen. Fuel was then tested for possible contaminants, particularly the presence of water. The test was conducted using a water-detecting paste, and the results confirmed that the sample was free of water contaminants.

Figure 14– Oil sump filter screen was noted to be free from any contaminants.
