FINAL REPORT

<u>RP-C4202</u> AVION DE TRANSPORT REGIONAL <u>ATR 42-500</u>

TITLE: An incident involving an ATR 42-500 type of aircraft with Registry Number RP-C4202 operated by AirSWIFT Transport, Inc., that had encountered a damaged aircraft main landing gear tires and wheel hubs during landing roll at Lio Airport, Runway 15, El Nido, Palawan, Philippines, on January 09, 2023, at around 1248H.

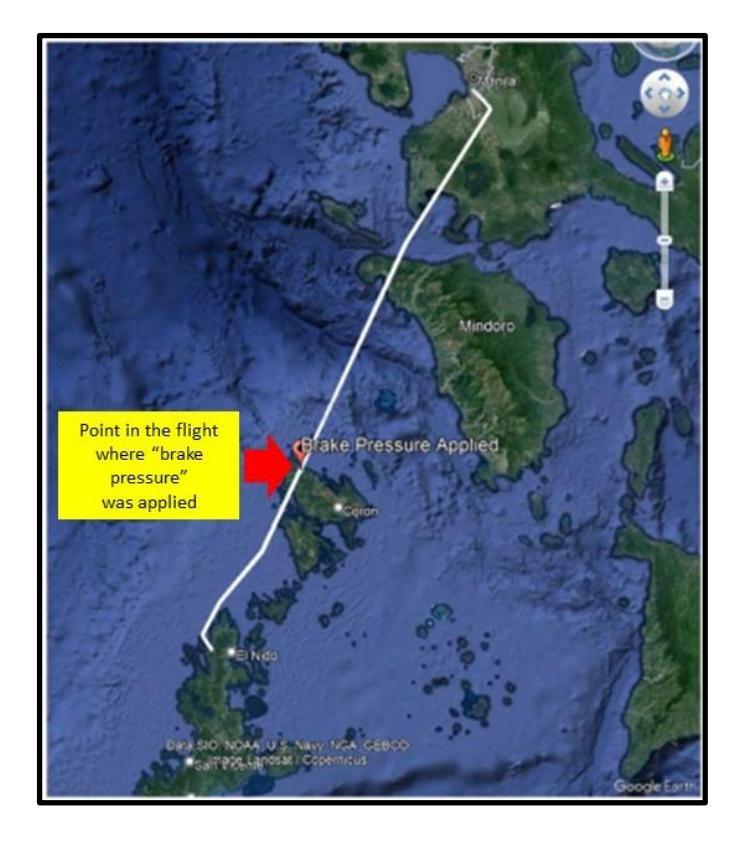
Figure 1 - Flight path and approximate location when brake pressures increased

On the Flight Data readout, the incident flight departed Ninoy Aquino International Airport (NAIA) on runway 13 and tracked in the south west direction towards Lio Airport. At 04:28:03 hour, the aircraft was cruising at 22,051 feet just over the northern tip of Busuanga Island (see Figure 1) when the brake pressures for all four (4) wheels increased to 2,040 psi (see Figure 2). The emergency/parking brake handle position is not a recorded parameter in the DFDR. During this period, the following were observed:

- A. No inputs recorded to the brake pedals at the Captain and First Officer's position;
- B. Changes to the hydraulic systems around this period were:
 - a. Blue hydraulic system: 2,969 psi \rightarrow 2,886 psi
 - b. Green hydraulic system: 2,916 psi \rightarrow 2,896 psi

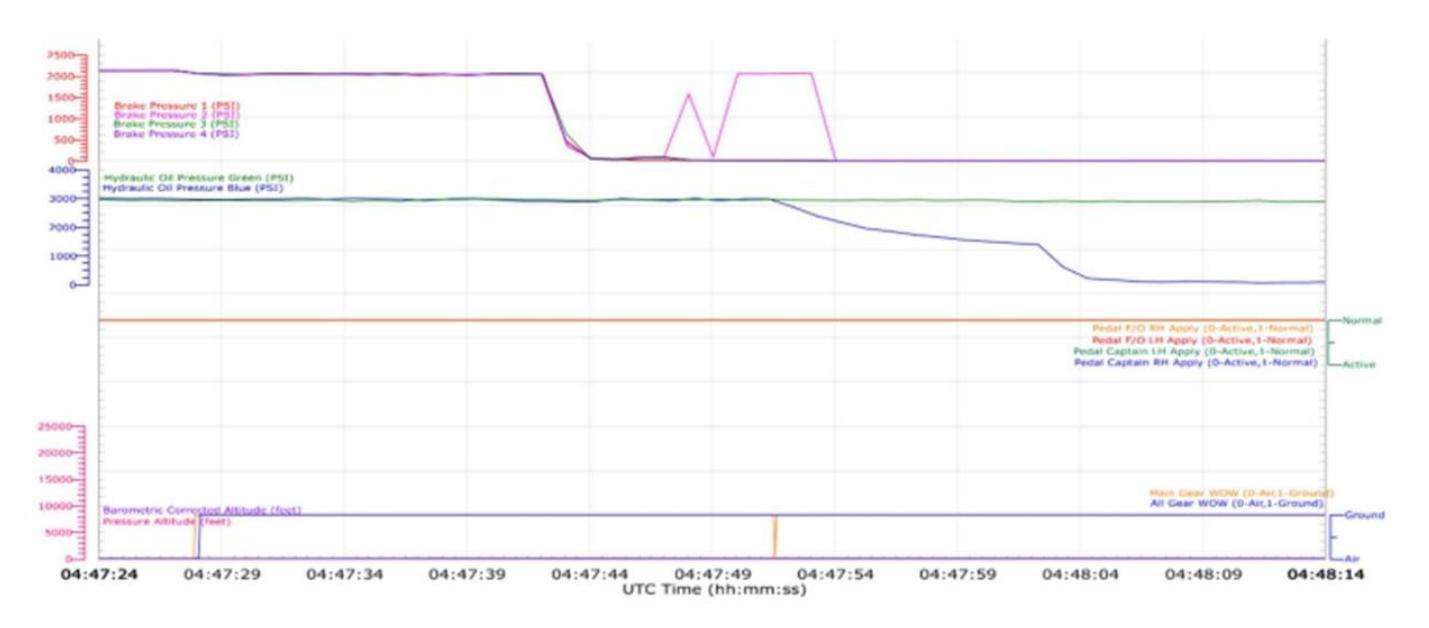
Figure 3 – Brake and Hydraulic Pressure between 04:47:28 to 04:48:08

The brake pressures of the four (4) wheels remained at nominal pressure of approximately 2,000 psi until the aircraft landed. At 04:47:28 hours, the first Weight-on-Wheels (WOW) Ground signal for the main gear was recorded, indicating the first instance where the main landing gear made contact with the runway surface. A second later, the All-Gear WOW Ground signal was recorded, indicating all three (3) landing gears were compressed and all wheels were in contact with the runway surface. At the point of touchdown, following parameters were recorded:

After the initial touchdown, the recorded brake pressure and hydraulic pressures over the next thirty (30) seconds are tabulated in the table below:

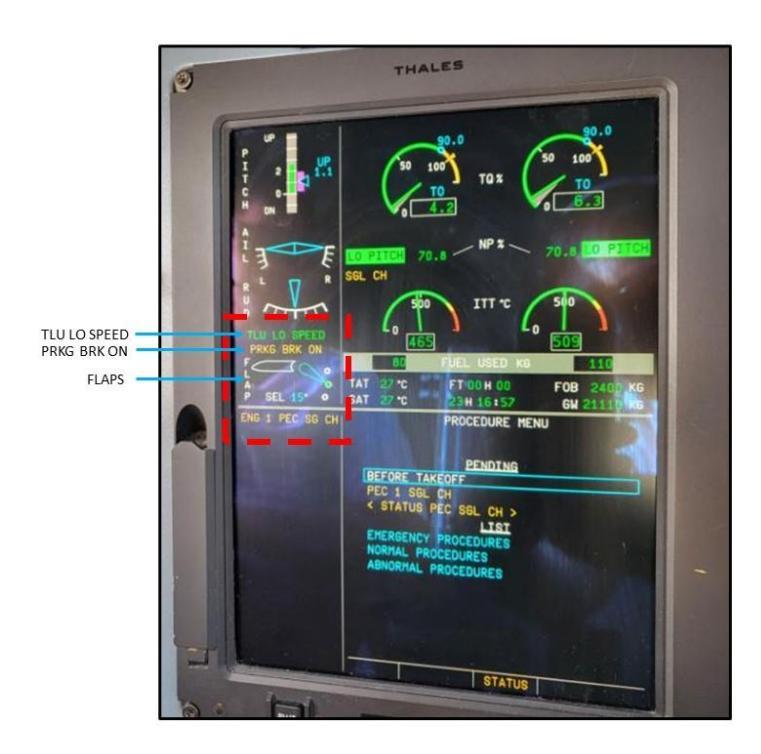
Figure 5 – PRKG BRK ON as indicated in the EWD

In one of the checklists, the "Before Landing" checklist (Figure 4) requires that the "Flaps" and "TLU LO Speed" shall be checked. On the aircraft instrument particularly on the EWD, the location of the "Flaps" settings indication is just below the indication for the "PRKG BRK ON" while the "TLU LO Speed" is above of the latter (see Figure 5).

In the accomplishment of this specific checklist, there was no mention on the CVR or in the interview of both flight crew if they have noted that the "PRKG BRK ON" indication was observed prior to their landing.

Though the CVR recording did not completely indicate that both flight crew have not noted anything unusual in the EWD, the likelihood that they might have captured this indication is possible if they only strictly followed each item on the checklist, performed the appropriate cross checking and being focused on the critical phase of the flight.

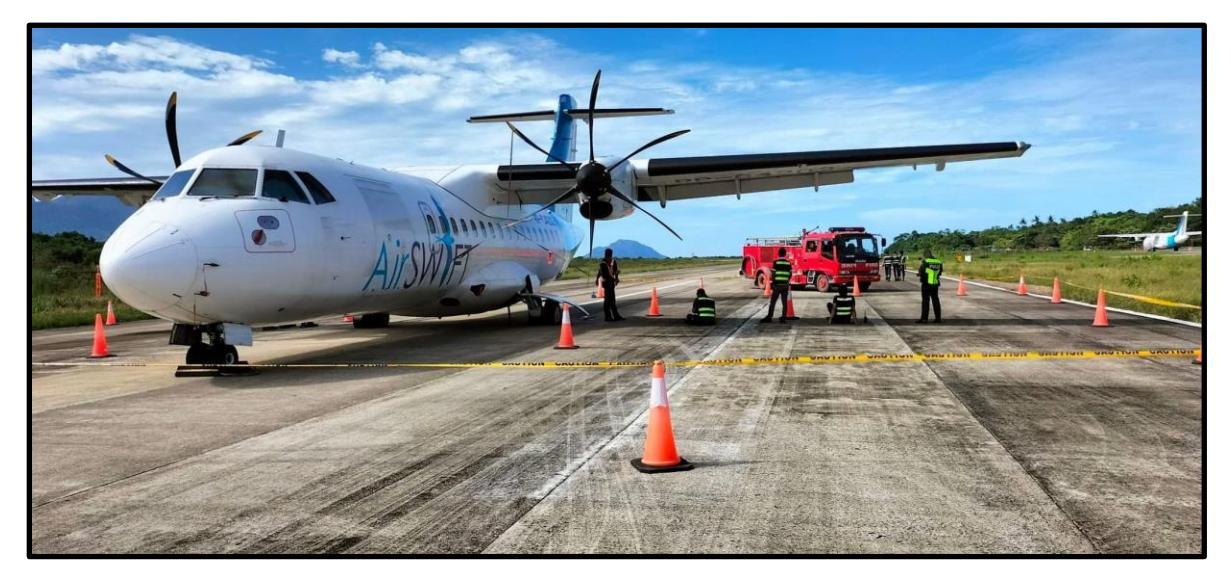
Figure 6 - RP-C4202 at the incident site

The aircraft came to rest at coordinates 11° 11' 58.5" N, 119° 25' 05.1" E which is approximately located 790 meters from the threshold of runway 15 and 591 meters from its touched down point.

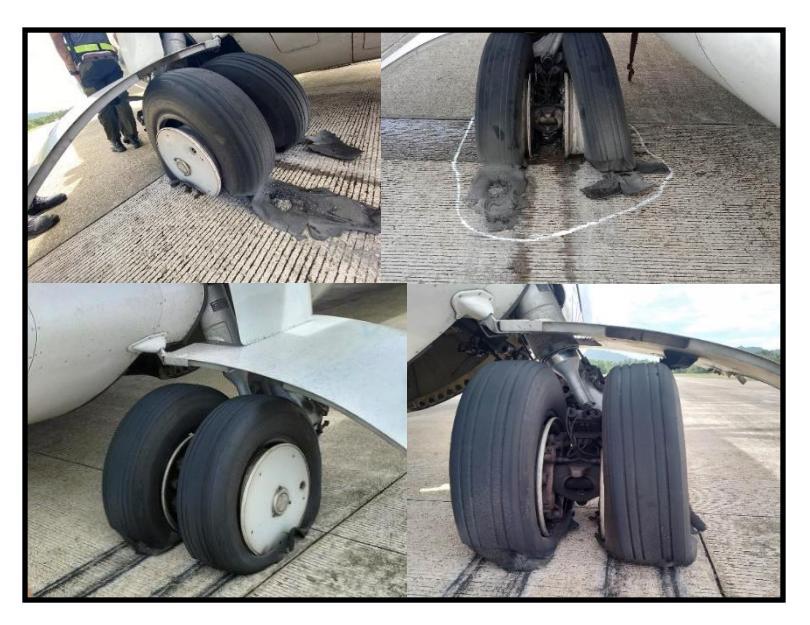
Figure 7 – RP-C4202 damaged main landing gear tires

Post incident inspection of the runway revealed the presence of skid marks from the four (4) main landing gear tires beginning from the tires initial contact with the runway surface till the aircraft final stopping position. Likewise, the four (4) main landing gear tires were noted to be busted and its main wheel hubs incurred scraping damage.

- C. No other "Fault" code retrieved;
- D. No evidence of structural and burned damage on the fuselage;
- E. All four (4) wheel tires are busted;
- F. Main wheel brakes nos. 1 and 2 were damaged and with external hydraulic leak;
- G. Main wheel brakes nos. 3 and 4 were intact and with no visible damage and hydraulic leak;
- H. No findings on the main landing gear struts and nosewheel tires.

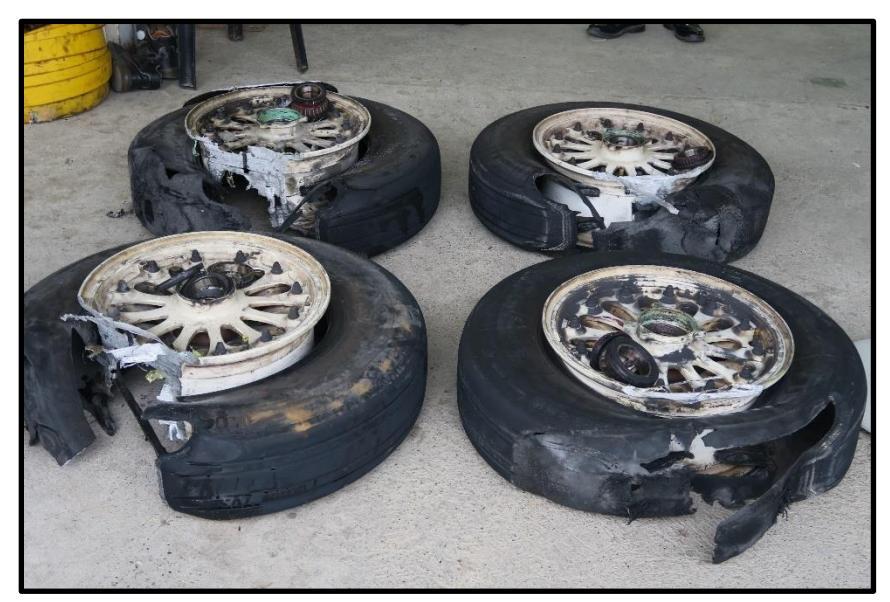
Figure 9 – Damaged tires and wheel hubs

- A. The scraping damage on the wheel hubs and the features of the busted tires indicates that the wheel was not able to roll after touchdown (Figure 9);
- B. Evidence of rubber deposits were noted from the initial touchdown point of the aircraft.

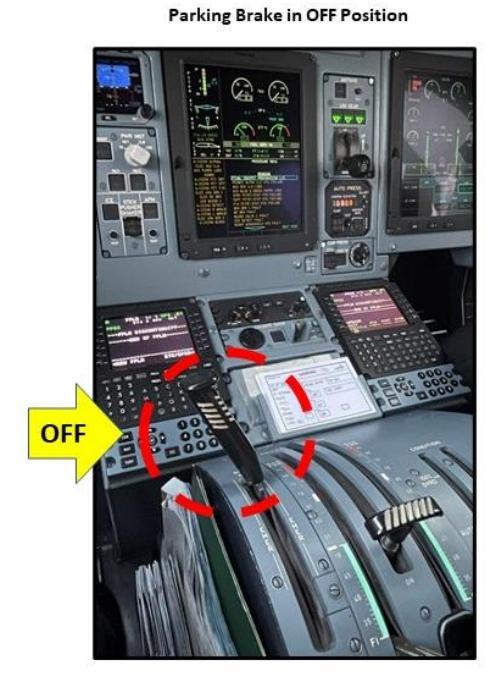
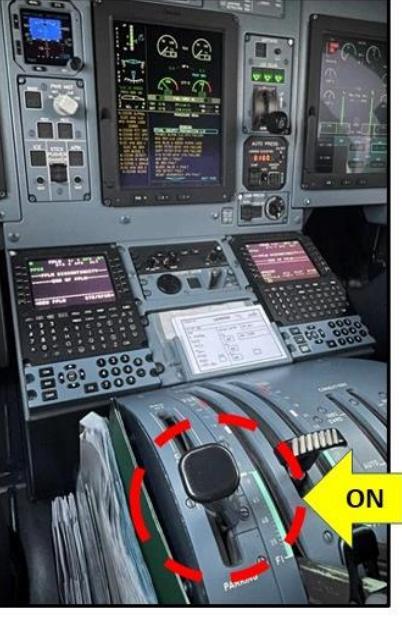
Figure 11 – Emergency Parking Brake Lever Operations

Operation of the parking and emergency braking is done by actuating the Emergency Parking Brake lever (Figure 11). In this case, the antiskid system becomes inoperative with all its protection channels. In Figure 5, it can be seen that when operating the emergency/parking brake lever, the hydraulic pressure in the blue circuit goes directly to the four (4) wheels of the main landing gears, through the shuttle valves, bypassing the antiskid valves. With this, the braking pressure is controlled by its positioning, so that when positioning it up, to half of the available movement, the braking pressure will be gradually applied up to 500 psi. Conversely, engaging the emergency/parking brake lever on the PARKING position, the braking pressure will increase up to 2,000 psi. Operating the emergency/parking brake lever (removal from "BRK OFF" position) will indicate an amber warning of "PRKG BRK ON" in the EWD.

- **a.** The emergency parking brake lever was manually engaged to PARKING position prior to landing.
- **b.** The flight crew failed to cross-check critical instrument indications in the EWD because they were in a hurry completing the checklist.

e. Coordination was made by AirSWIFT with ATR regarding "Parking Brake Engagement during Flight – Alert/Warning" wherein ATR recommended reinforcing flight crew training on the matter.

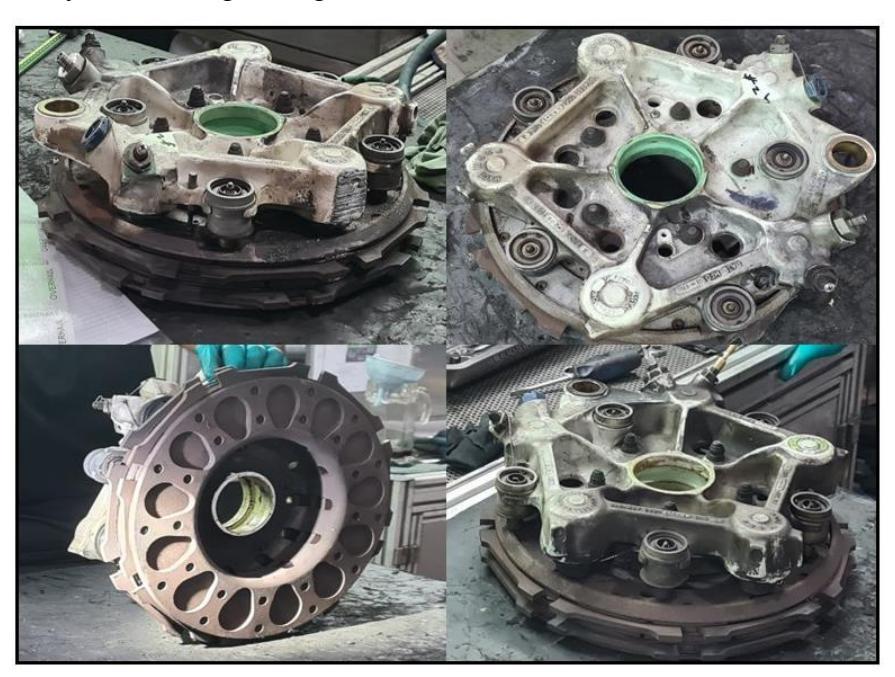
Figure 12 – Brake assembly inspection at TP Aerospace Singapore

- A. During physical and hydraulic functional test, there was no abnormality found on main wheel brakes nos. 3 and 4. All have been found to be properly rotating and functioning. Detailed inspection further revealed that the pressure plate, stator plate, and torque tube assembly are out of GoodRich CMM 32-46-86 limit and required replacement.
- B. For main wheel brakes no. 1 and 2, the planned hydraulic functional check was not performed since the brakes assembly are already damaged as a result of the incident. On the detailed inspection, the Piston Housing Assembly P/N: 266-248-1, pressure plate, stator plate, and torque tube assembly are out of GoodRich CMM 32-46-86 limit and required replacement.

With the above shop findings, it can be concluded that the installed brake assemblies were operationally functioning during the time of the incident.
