AIRCRAFT ACCIDENT INVESTIGATION AND INQUIRY BOARD

FINAL REPORT

<u>RP-C5801</u> TEXTRON AVIATION INC., BARON BE-58

DATE OF OCCURRENCE: SEPTEMBER 24, 2022

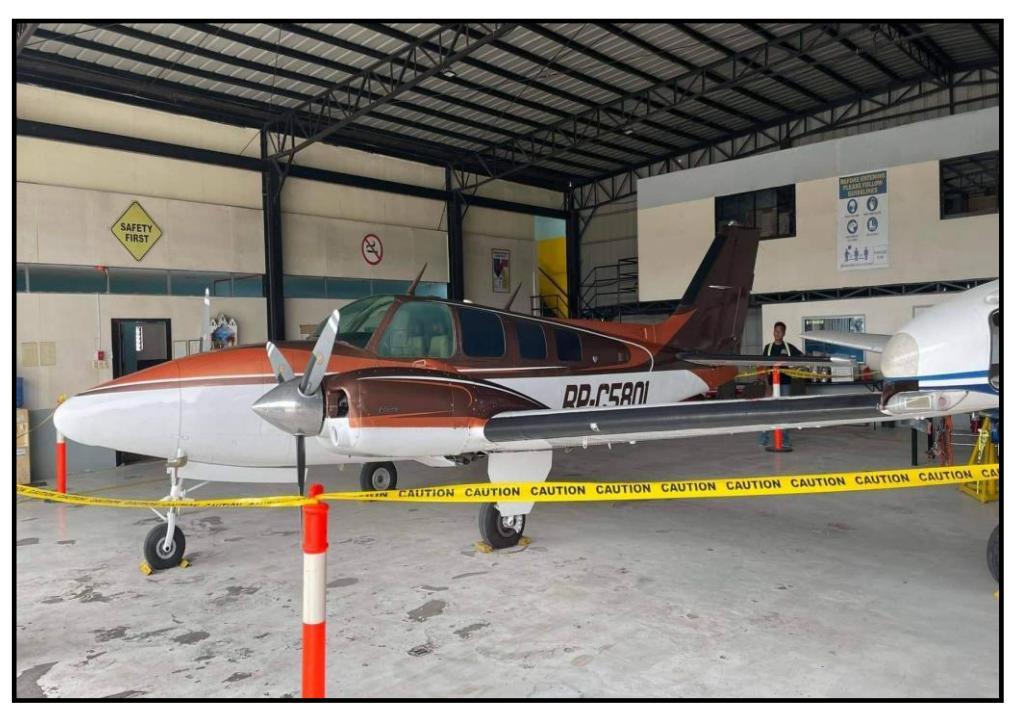
Figure 1 - RP-C8612 at the ramp after the incident.

The rudder and tail cone of the aircraft sustained damage, and the left elevator was missing.

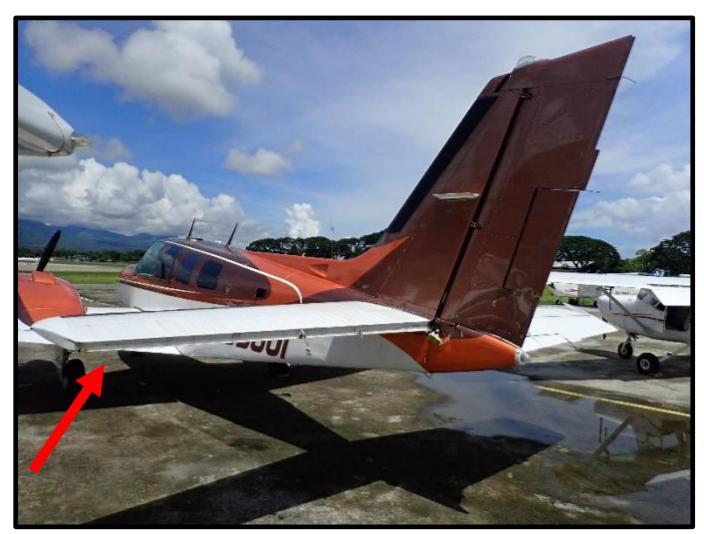
At approximately 8,000 feet, the aircraft encountered cloud turbulence, causing it to bank right. It then experienced a sudden altitude drop, but the pilot regained control and leveled off at 2,000 feet. After ensuring the occupants were unharmed and informed of the incident, the flight landed safely at Dumaguete Principal Airport. A post-flight inspection by the pilot and company mechanic revealed damage to the rudder and tail cone, with the left elevator missing (Figure 2).

Figure 2 - The damaged emphanage section of the aircraft.

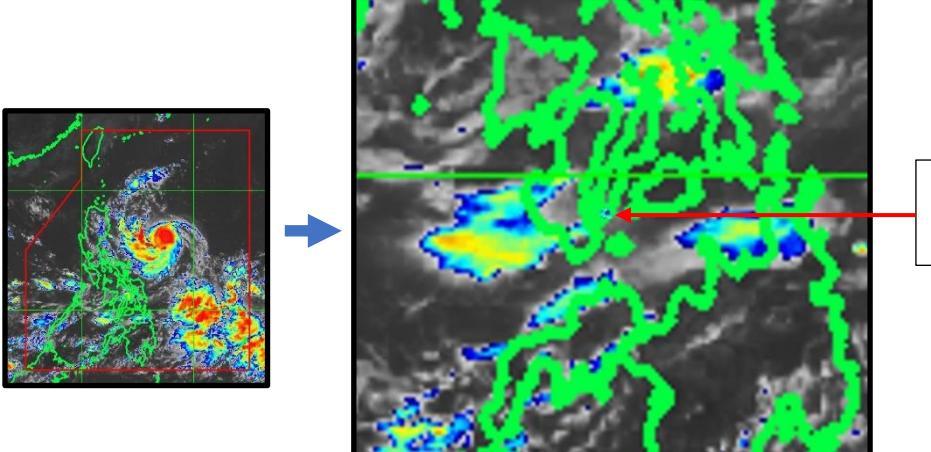
Area of Occurrence.

Figure 4 - PAGASA weather report as RP-C5801 was on the area.

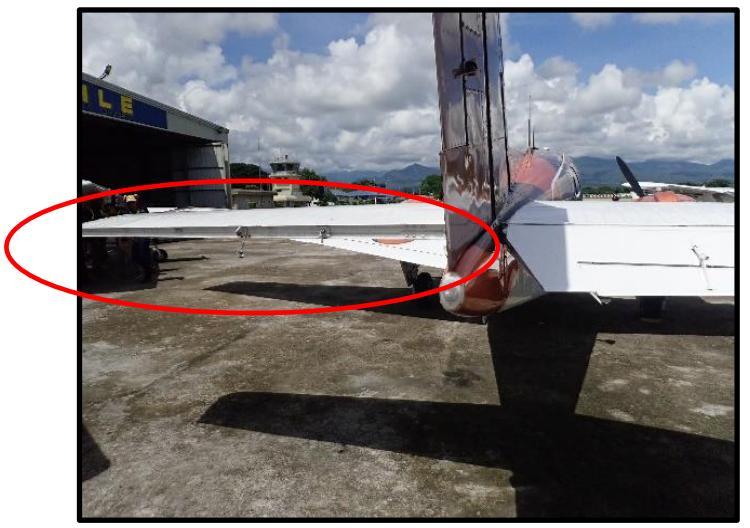
The pilot conducted an inspection of the aircraft after all occupants had disembarked and discovered that the left elevator was missing (Figure 6). Before its complete detachment, the loose elevator likely caused instability, contributing to the uncontrolled maneuver and abrupt altitude change.

Figure 6 - The aircraft missing left elevator.

Once the left elevator fully separated from the stabilizer structure, the pilot regained control of the aircraft. No issues were detected with the power plant or flight control systems. The aircraft was placed in a holding pattern before receiving clearance to land at Dumaguete Principal Airport.

a. The structural failure of the left elevator due to the aircraft entering a severe weather system during descent.

The flight encountered a cloud buildup that likely contained strong turbulence, wind shear, or convective activity, resulting in excessive aerodynamic loads that led to the separation of the left elevator.

- **5.1** Following the occurrence, Fliteline Airways Phils. Inc. initiated the following safety corrective actions: (Appendix A).
 - a. The company conducted safety meeting to all flight crew, focusing on weather information and briefing for flight operations.
 - b. The company conducted safety meeting to all flight crew and mechanics, focusing on company pre-flight inspections and their responsibilities for flight.
