AIRCRAFT ACCIDENT INVESTIGATION AND INQUIRY BOARD

FINAL REPORT

RP-C8595 TEXTRON AVIATION INC./C152

DATE OF OCCURRENCE: MARCH 30, 2025

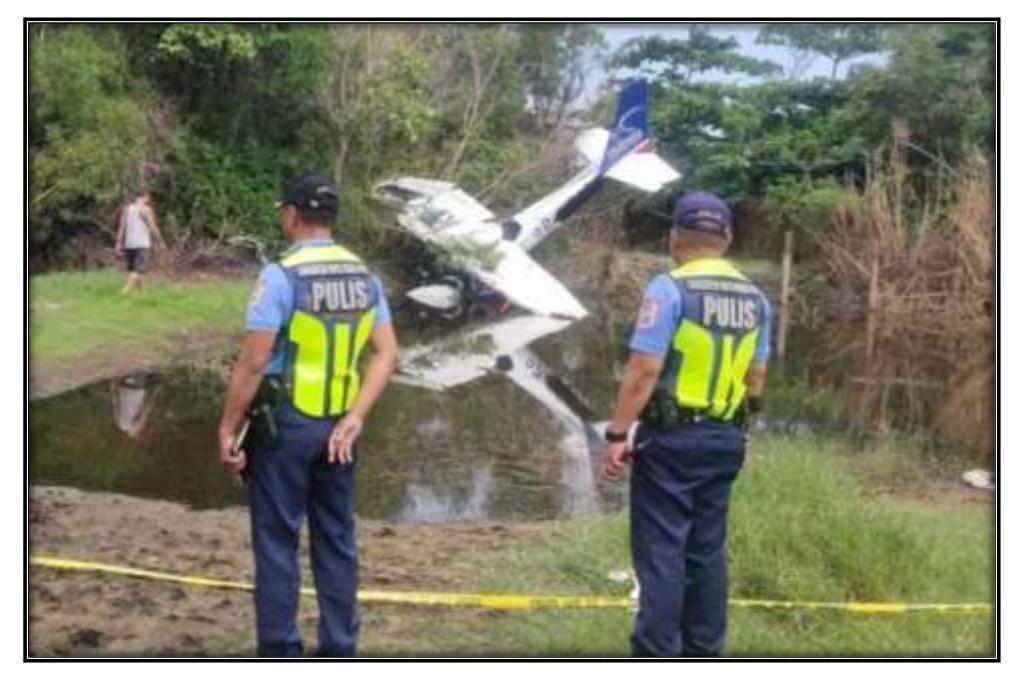
Figure 2 - RP-C8595 Final position.

The aircraft wreckage was found with a final heading of 244 degrees and grid coordinates 16.038843N; 120.248833E. It was located 312 meters from the edge of RWY 08 in Lingayen Airport. Inspection of the crash site revealed the following:

- **a.** The engine and propeller were submerged in the water upon impact.
- **b.** All significant components of the aircraft were located within the main wreckage area, approximately ten (10) meters in diameter.
- **c.** The entire fuselage and wings sustained substantial damage, with the cockpit and flight controls highly fragmented. The instrument panel was destroyed, and most instruments were displaced from their panel mounts.

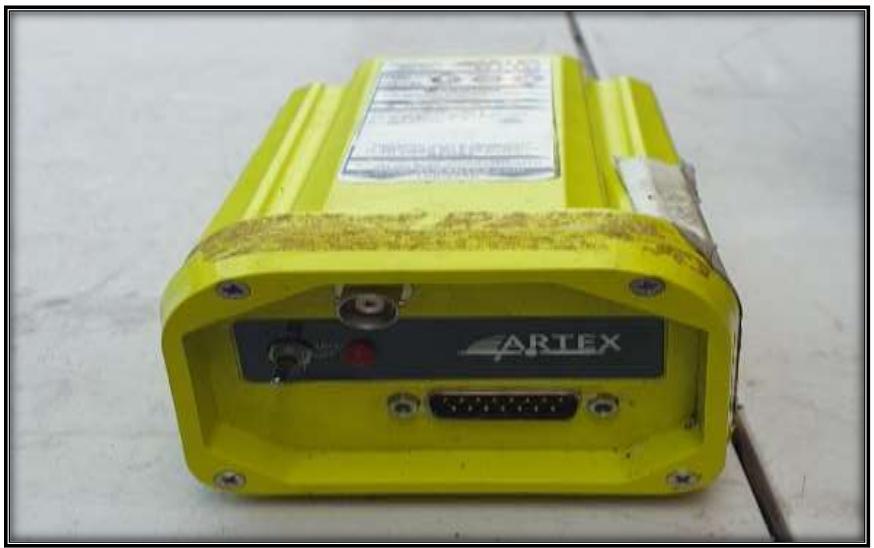
The aircraft was equipped with an Artex emergency locator transmitter (ELT) 345, SN: 267-14064, which transmitted on fixed frequencies 121.5 MHz and 406 MHz. Upon initial examination of the wreckage at the accident site, the ELT was not damaged. (Figure 3). It was still transmitting a distress signal and was shut off by the mechanic of the responding company.

Figure 3 - RP-C8595 ELT

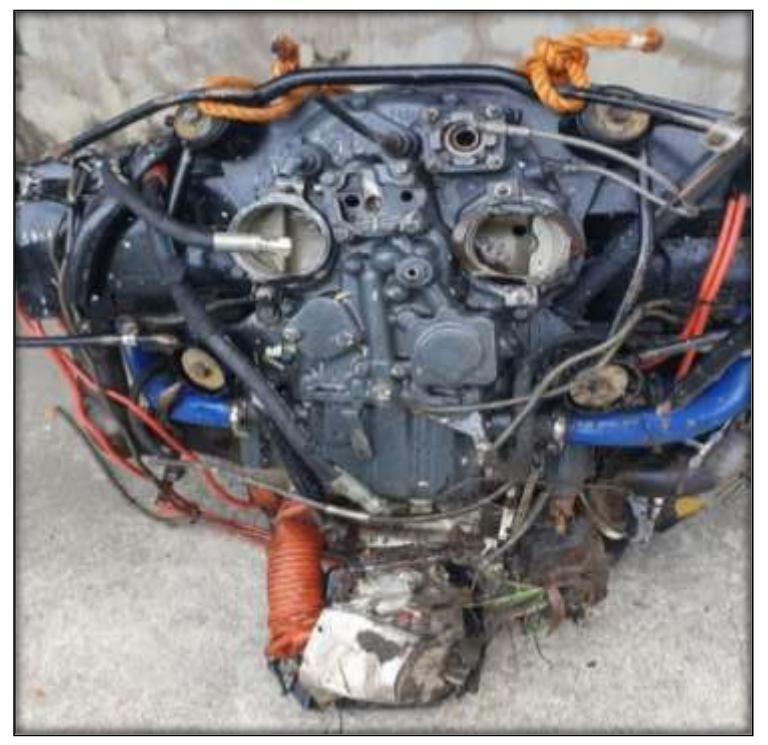
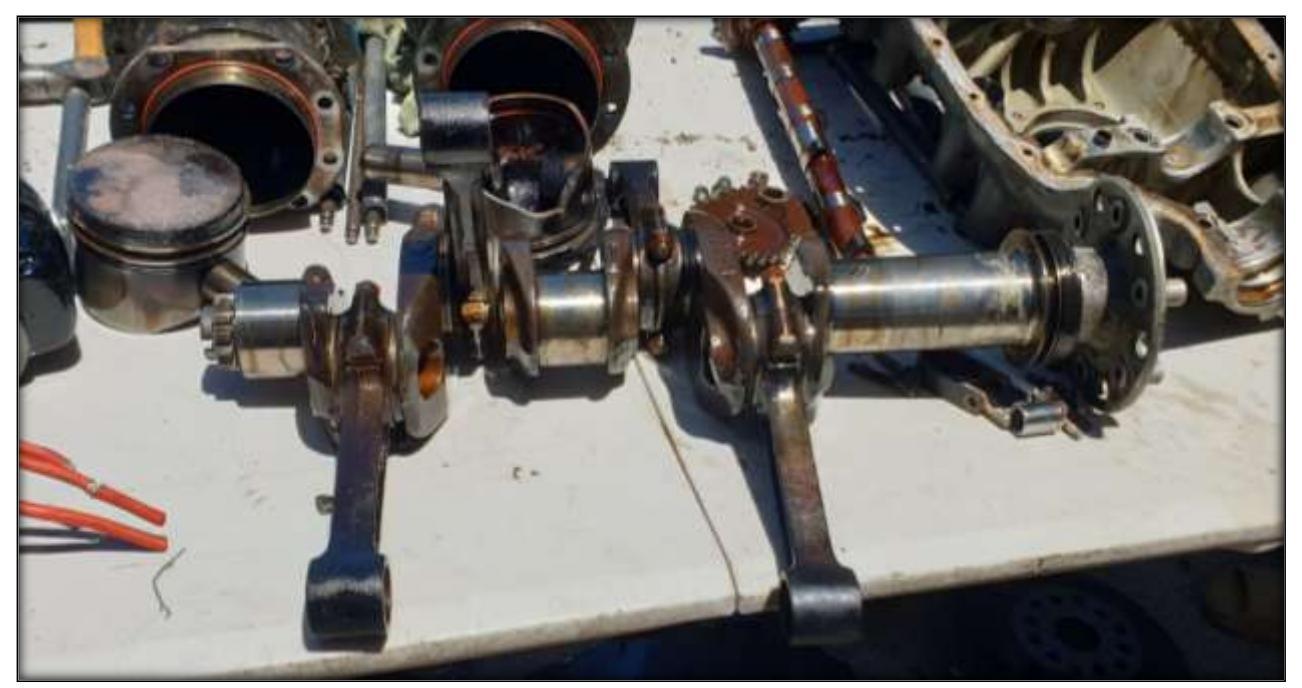
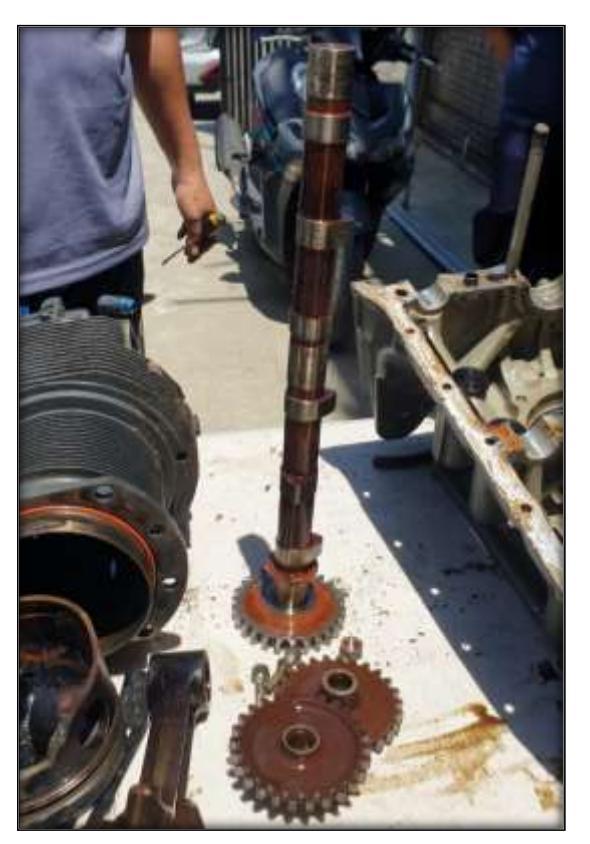
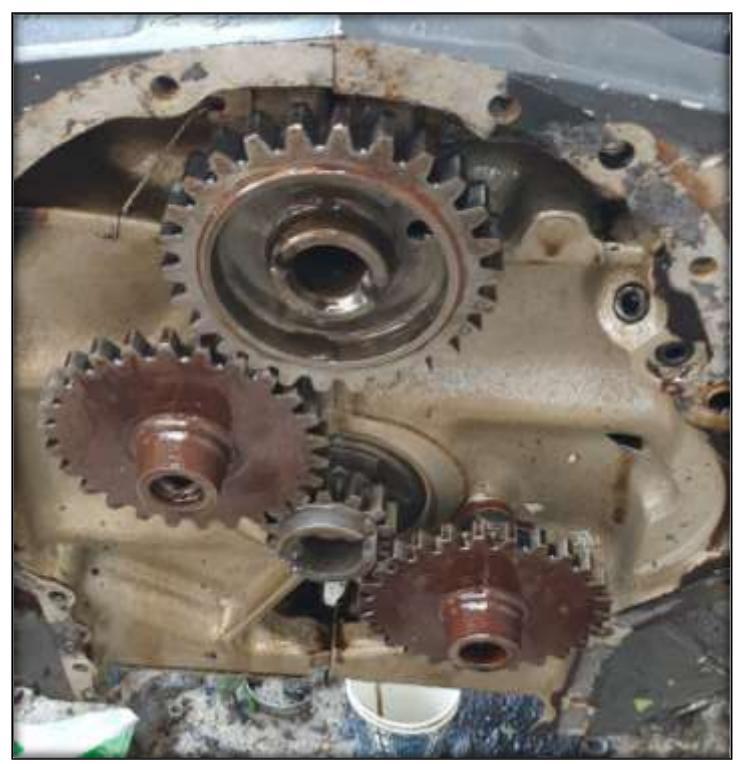
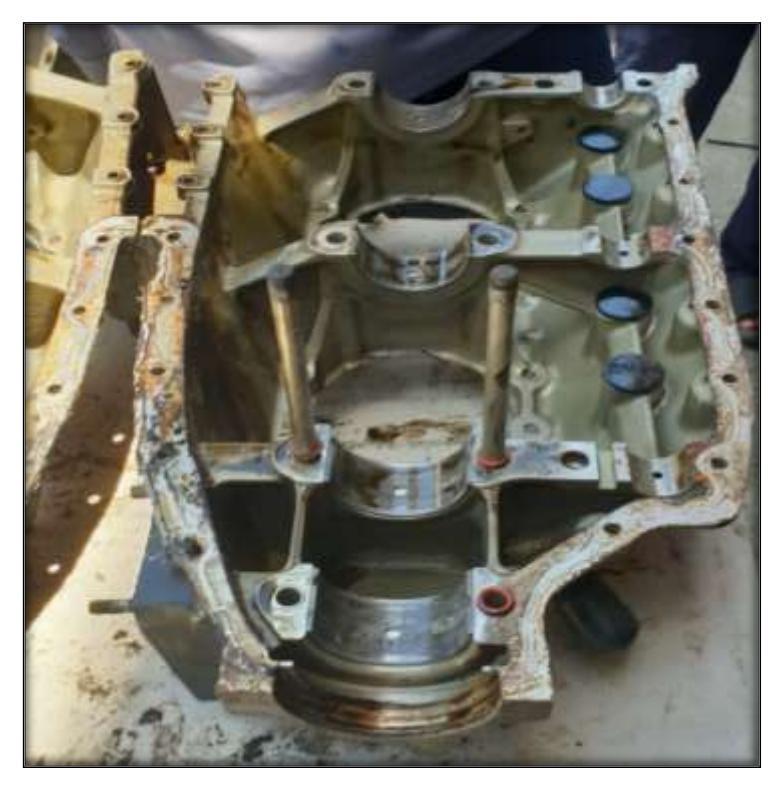
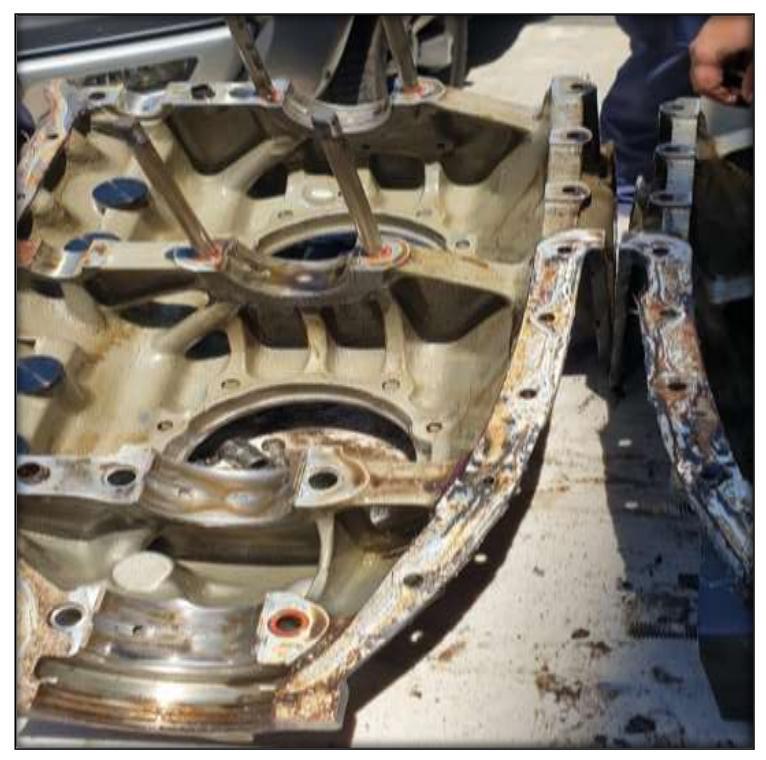
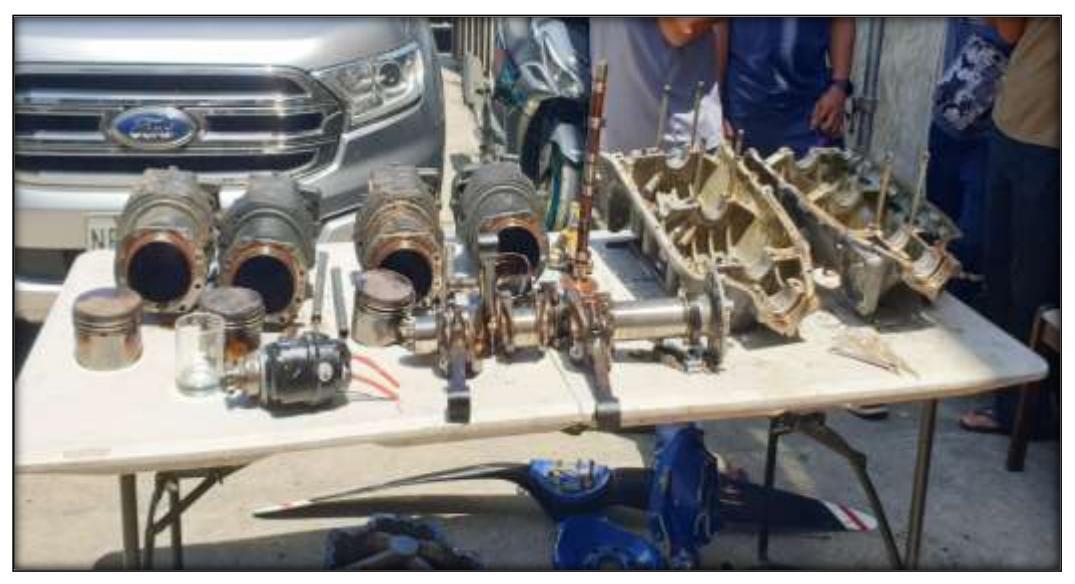
As an observation based on the evidence found during the teardown inspection, the inspection did not reveal mechanical malfunctions or anomalies that would have affected the aircraft's normal operation. Internal examination also indicated that the other components of the engine were all in excellent condition. In addition, the

- **3.1.8** Internal examination also showed that the other components of the engine were all in good condition.
- **3.1.9** The damage to the spinner indicated that it resulted from the impact while it was still in motion at the time of the accident.

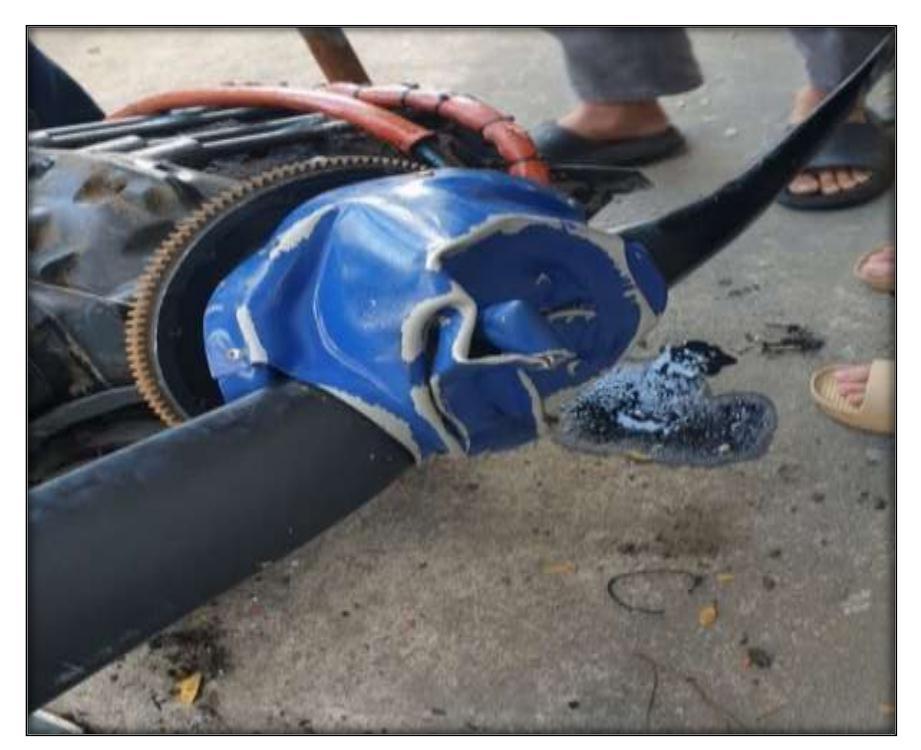
damage to the spinner indicates that it resulted from the impact while it was still in motion at the time of the accident (Figures 5-21).

Figure 6 - RP-C8595 spinner with impact damage.

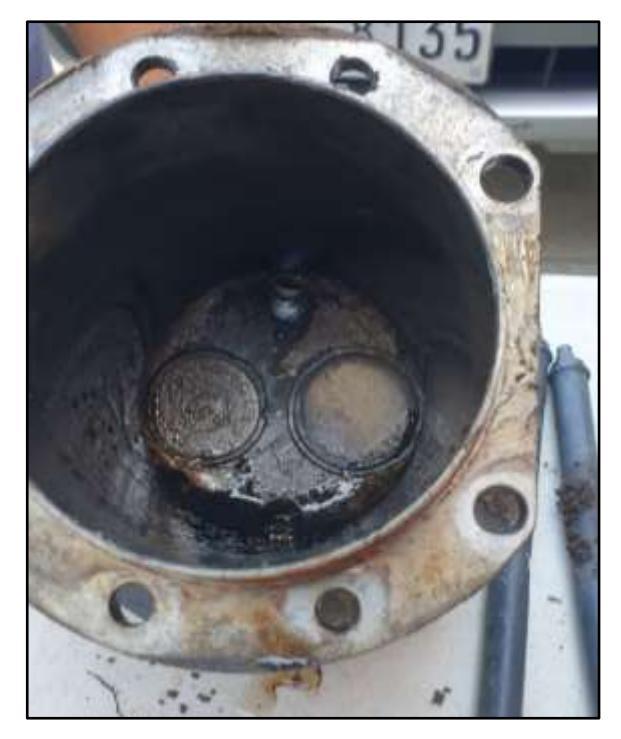
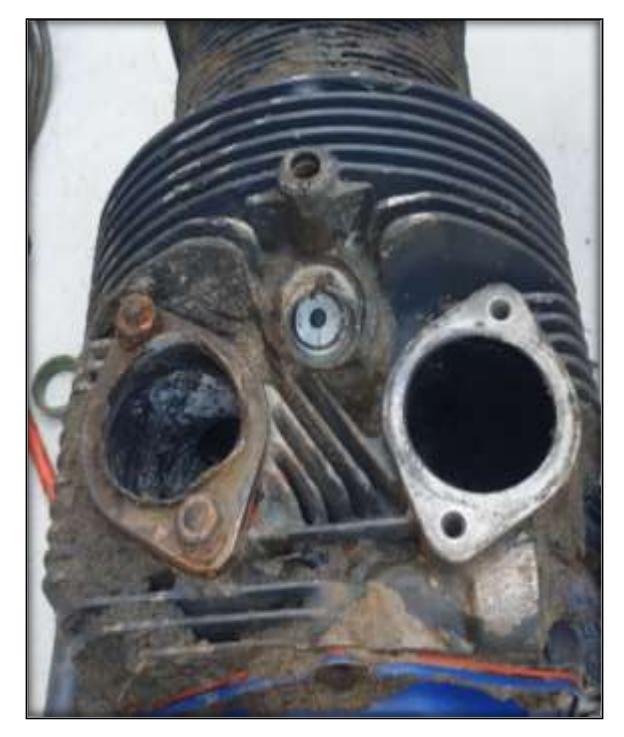
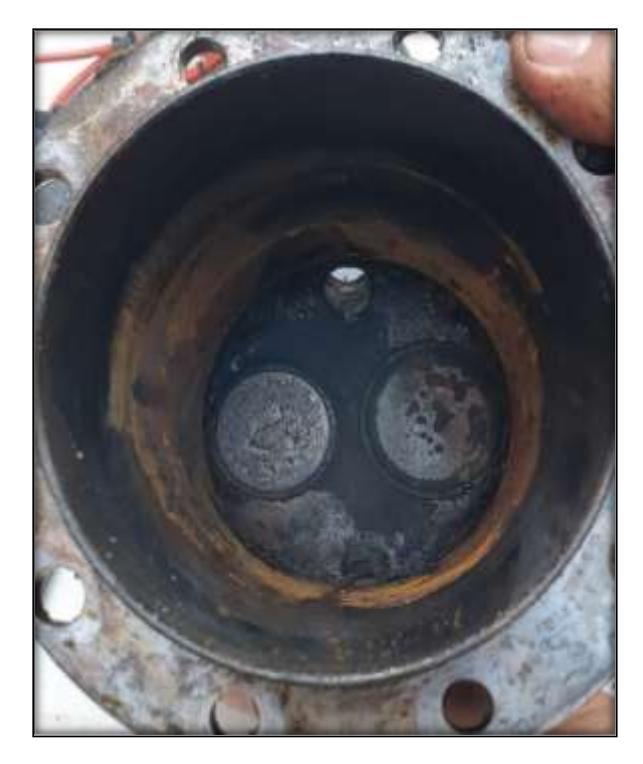
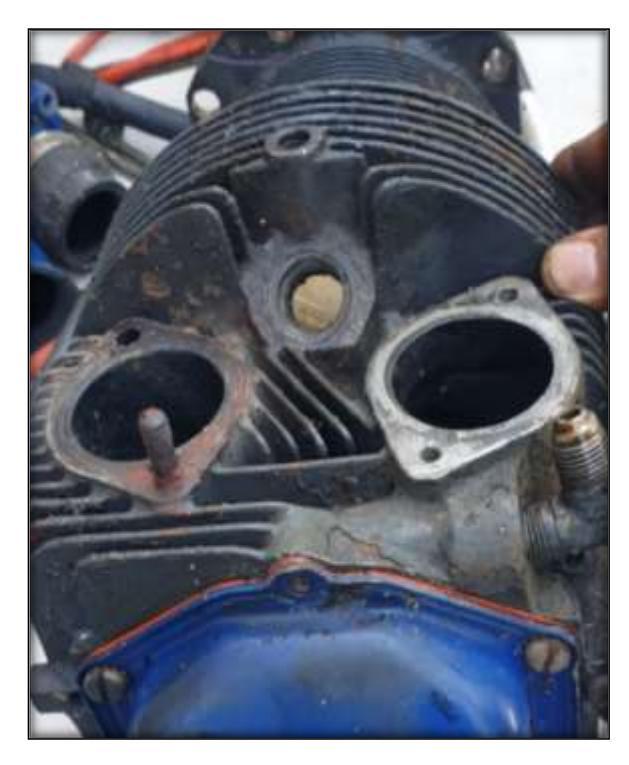
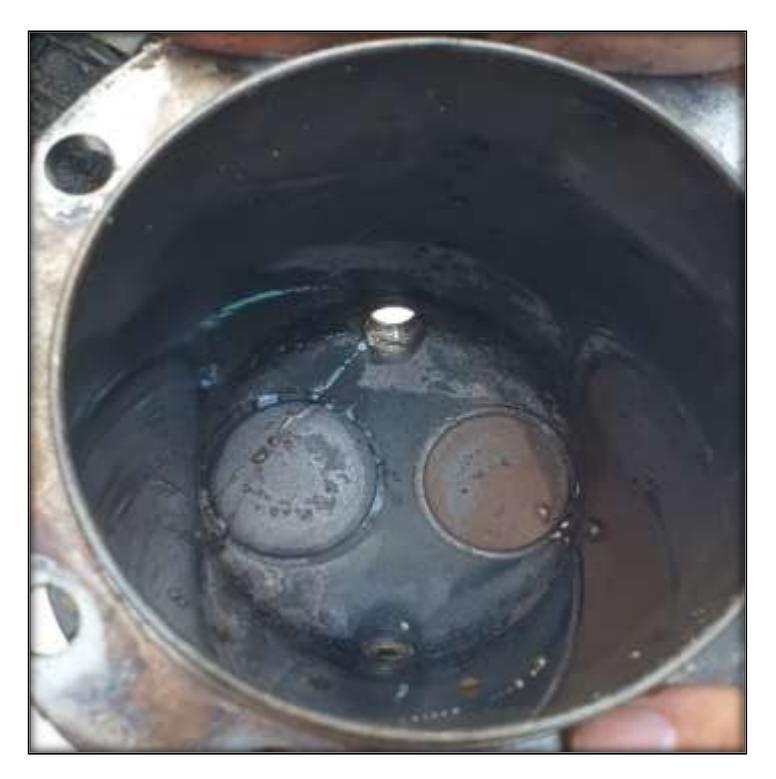
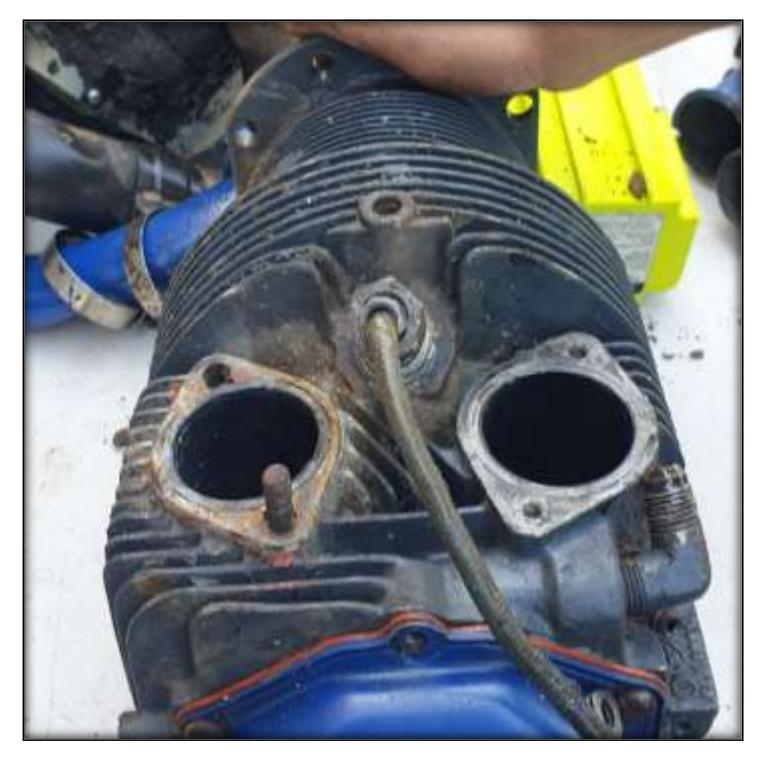
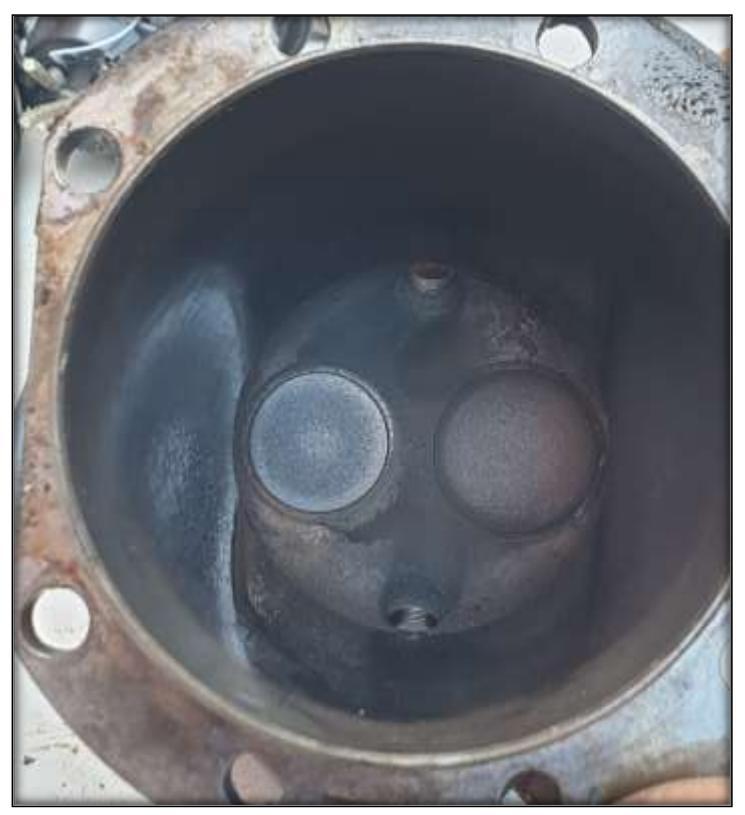
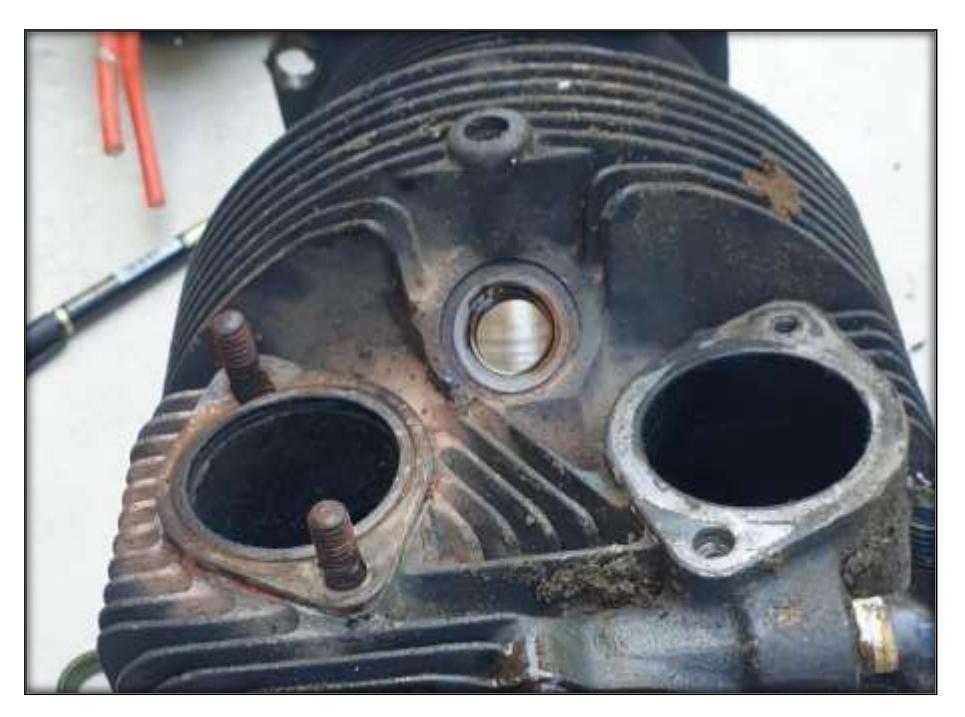
- **3.1.6** During teardown inspection, the cylinder heads, cylinder barrels, and cooling fins showed no signs of cracks.
- **3.1.7** The teardown inspection of the engine revealed no evidence of pre-impact mechanical malfunctions or anomalies that would have affected the aircraft normal operation.

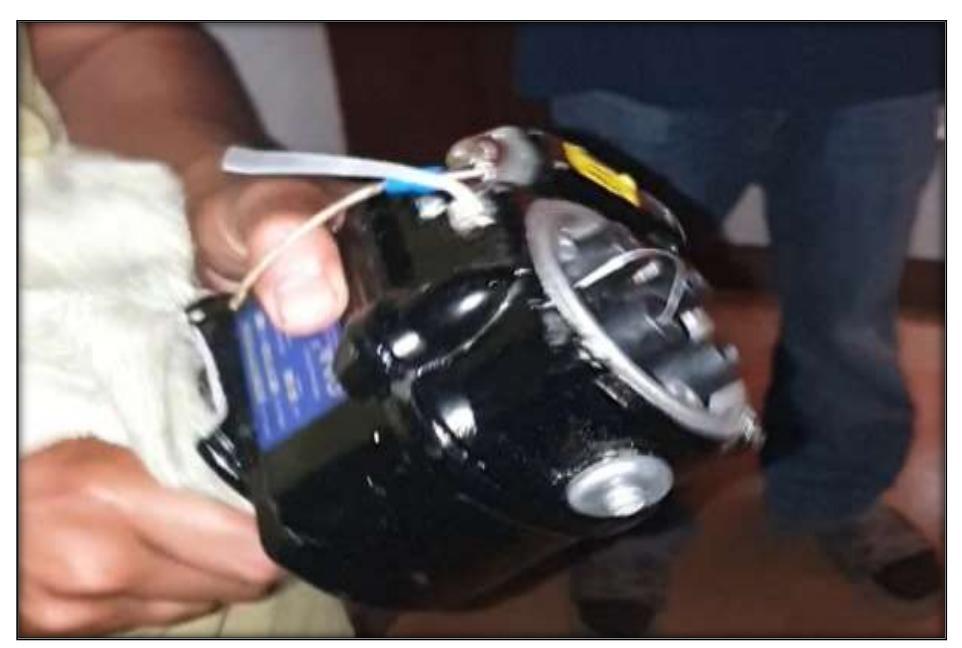
On March 30, 2025, the engine of RP-C8595 was removed from the crash site and brought to the operator's hangar for a teardown inspection the following day. The inspection focused on dismantling the engine. The accessories were initially removed to inspect the engine. The magneto was removed still intact, but the flange was broken. The oil filter was also broken after removing the accessories. Both the carburetor and fuel bowl were impact damaged. The cylinders were removed still intact in the connecting rod. All the cylinder heads, cylinder barrels, and cooling fins showed no signs of cracks except for the piston in cylinder no. 4 that was damaged due to sudden stoppage impact. The crankcase was split in half after all bolts on the crankcase were removed. The crankcase has no visible cracks. All bearings were inspected, and no abnormalities were found. The crankshaft flange was bent due to impact. The connecting rods, camshaft, and tappet are all intact. The spark plugs were checked and were found to be working properly, except for the spark plug on cylinder no. 1 that was broken due to impact. Spark checks on both magnetos were also conducted and were found to be working properly.

Figure 20 - RP-C8595 Magneto check.
