# AIRCRAFT ACCIDENT INVESTIGATION AND INQUIRY BOARD

**FINAL REPORT**

RP-C5656 CESSNA 152

**TITLE**: A serious incident involving a Textron Aviation Inc., Cessna 152 type of aircraft with Registry Number RP-C5656 operated by Fliteline Aviation School, Inc., had an aircraft overrun at Runway 17, Plaridel Community Airport, Lumang Bayan, Plaridel, Bulacan, Philippines on July 13, 2024 at about 1345H (Local).

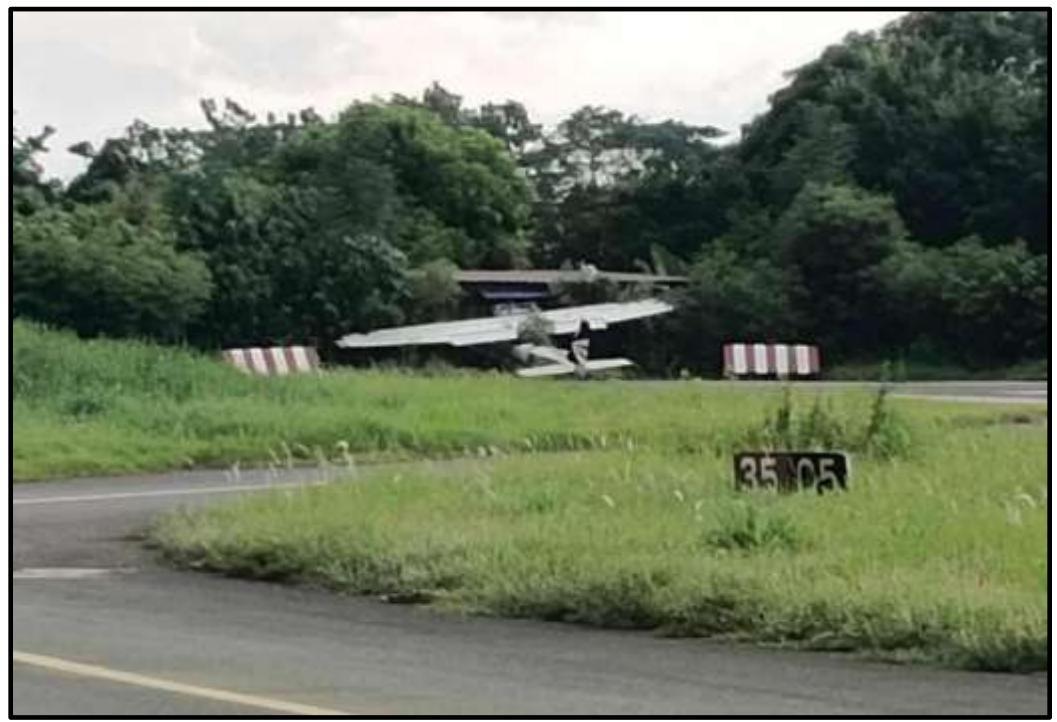
On or about 1345H of July 13, 2024, a Textron Aviation Inc. Cessna 152 type of aircraft with registration number RP-C5656 sustained damage upon bounced landing followed by an excursion at Runway 17, Plaridel Community Airport, Lumang Bayan, Plaridel, Bulacan, Philippines. The aircraft is being operated by Fliteline Aviation School, Inc., based at Plaridel Airport. The aircraft departed at around 1330H from the same airport for scheduled flight training. Onboard the aircraft were the Flight Instructor (FI) seated on the right side and a Student Pilot (SP) on the left side. The aircraft's final position was at coordinates 14° 53' 12.76" N, 120° 5111.44" E, and a final heading of 168°.

Figure 1 - The aircrafts final resting point.

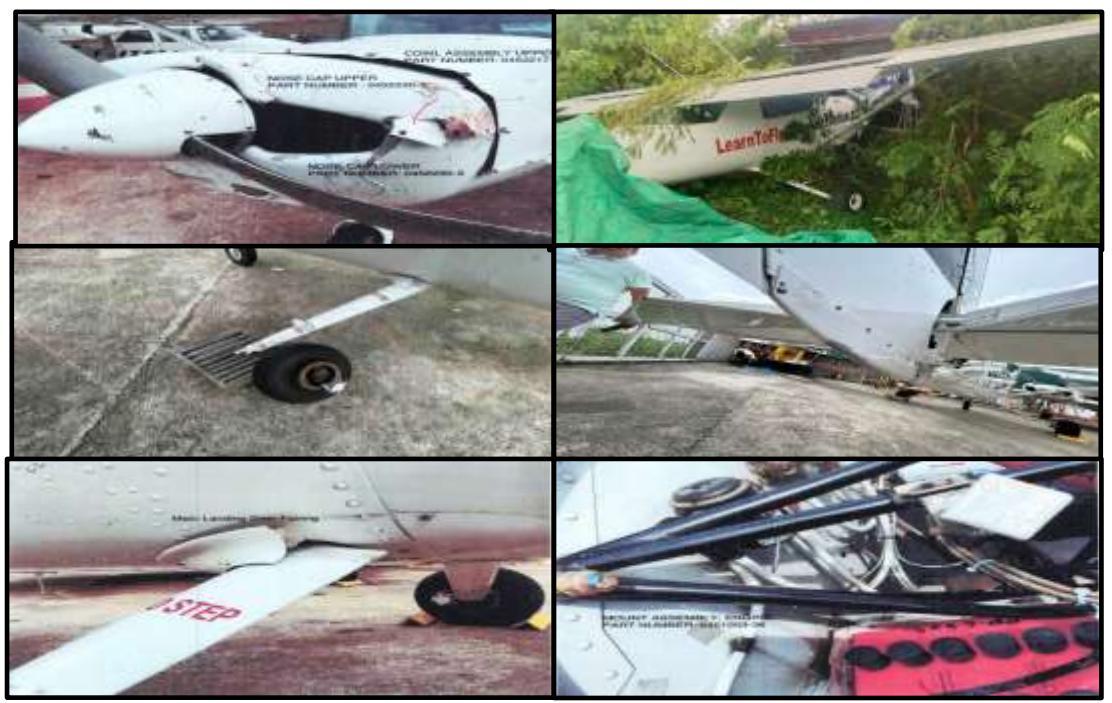
The aircraft sustained damage to its wings, left landing gear, fuselage, upper and lower engine cowlings, and propeller. In addition, the two (2) occupants sustained minor injuries. The FI and SP were able to exit from the aircraft on their own and were transported to a hospital for medical assistance. Visual metrological condition prevailed at the time of occurrence, and a training flight plan was filed by the operator. The

Figure 2 - The damages incurred by RP-C5656.

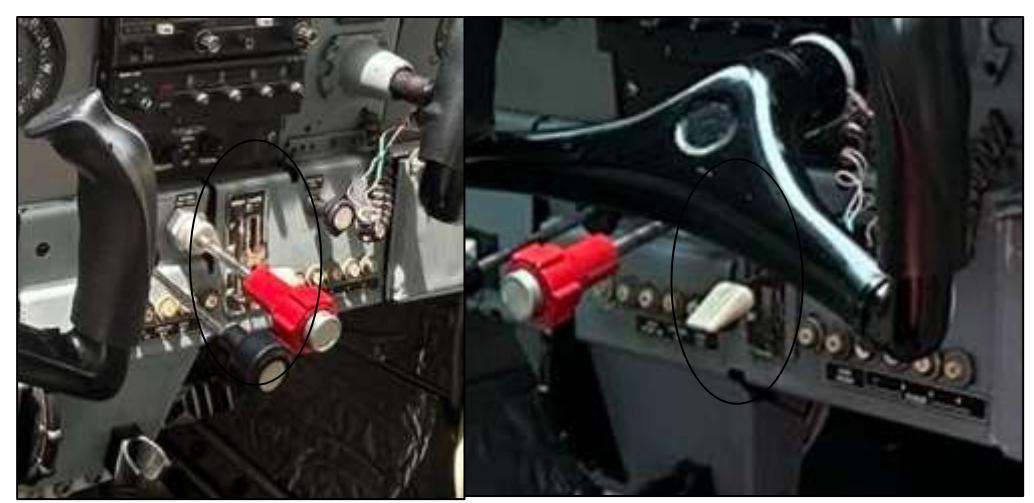
An inspection of the aircraft structures for damage assessment was conducted by the operator together with their mechanics and was witnessed by an AAIIB investigator on July 14, 2024. The aircraft engine was also inspected on the same day. A flaps retraction/extension activity was performed by the operator and witnessed by the AAIIB investigator. The flaps are operated by a flap switch, which is a "step type." It can be set by one (1) step increment or decline. It was found that the flaps were operational at the time of occurrence.

Figure 3 - The "Step-type" Flap switch.
