AIRCRAFT ACCIDENT INVESTIGATION AND INQUIRY BOARD

FINAL REPORT

<u>RP-C5911</u> BOMBARDIER, DHC 8-402 (Q400)

TITLE: A serious incident involving a Bombardier, DHC 8-402 (Q400) type of aircraft with Registry Number RP-C5911 owned and operated by Air Philippines Corporation (PAL Express), that had a gear-up landing resulting to runway excursion at Mactan-Cebu International Airport (RPVM), Philippines on December 10, 2021, 1140H(Local).

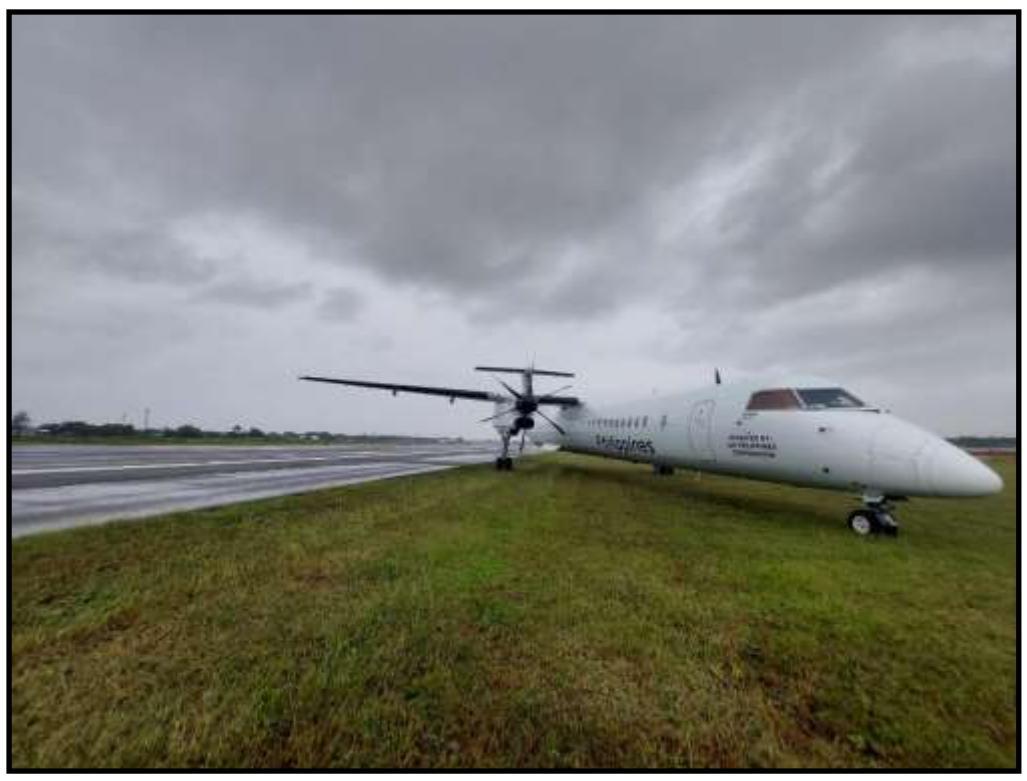
The aircraft came to a complete stop at the grassy left side portion of the runway, about 1,500 meters from the threshold of Runway 04, at coordinates 10.309431N, 123.980965E, and with a final heading of 22 degrees. Inspection of the aircraft shows it sustained no damages. No post-fire ensued. Mactan-Crash Fire Rescue Unit (CFRU) immediately responded to help secure the aircraft. The passengers deplaned normally out of the aircraft using the L1 door and were ferried to the airport terminal by bus services. At 1141H, Mactan Tower declared the activation of Emergency Plan: Aircraft Accident On-Airport (Emplan 1) and informed all responding units. At 1438H, the runway was opened and back to normal operation.

Figure 1. The aircrafts final resting point.

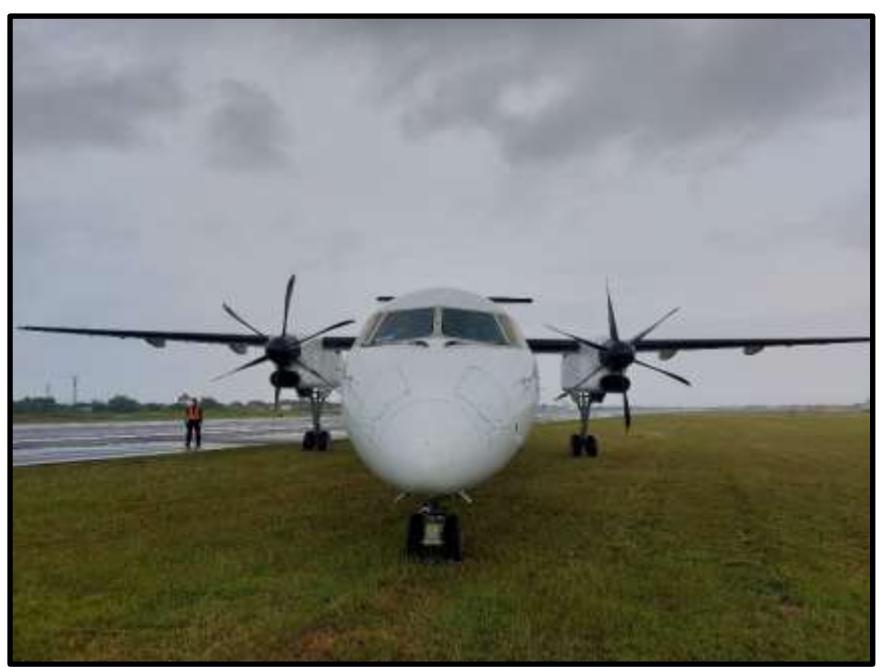
During the landing roll, the aircraft swerved to the left side of the runway and came into contact with the unpaved ground. The nose landing gear steering was not responding to the pilot inputs. The aircraft came to a full stop at coordinates 10.309431 N and 123.980965 E, with a final heading of 22^{0} .

Figure 2: The aircraft was not damage from external factor.

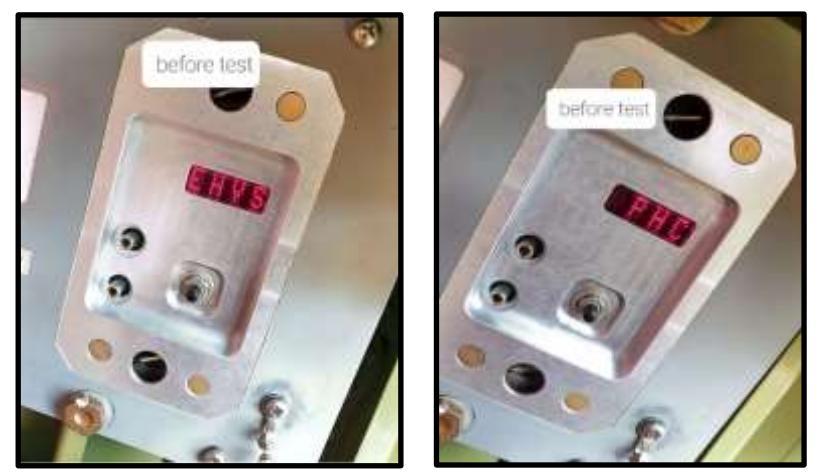
A BITE check was conducted after the event by the operator, AMO, and witnessed by the AAIIB investigators. During the Steering System Check on the nose steering light, it was set to be illuminating at the aircraft annunciator panel. The inspection was conducted to determine whether the aircraft's steering function was normal. In order to simulate the conditions during aircraft landing, the aircraft was connected to an external electric power supply, and the No. 2 hydraulic system was pressurized by the hydraulic source. The operation of the rudder pedals and PHC was conducted according to the aircraft maintenance manual, and no abnormality in the steering function was found.

Figure 5: The SCU BITE check.

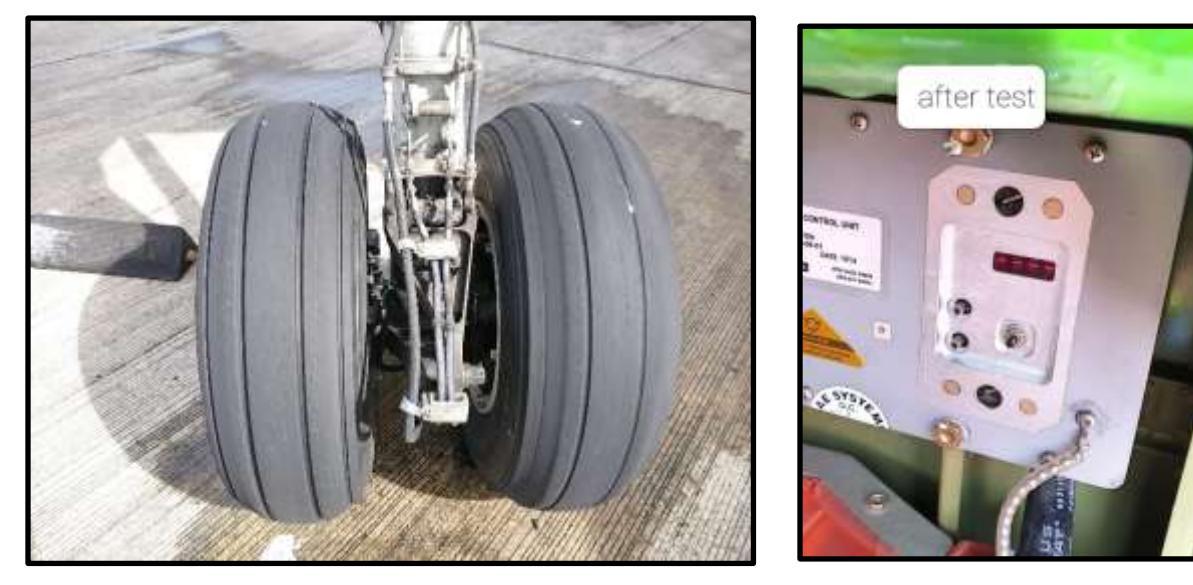
Simulation was also conducted for the steering function using PHC in the aircraft. The Electro-Hydraulic Servo Valve Coil (EHVS) and Pilot Hand Control (PHC) appear on the SCU. This related abnormality or operation of the PHC with the aircraft "in-air" condition codes was found. The EHVS code is automatically registered every time the SCU power is turned "on" and does not always mean detection of a fault. As a result of the BITE check, the EHVS and PHC fault codes were recorded. The steering system function was confirmed to be normal.

Figure 6: Nose steering check.

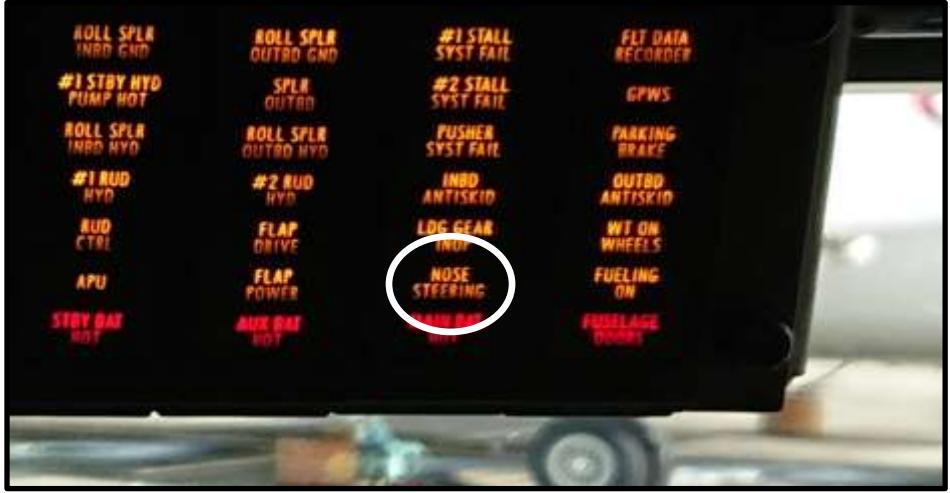
Figure 8: The nose steering light.

The aircraft warning systems are intended to provide the flight crew with adequate warning and caution. In this occurrence, the aircraft swerved to the left, and the crew noticed "nose steering" at the indicated warning light (Figure 8).

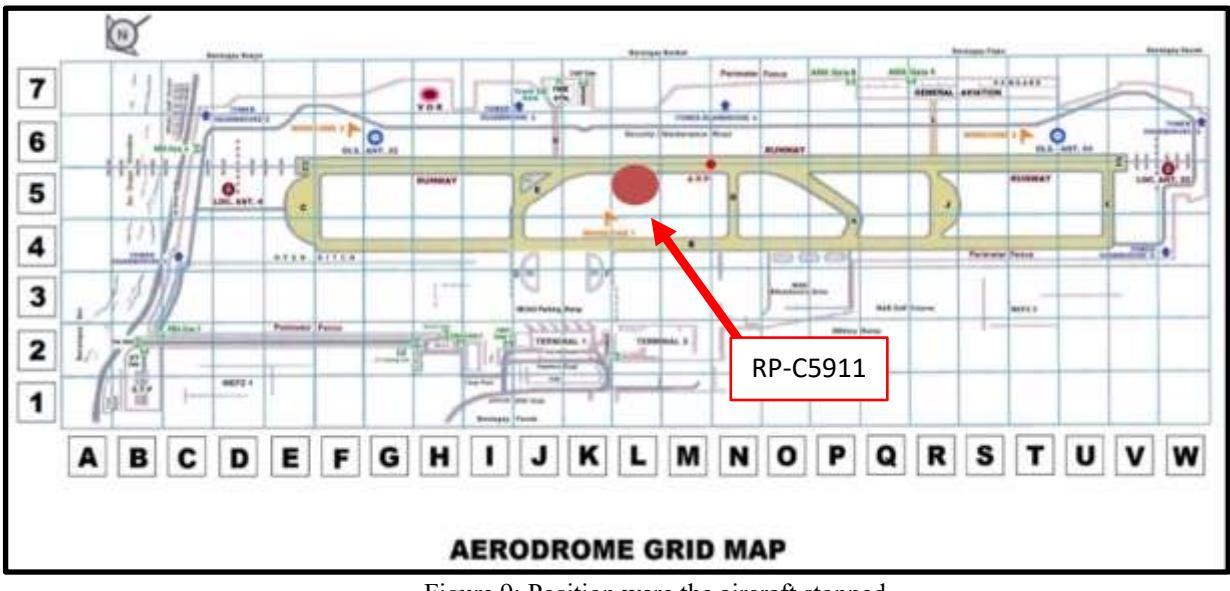
Figure 9: Position were the aircraft stopped.
