# AIRCRAFT ACCIDENT INVESTIGATION AND INQUIRY BOARD

## FINAL REPORT

RP-C119  
PA-23-250

**TITLE:** Accident involving a Piper Aztec PA-23-250 Registry Number RP-C119 owned and operated by Skyline Aviation88 ditched into the sea following a right-hand (RH) engine failure on August 31, 2019, at around 1330H at about 2 kilometers from Isla Kampanario, Brgy. Papaya, Nasugbu, Batangas.

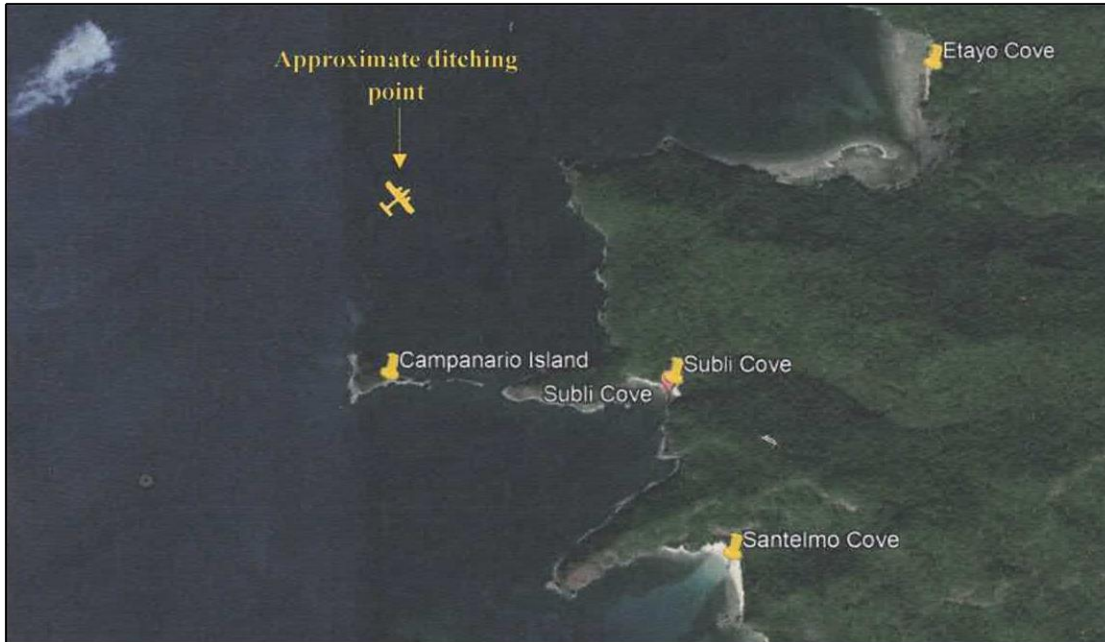
Figure 1: Approximate ditching point

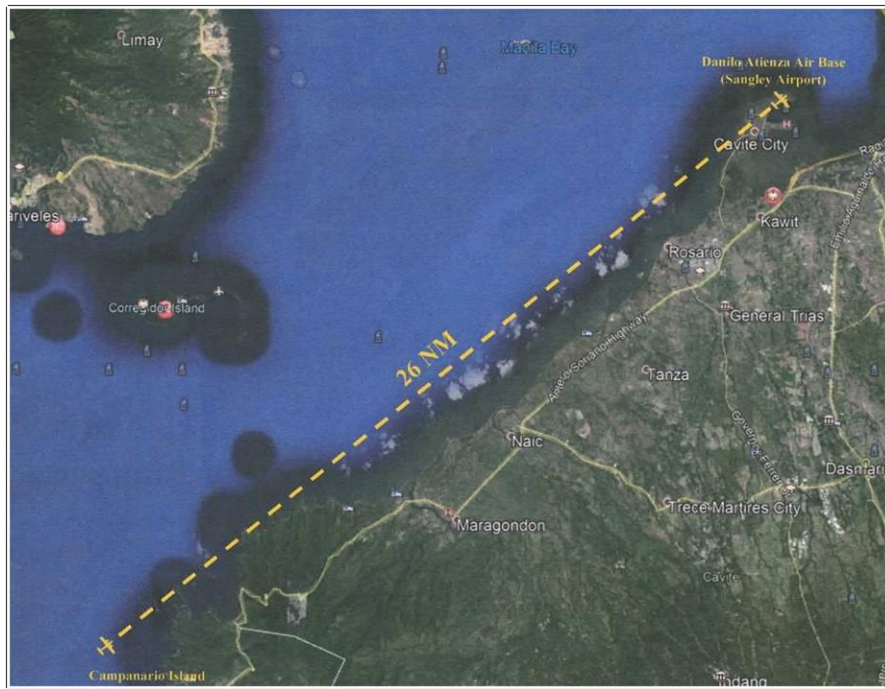
According to the pilot, the aircraft took off from Cuyo Principal Airport at about 1130H bound for Sangley Airport, Cavite. The flight was cruising at 4000 feet and uneventful until 40 NM to Sangley Airport. While on initial descent, the pilot observed a decreasing fuel flow on the RH engine. The fuel flow continued to decrease until the RH engine stopped. The aircraft continued its descent towards Sangley Airport and leveled off at 2,500 feet with one engine inoperative. While approaching Nasugbu, Batangas, about 30 NM from Sangley Airport, the pilot observed that the aircraft was starting to descend and could not maintain altitude. As the aircraft continued to descend, the pilot chose to ditch it near Campanario Island, Barangay Papaya, Nasugbu, Batangas. The ditching point is approximately 24 NM from Sangley Airport (Figure 2).

Figure 2: Distance to Sangley Airport
