# AIRCRAFT ACCIDENT INVESTIGATION AND INQUIRY BOARD

## FINAL REPORT

RP-R3027  
AG CAT G-164A

**TITLE:** Serious incident involving an Agcat G-164A type of aircraft with Registry Number RP-R3027 operated by Mindanao Rainbow Agricultural Development Services, Inc (MRADS) that made a runway excursion after an aborted take-off at Agrotech Integrated Farm Airstrip, Monkayo Davao De Oro on September 24, 2019 at about 0610H.

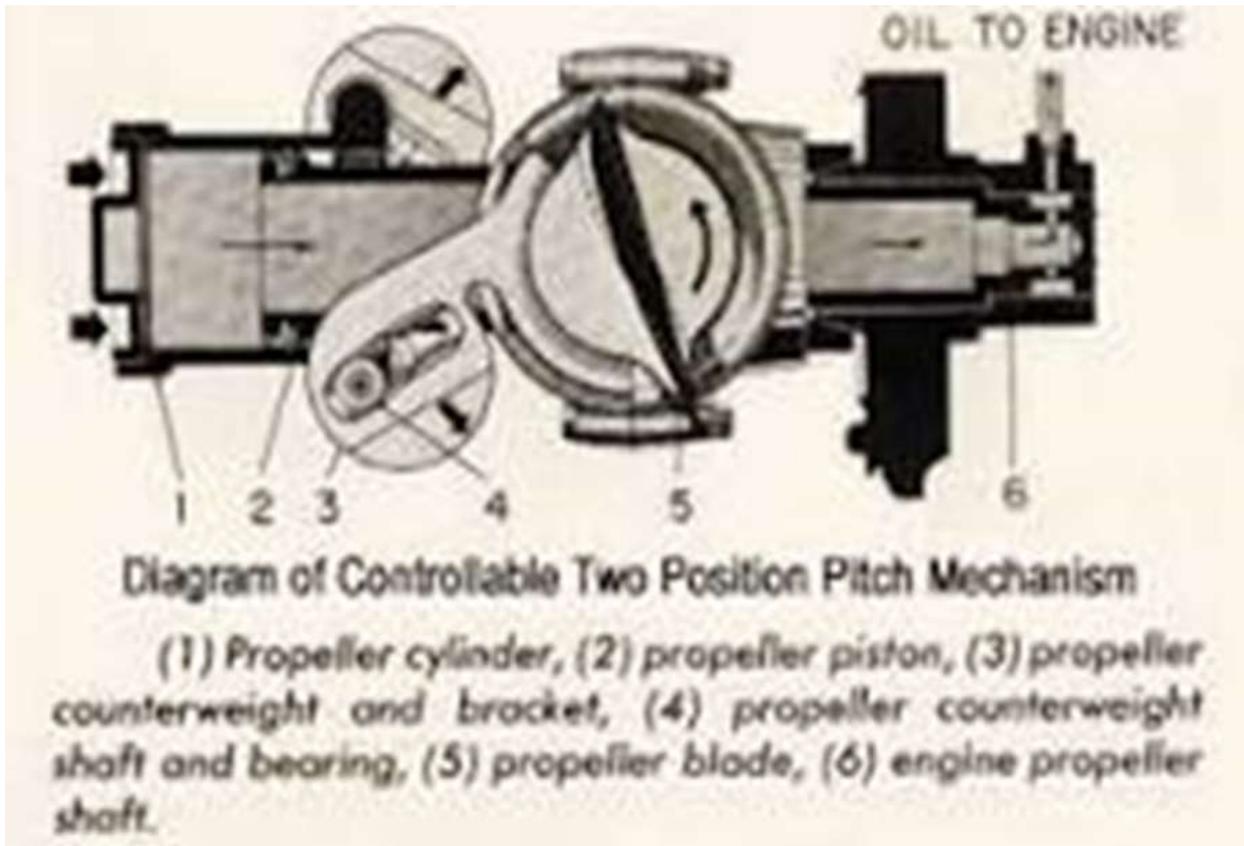
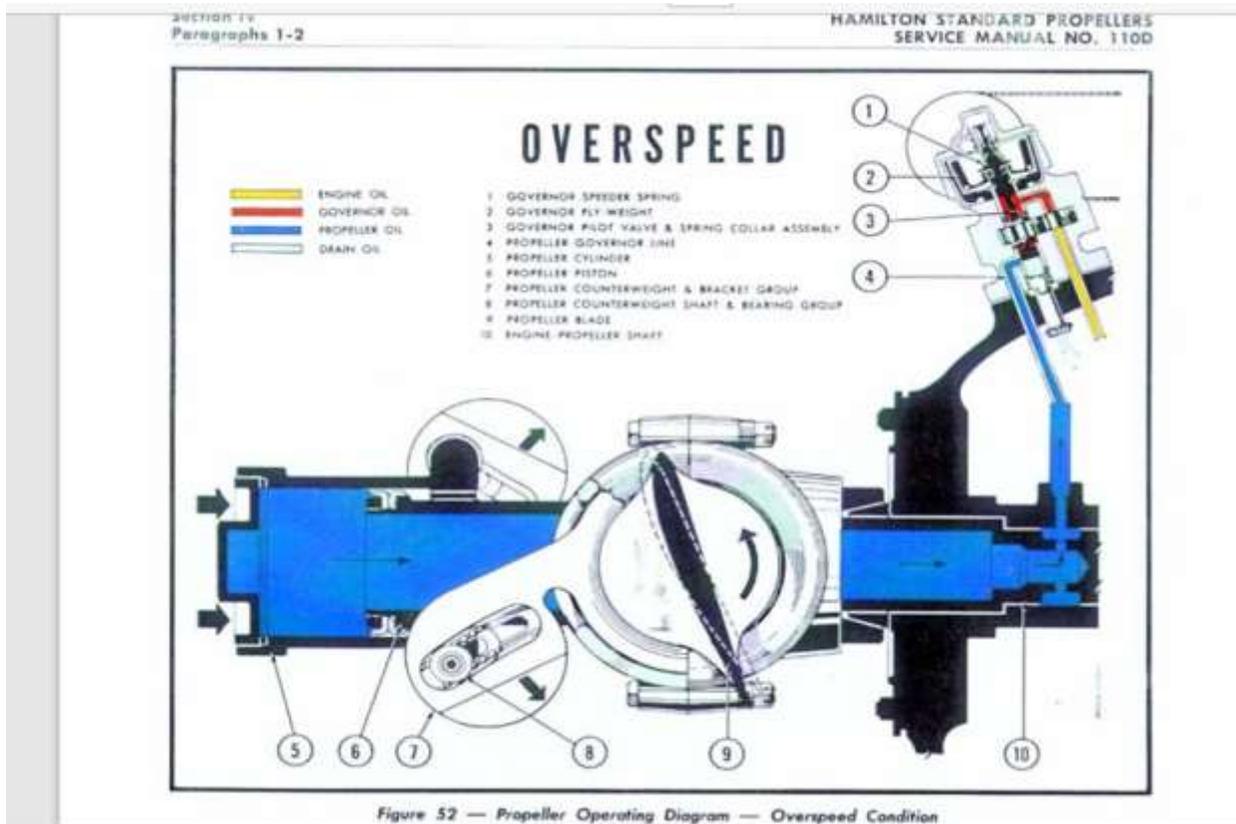
Figure 5 - Operation of a two pitched propeller.

After the incident, the pilot examined the aircraft for damages. The broken counterweight bracket, which helps balance the propeller and adjust blade pitch to maintain a constant RPM under varying conditions and ensure efficient flight performance, was clearly visible in the damaged aircraft. The diagrams below show how a controllable counterweight two-position pitch mechanism operates.

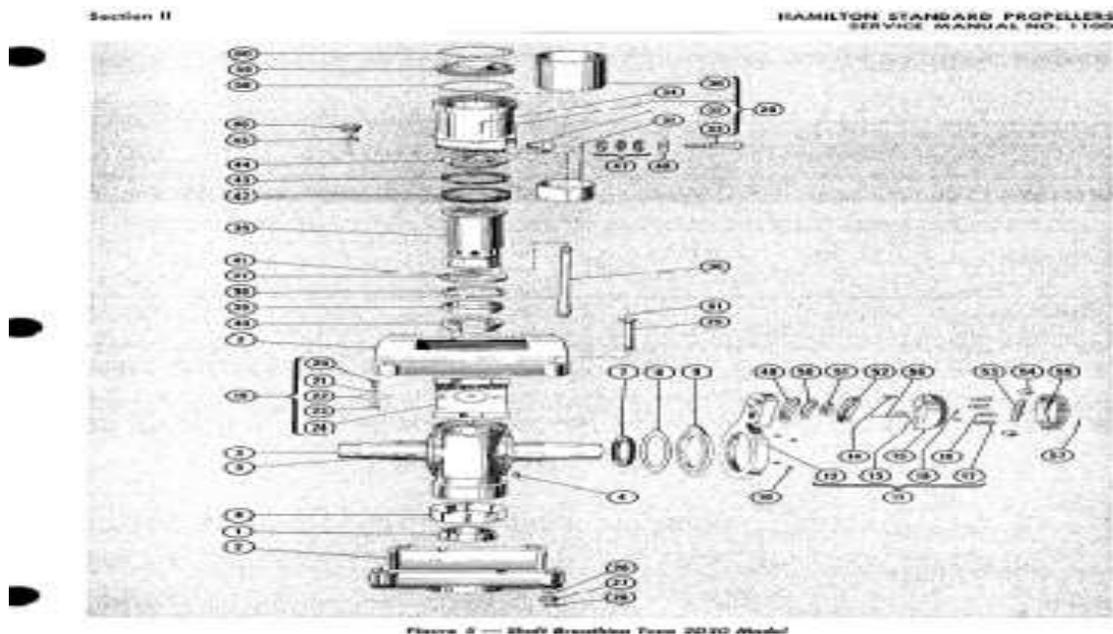
Figure 7 - The Propeller Hub Assembly Diagram.

Understanding the propeller as a whole, the counterweight type propeller is composed of two (2) major assemblies, the hub assembly and the blade assembly. The hub assembly comprises the hub group, the counterweight group, and a cylinder group (Figure 7).

Based on Section V of the handbook, the propeller counterweight bracket shall be inspected during the 200-to-240-hour inspection, wherein the counterweight bearing shall be checked for ample lubrication, the counterweight bearing retainer should be thoroughly cleaned, and the balls should be examined for pit marks and cracks. The counterweight bearing races should be closely examined for wear, galling, or brineling, and visually inspected for fatigue cracks, all of which are found in the cylinder assembly. Moreover, Section VI para 5 (6) (7) (8) (9) of the handbook describes the detailed inspections to be undertaken during the installation and maintenance of counterweight brackets and accessories.

- Note: No. 11 - Counterweight Bracket Assembly.
- No. 12 - Counterweight Bracket.
- No. 29 - Cylinder Assembly.
- No. 43 - Counterweight Bearing Inner Race.

The procedures defined in the handbook concerning counterweight bracket and accessory inspection should be observed and incorporated in the operator's procedures and maintenance manual to be accomplished during the particular periodic inspections.

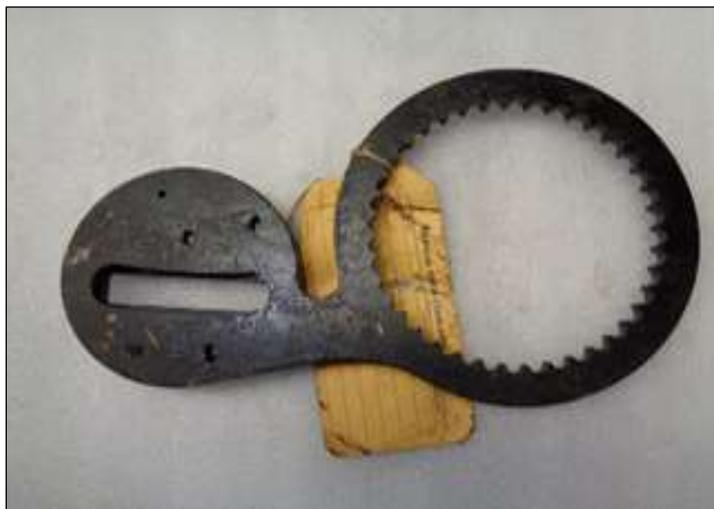
Figure 8 - A Propeller Counterweight Bracket.

Fatigue appears to be the cause of the propeller counterweight bracket's failure. Despite the unique circumstances, a thorough inspection of the propeller counterweight bracket and its accessories is necessary. The 50-hour, 100-hour, and annual inspections provide limited information about the necessary inspections for propeller counterweight brackets and accessories.

- a. The failure of the propeller counterweight bracket.

- 4.1 To ensure that the operator, Mindanao Rainbow Agricultural Development Services Inc., includes in their pre-flight and post-flight inspection checklists the inspection of the propeller counterweight bracket and accessories for wear, tear, and fatigue.
- 4.2 To ensure that the operator, Mindanao Rainbow Agricultural Development Services Inc., adheres to the propeller inspections in the Hamilton Standard Propellers Handbook, particularly on counterweight brackets and accessories.
