## AIRCRAFT ACCIDENT INVESTIGATION AND INQUIRY BOARD

### **FINAL REPORT**

**RP-C1174**  
**TEXTRON AVIATION INC. CESSNA U206F**

**TITLE:** An accident involving a Textron Aviation, Inc. C-U206 type of aircraft with Registry Number RP-C1174 had a Controlled Flight Into Terrain (CFIT) accident at the mountainous area of Barangay Ditarum, Divilacan, Isabela, Philippines on January 24, 2023, at around 1455H.

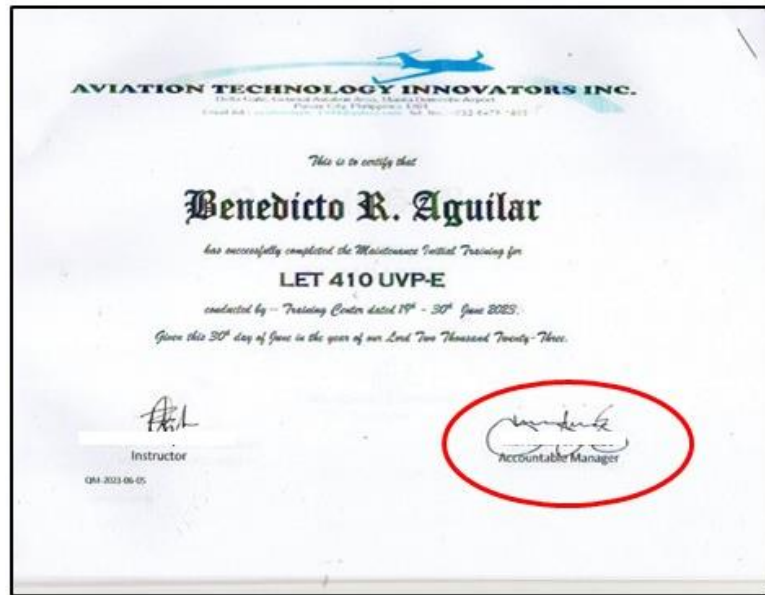
Figure 6 – Sample document issued by ATII with the valid signature of their Accountable Manager.

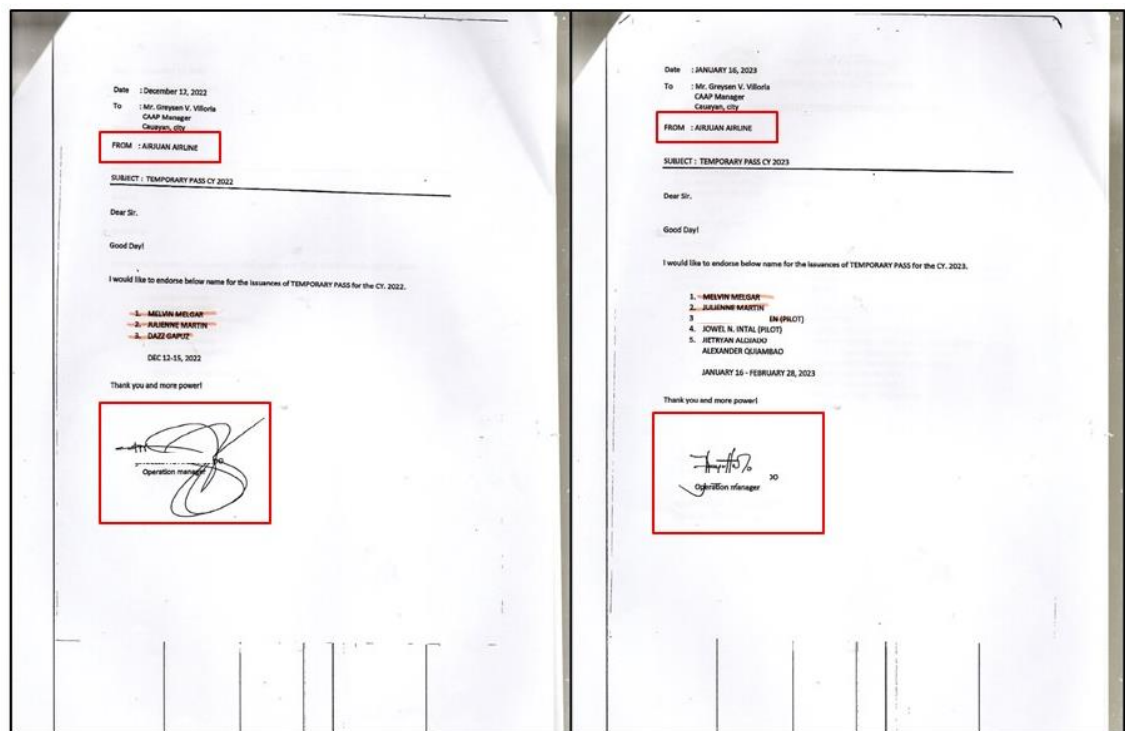
Figure 10 – Airport access passes application of AIRJUAN airline submitted to CAAP Cauayan Airport Manager dated December 12, 2022 and January 16, 2023.

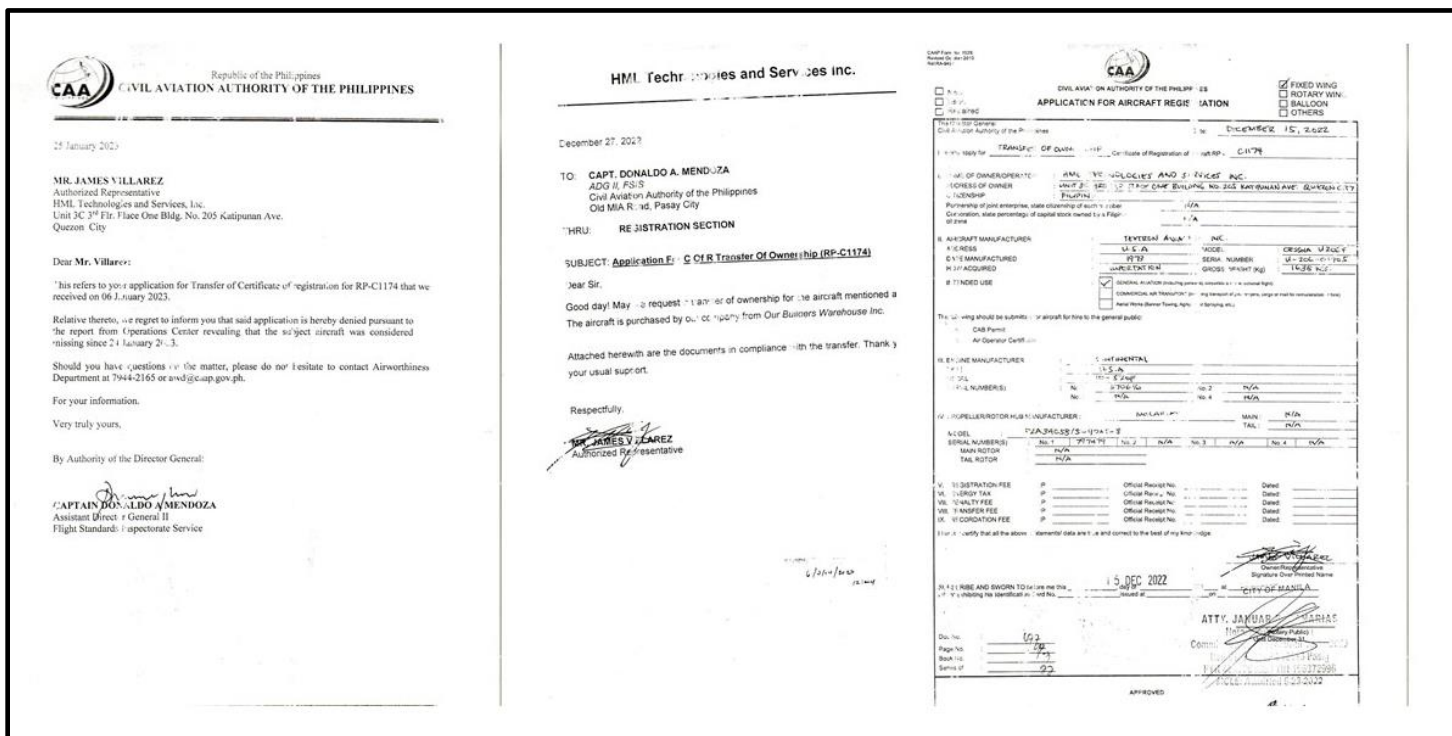
Figure 13 – Documents related to the application for transfer of ownership of RP-C1174 from Our Builders Warehouse, Inc. to HML Technologies and Services, Inc.

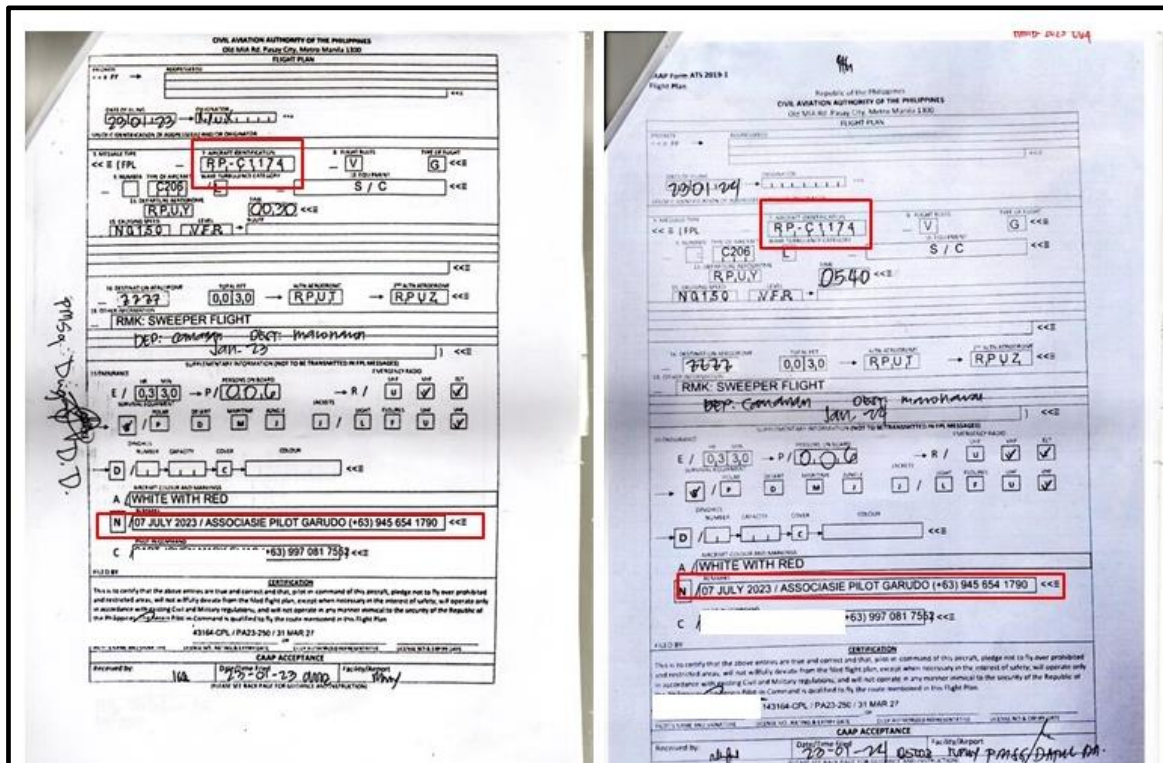
Figure 14 – Flight Plans filed for RP-C1174 under APG.

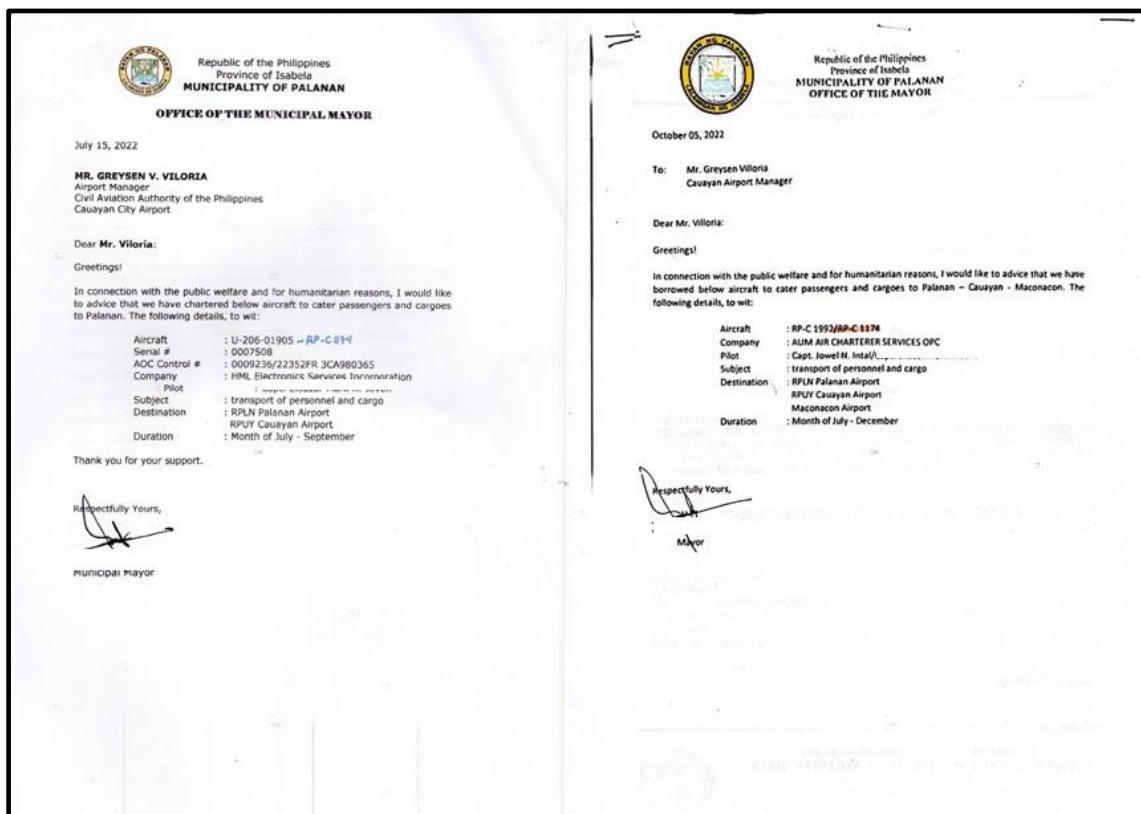
Figure 17 – Letter from the LGU of Palanan, Isabela informing CAAP Cauayan that they will utilize RP-C1174 for public welfare and humanitarian reasons.

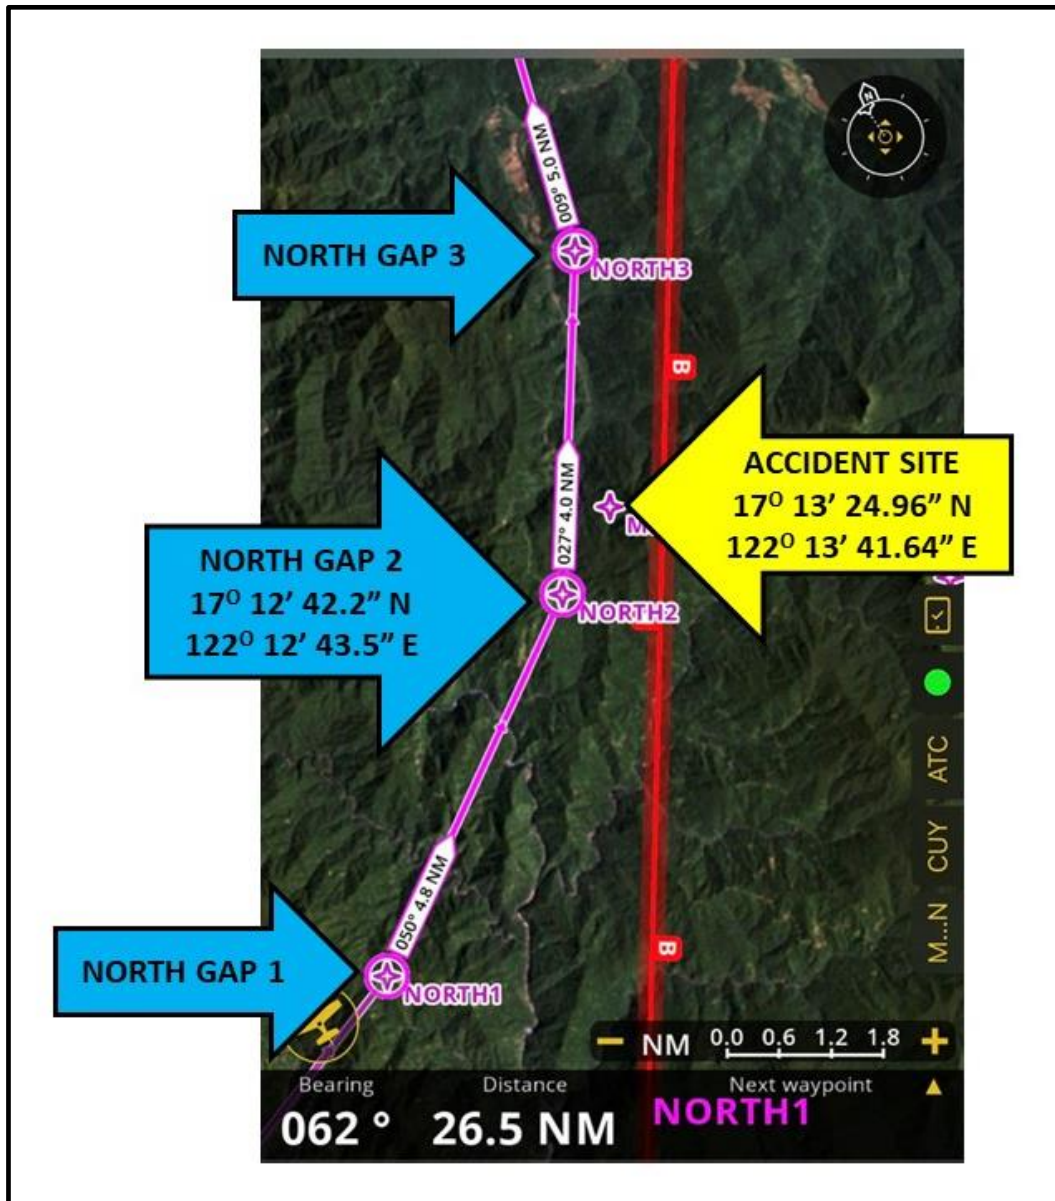
Navigating over the Sierra Madre mountains presents pilots with a number of challenges, mainly due to the presence of elevated terrain and the potential for sudden and erratic localized weather conditions. Under VFR, pilots are expected to be able to see outside the cockpit, control the aircraft's altitude, and avoid obstacles as well as other aircraft. Given the details about the prevailing weather at the time of the accident and the terrain features along this route, it is evident that these factors played a substantial role in the occurrence of this accident.

Figure 19 – Waypoints North Gap 1 to 3 located within the Sierra Madre and the accident location site.

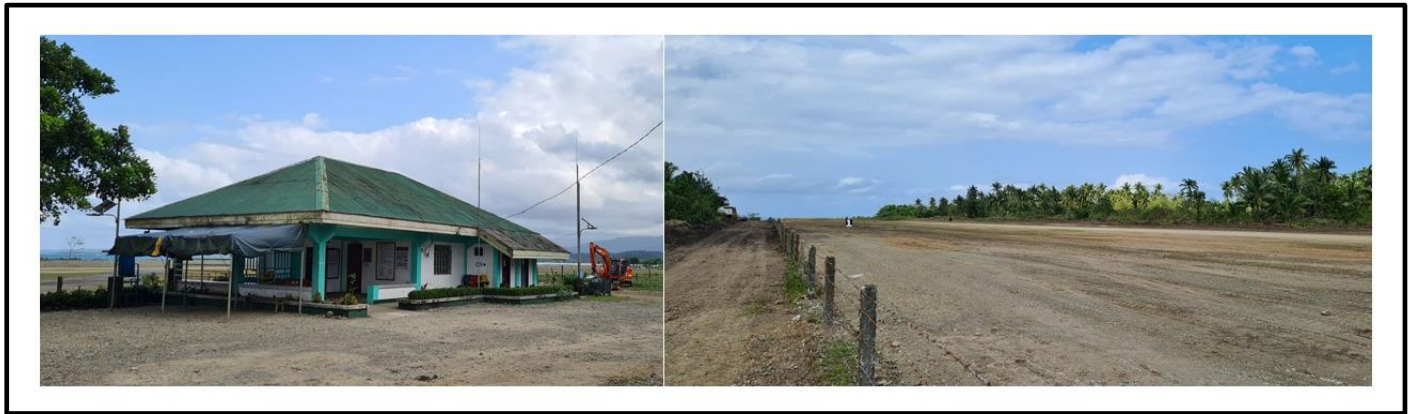
Figure 20 – Maconacon airport.

With the above information, it was found that the airport had been operating and providing flight operation services to general aviation and commercial operations without the required PTO for an airstrip when the accident happened on January 24, 2023
