AIRCRAFT ACCIDENT INVESTIGATION AND INQUIRY BOARD

FINAL REPORT

RP-C 1234
PIPER AIRCRAFT INC., PA-32-300

TITLE: Accident involving a Piper Aircraft Inc., PA-32-300 type of aircraft with Registry Number RP-C1234 owned and operated by Fliteline Airways Philippines Inc. that experienced controlled flight into-terrain within the vicinity of Barangay Casala, San Mariano, Isabela, Philippines, on November 30, 2023 at about 1040H (local).

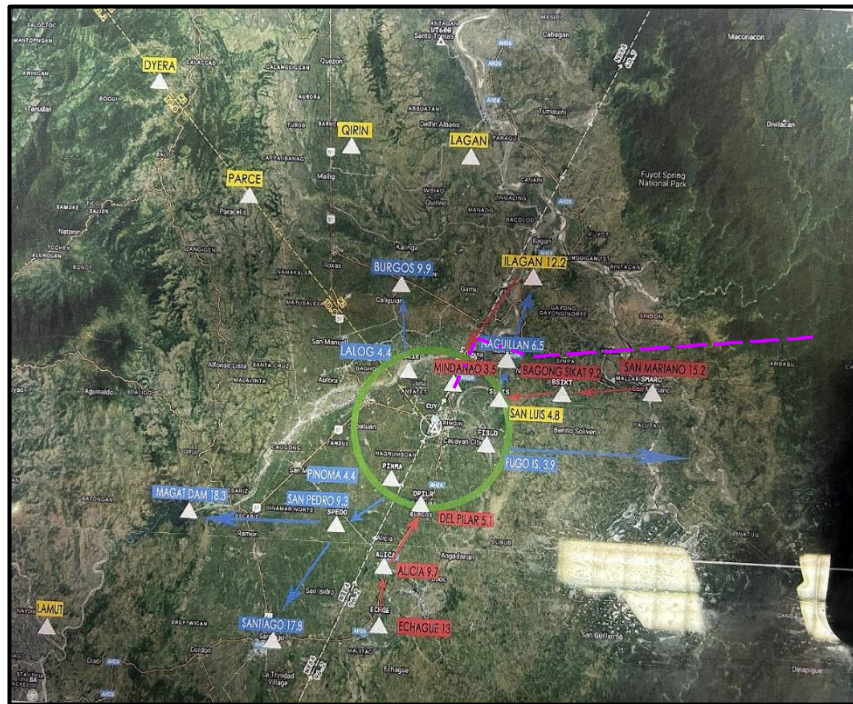
Figure 12 - RPUY VFR outbound East departure.

Based on Cauayan ATC, the pilot was cleared VFR via RWY 30 for East departure. The outbound pilot will report 15.2 NM out (San Mariano area) onto the desired VFR altitude (Figure 12). Upon reaching 15.2 NM, the pilot then will advise Cauayan ATC the switching to Unicom frequency (121.90Mhz) for traffic information monitoring while maintaining VFR flight.
