FINAL REPORT

RP-C8598
TEXTRON AVIATION INC. CESSNA 152

OPERATOR: ECHO AIR INTERNATIONAL AVIATION ACADEMY, INC.

DATE OF OCCURRENCE: AUGUST 1, 2023

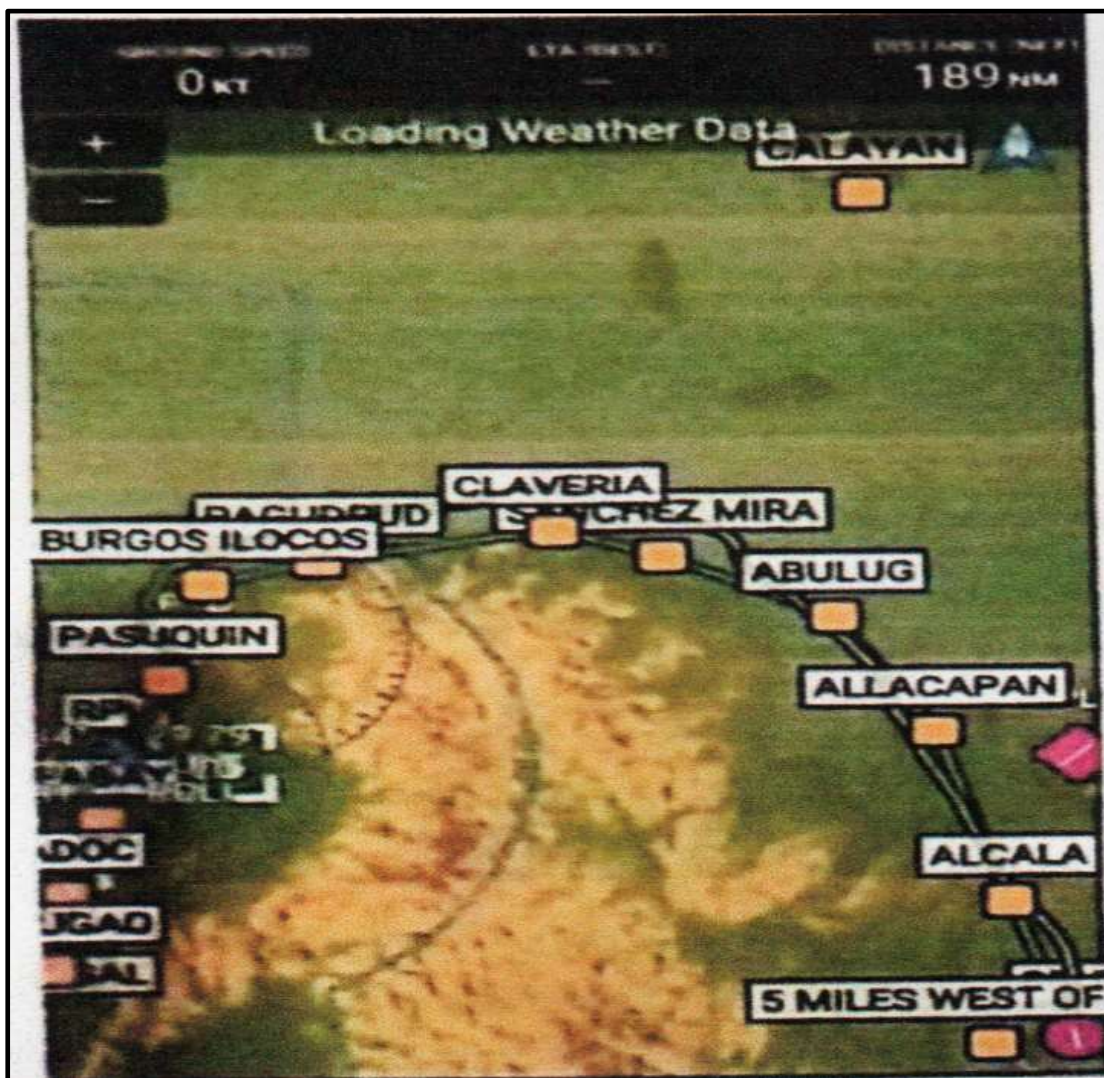
Figure 5 – Screenshot of the training waypoints plotted on the mobile GPS app.

During navigation training, flight instructors commonly employ a GPS mobile application to plot training waypoints and routes (Figure 5). In addition to the GPS mobile app, both Flight Instructors and Student Pilots are said to be required to utilize the navigational log developed by the school and an appropriate map for tracking and successfully navigating the planned training flight route. The navigational log serves as one of the tools for planning a certain flight route, especially during navigation training sessions. The execution of the plotted route on the navigation log is imperative to fulfill this specific training requirement.

On review of the available navigation log and the documented route under its Procedures Manual, inconsistencies were noted on both documents, particularly regarding the identified check points for that specific route. The check points indicated on the navigation log are different from the published route (Figure 7) in its manual. In addition, there is no specific documentation under their manual that a navigation log is specifically required during cross-country flight training.

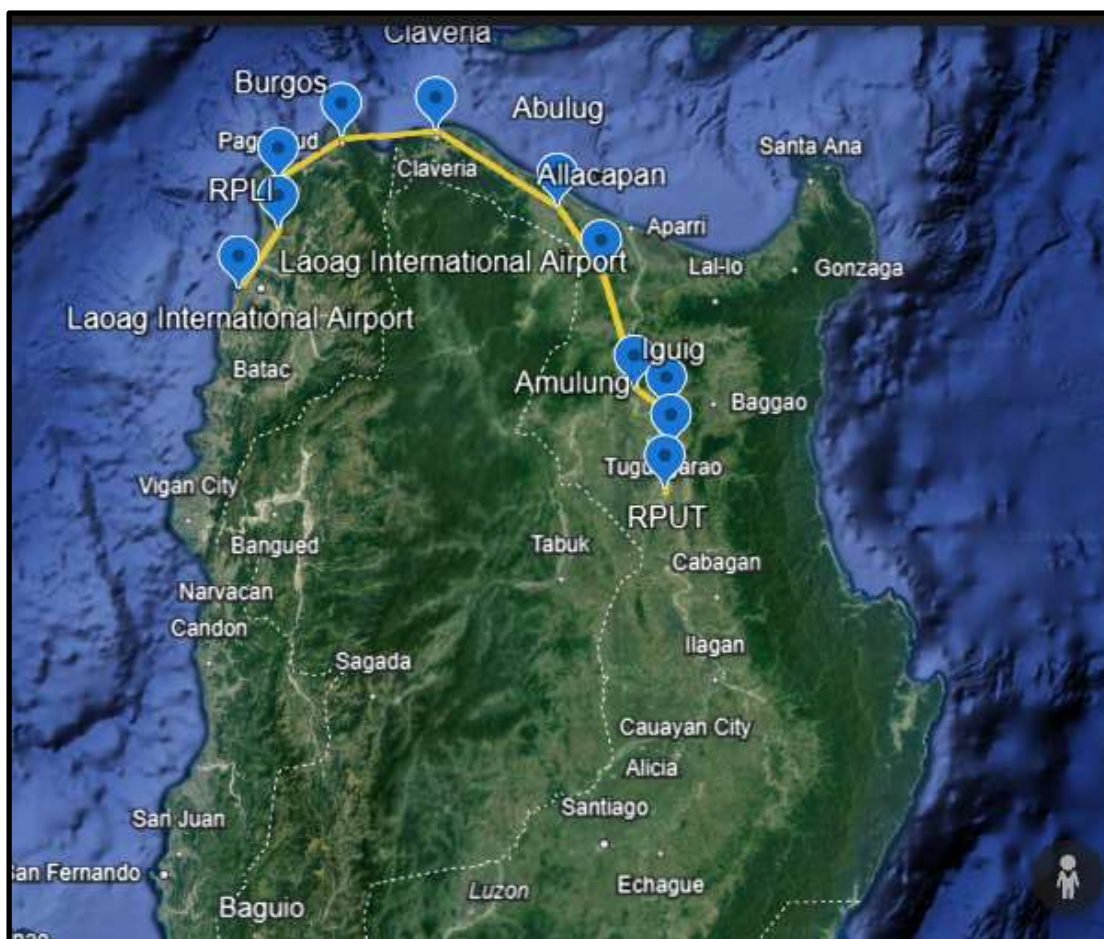
Figure 10 – RP-C8598 flight route for RPUT-RPLI.

On this scheduled training flight, RP-C8598 departed RPUT at around 0939H instead of its originally planned departure time of 0800H. The delay was attributed to adverse weather conditions that morning, specifically the ceiling condition, which was below the minimum required for flight. The pilots opted to wait for an improvement in weather conditions before initiating departure. Once the weather conditions became favorable, the aircraft took off from RPUT, heading north towards the shoreline. The flight followed the published training route as outlined in Echo Air's Navigation Log form (Figure 10). On the other hand, the second aircraft scheduled to fly with RP-C8598, which was RP-C9062, departed RPUT for RPLI at around 0918H. Though with the same flight destination, RP-C9062 deviated from the published route, as disclosed during the interview of its assigned FI/PIC and the other FI who was also onboard the flight for his route familiarization. According to the flight FI, he anticipated inclement weather conditions along the published route, leading to his decision to deviate. However, this deviation did not have prior approval from the school's HOT or CFI. Additionally, the aforementioned FI stated that this was not his first time flying this particular route, and he had a history of using this deviated path, which involves crossing mountainous terrain from RPUT to RPLI v.v. This information was further corroborated by other FIs who had heard from their colleagues and students that this specific FI had been navigating over this mountainous terrain without obtaining consent from Echo Air's management. Notably, this deviation from the published route was never reported to the relevant HOT and CFI within the organization.

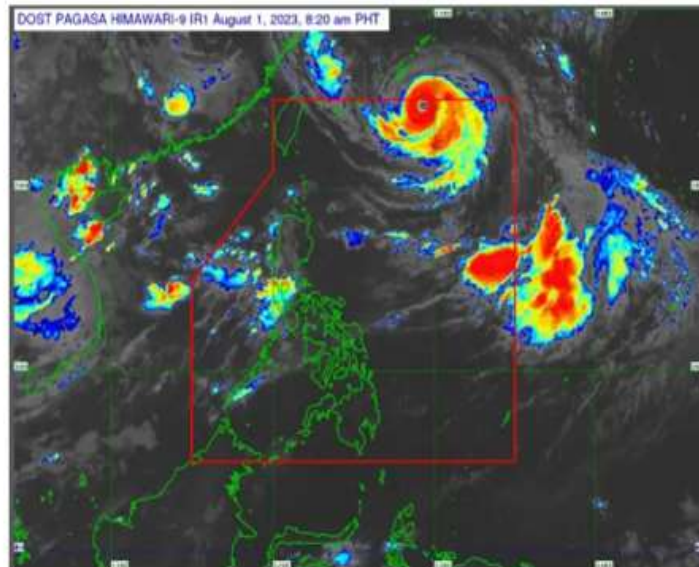
Figure 12 – PAGASA weather satellite data

The southwest monsoon will bring cloudy weather conditions with scattered rain showers and thunderstorms over Cordillera Administrative Region, Cagayan Valley, Calabarzon, the rest of Ilocos Region, the rest of Central Luzon, the rest of MIMAROPA, and Antique.

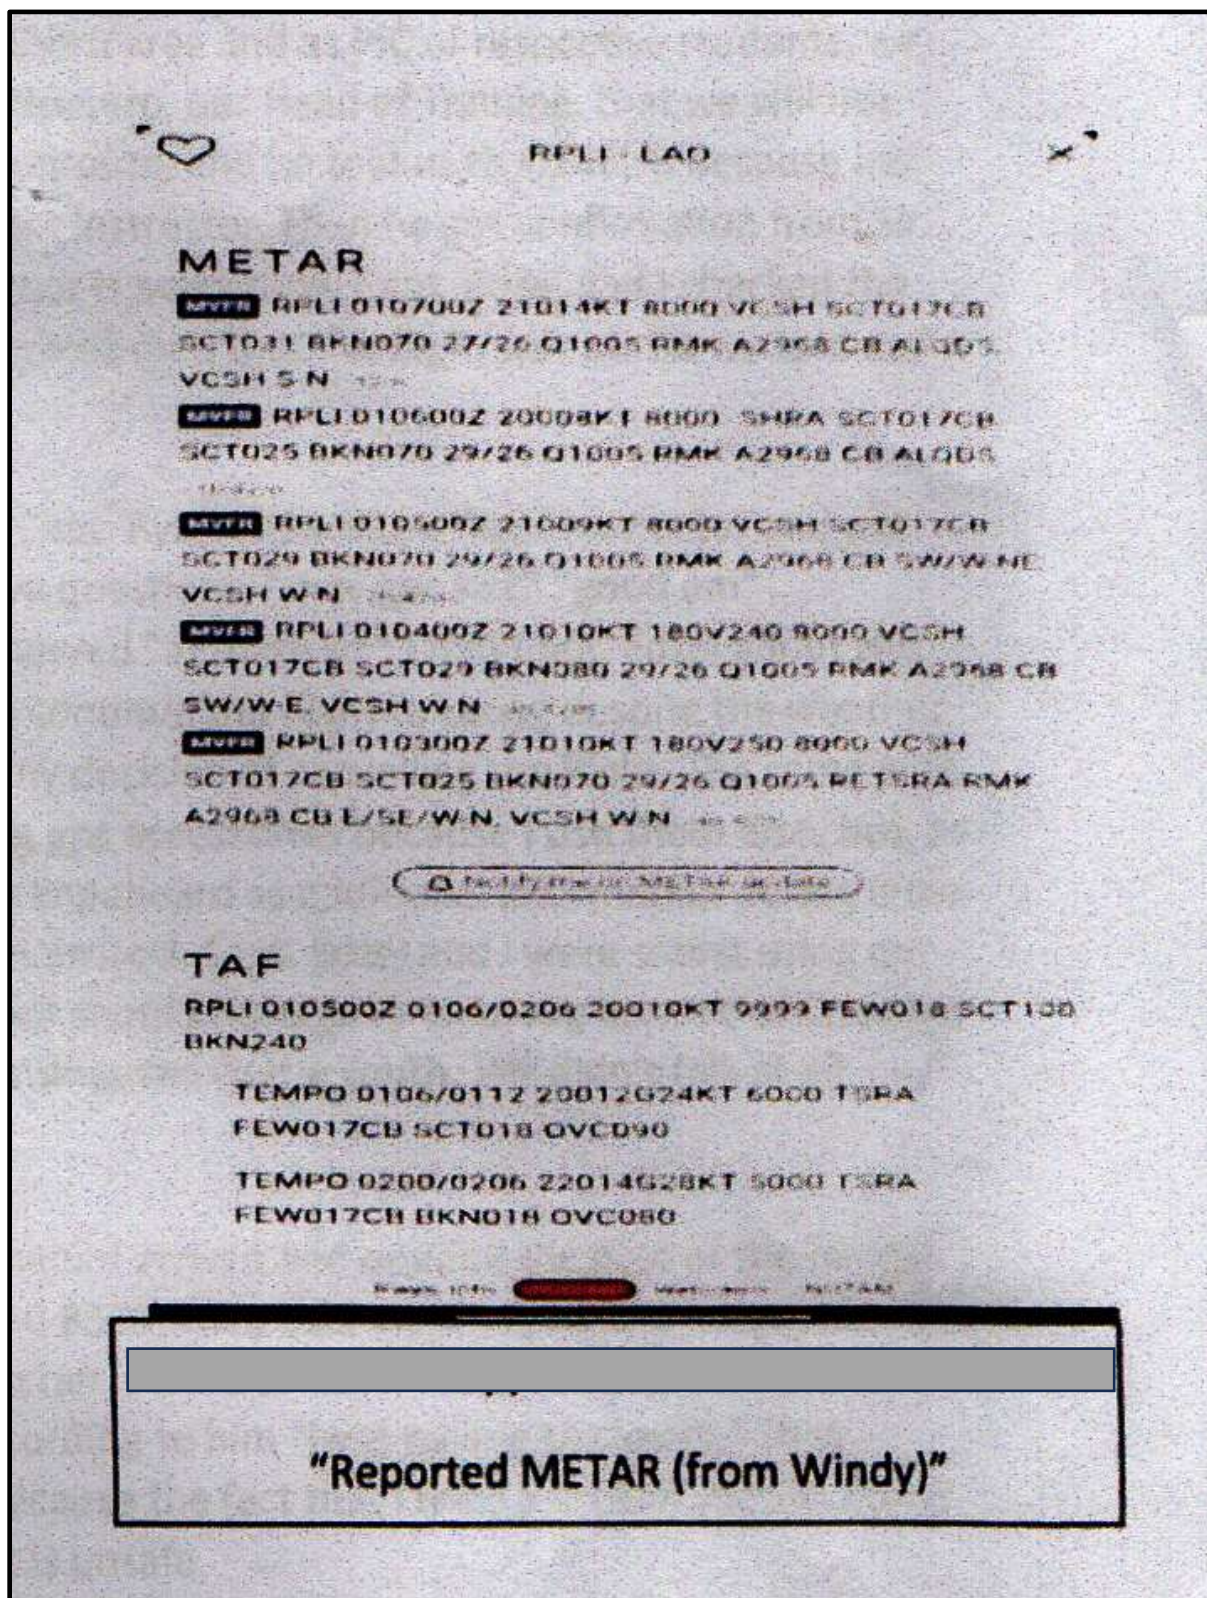
Figure 16 – Reported METAR

Based on the information above, gusty conditions, especially in coastal areas and upland/mountainous areas exposed to wind (see particularly Tropical Cyclone Bulletin Nos. 13 and 14 – Typhoon Falcon, issued at 0500H and 1100H on August 1, 2023), are forecasted due to the enhanced southwest monsoon caused by Tropical Cyclone Falcon. Although the mentioned weather disturbance is already outside the Philippine area of responsibility, it still has some forecasted impact on various areas, such as Zambales, Batanes, Babuyan Islands, Abra, Benguet, Zambales, Bataan, the central and southern portions of Aurora, Pampanga, Bulacan, Metro Manila, and most of the Ilocos Region, CALABARZON, MIMAROPA, Bicol Region, and Western Visayas. Significantly, the published and actual route of RP-C8598 traverses through some of these impacted areas. This weather condition was further confirmed based on the information and documents provided by the next-of-kin (NOK) of RP-C8598's FI, wherein it was disclosed that the private message between the SP and his family member revealed their encounter with bad weather along the route.

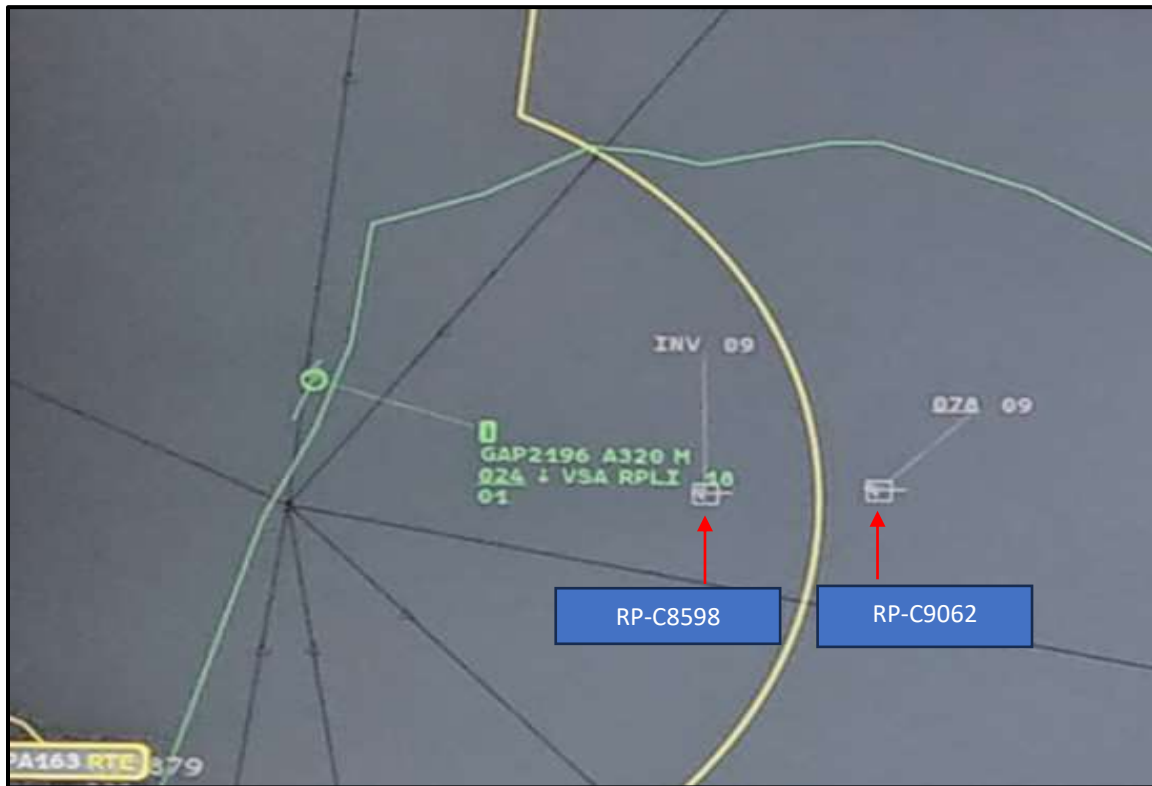
Figure 18 - Radar depicting both aircraft at flight at about 0443 UTC

In addition to the above, the weather conditions on the area where the aircraft disappeared from the radar were corroborated by the crew of RP-C9062 who initiated the initial search for the missing company aircraft. Their search was hindered by the deteriorating weather conditions in the area, which complicated the search operation.
