# AIRCRAFT ACCIDENT INVESTIGATION AND INQUIRY BOARD

## FINAL REPORT

RP-C8840

Cessna152

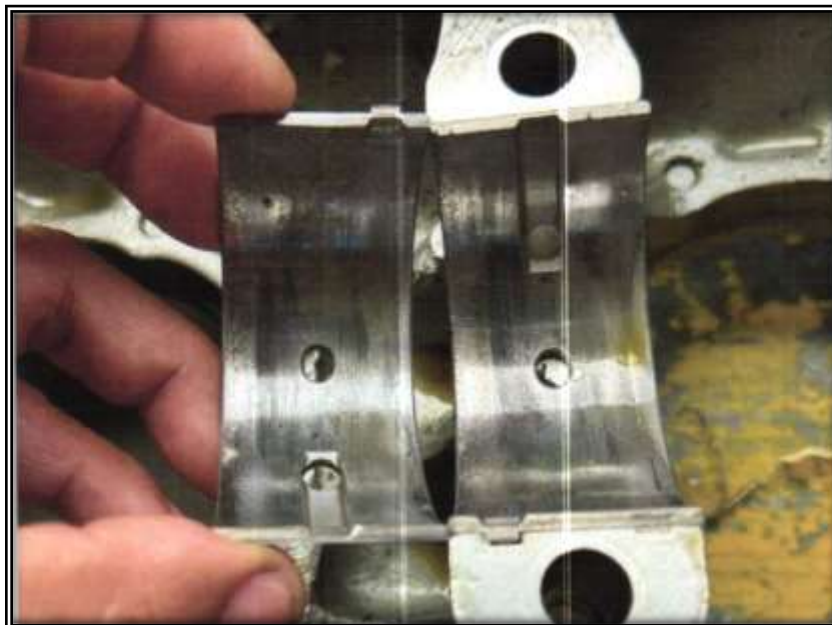
Figure 11 - Photo of undamaged bearing (For reference only).

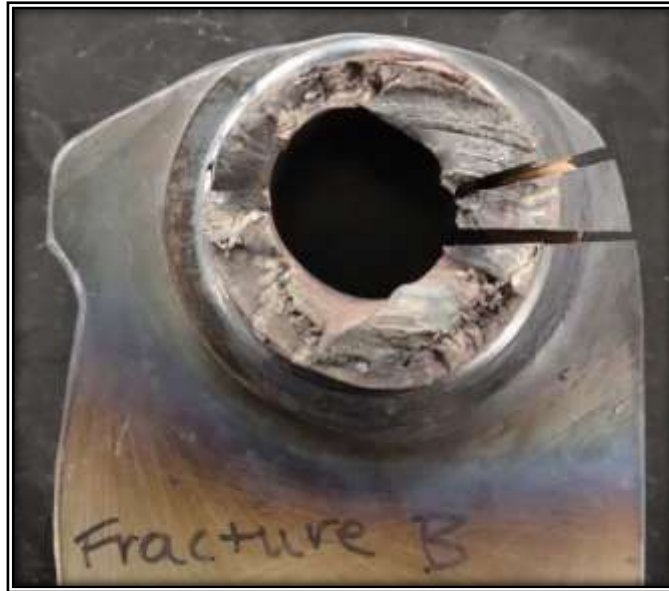
The fracture surface of the rear sample was sectioned in order to obtain a sample for hardness and microstructural analysis. The location of the sample section is shown in Figure 29, with the sectioned surface mounted face-down. Due to the damage that was sustained to the number 3 pin and its fracture surfaces, the values reported are for information only and should not be utilized as a judge of material conformance. Core hardness was measured at  $55.5 \pm 1.0$  HRC, which is significantly higher than the requirement of 32 - 39 HRC. Two microhardness traverses were placed, one on the ID and one of the OD of the sectioned sample. The microhardness profile is shown in figure 30, with the results recorded in HV then converted to HRC. The average hardness was 56 HRC, and no case depth was observed. For reference, the hardness value recorded is significantly higher than the 64 HR30N minimum requirement for the case hardness.

Figure 29. Reference location for the sectioned sample obtained from the fracture surface of the rear sample.

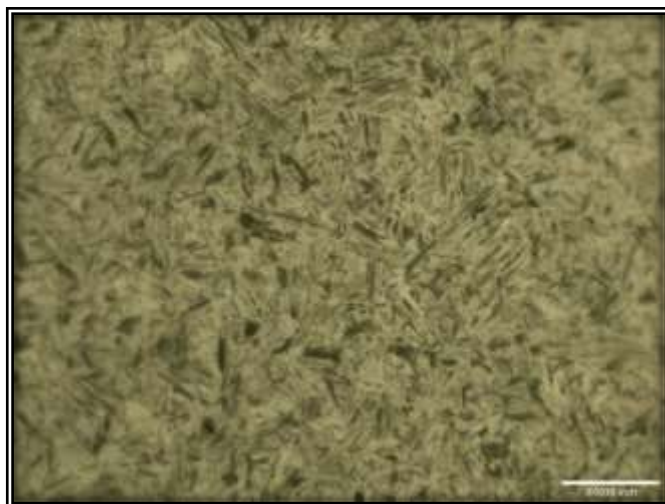
Multiple cracks are visible along both the ID and OD of the sample cross-section, with the largest crack visible in figure 31, with the maximum separation of 0.02157 inches. Additional cracking was observed likely resultant of heat checks stemming from rapid temperature changes during the failure is shown in figure 32. The sample was etched with nital to view the microstructure, which consist of tempered martensite in the core, is shown in figure 33. The case microstructure consists of fine grains with small

Figure 33 - 500x original magnification of the core microstructure of the sectioned rear sample after being etched with nital.

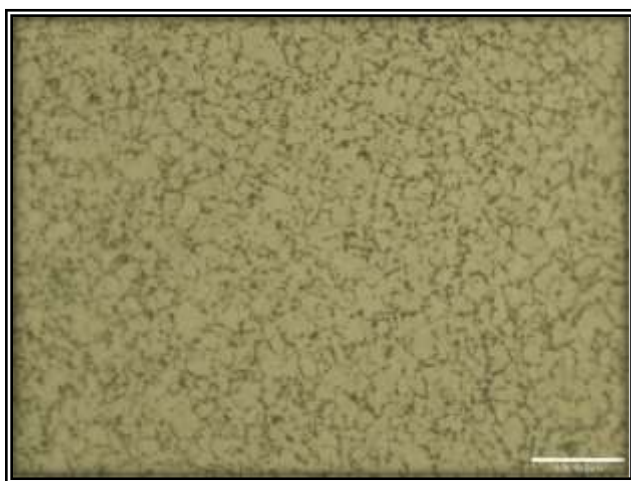
particles lining the grain boundaries, likely of carbide and nitride particles is shown in figure 34. There are fine grains present in the microstructure immediately below the scale layer on the OD and extend approximately 0.024 inches into the material. The altered microstructure of the case was observed on the ID, OD, and in some regions along the fracture surface. The microstructure difference was indicative of a significant heat event, which altered the microstructure from the typical tempered martensite and dispersed nitrides at the case. A white layer with a thickness of 0.00075 inches from the original gas nitride heat treatment process was visible along the ID of the sample is shown in figure 35.

Figure 34 - 500x original magnification of the case microstructure of the sectioned rear sample after being etched with nital.

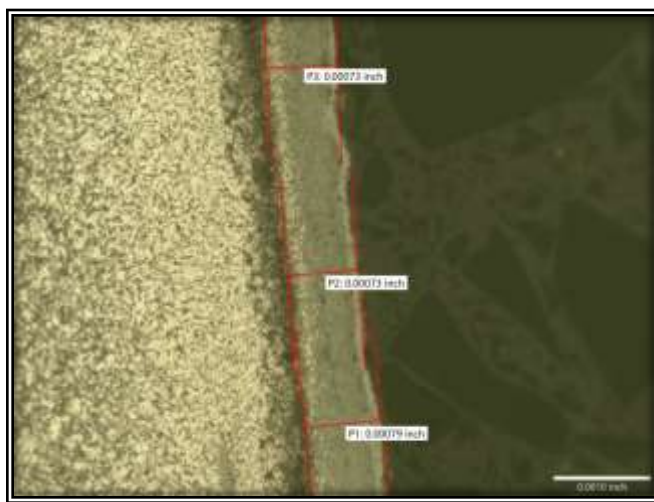
Figure 35 - 500x original magnification of the case microstructure of the sectioned rear sample after being etched with nital.

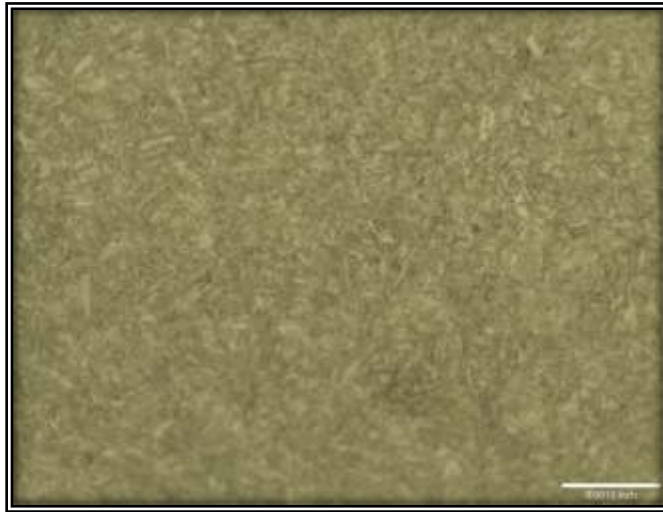
The number 1 pin was sectioned and evaluated for conformance as a reference for the condition of the number 3 pin. After being etched with nital, the core of the sectioned sample of the number 1 pin was observed to consist of tempered martensite shown in figure 40, is conforming. The case microstructure consisted of tempered martensite and dispersed nitrides is shown in figure 41. Patches of white layer from nitride treatment were also visible. The core hardness of the pin was  $34.0 \pm 0.1$  HRC, which is conforming. The case depth of the pin with an average value of 0.0245 inches, is conforming to the requirement of 0.018 – 0.026 inches.

Figure 40 - 500X original magnification of the core microstructure of Pin number 1 after being etched with nital. The core microstructure consists of tempered martensite, which is conforming.

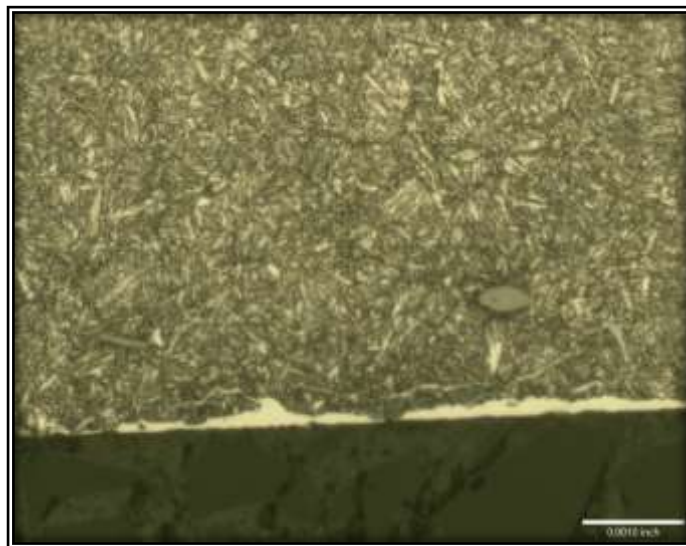
Figure 41- 500X original magnification of the case microstructure of Pin number 1 after being etched with nital. The case microstructure consists of tempered martensite and dispersed nitrides, which is conforming. Some regions of the white layer from the nitride process are present.

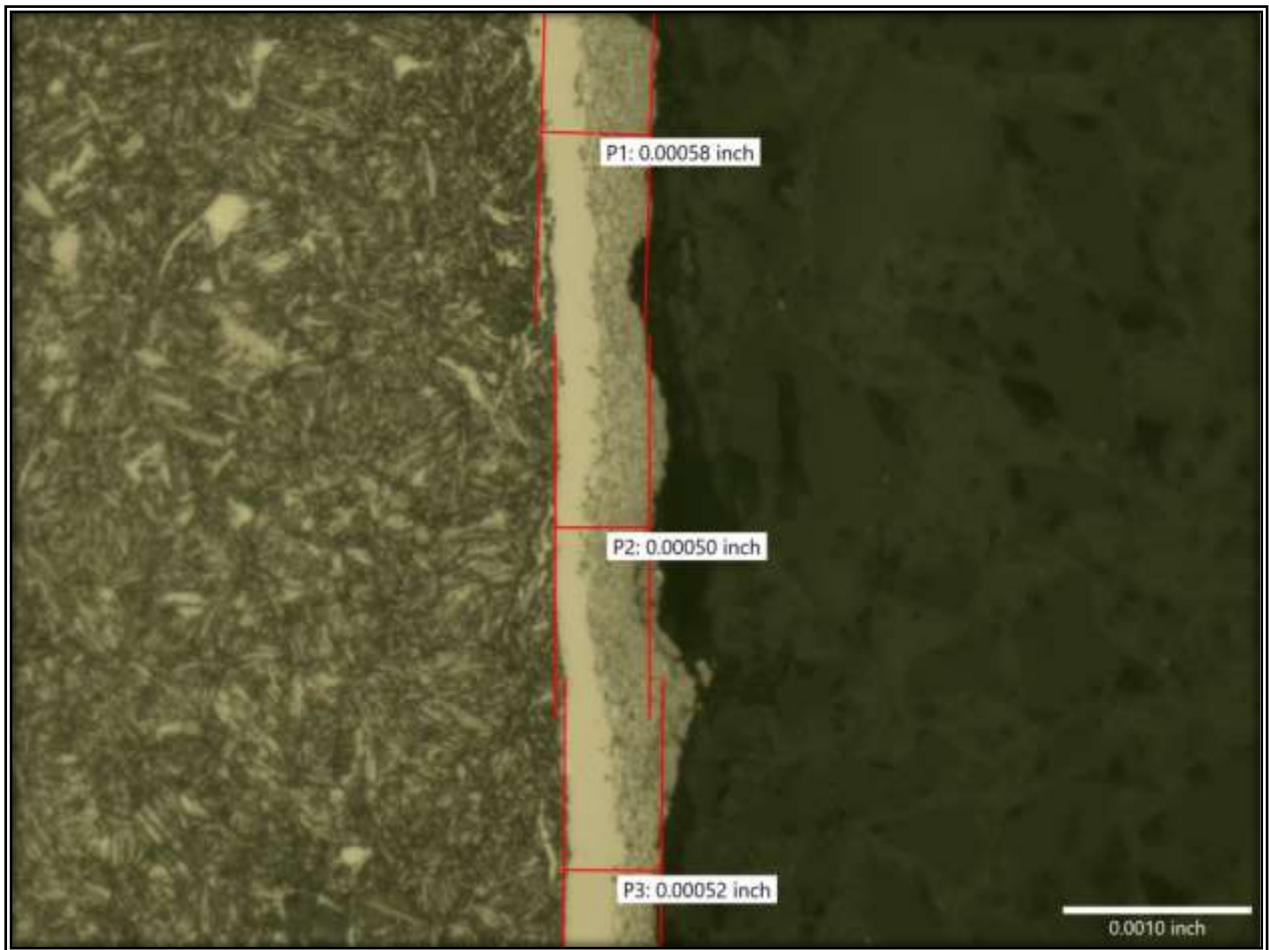
A section of the number 2 cheek was isolated and prepared for conformance testing away from the region of failure. The average core hardness that was obtained was  $34.4 \pm 0.1$  HRC, which is conforming to the 32 - 39 HRC requirement. Several microhardness traverses were placed on the sectioned sample. The sample was etched with nital to observe the case and core microstructures. The case consisted of tempered martensite and dispersed nitrides. The white layer measured 0.00053 inches thick, is shown in figure 42. The core microstructure consists of tempered martensite is shown in figure 43. Both the case and core microstructures were conforming to LPS-366 and LPS-468. The sample was also evaluated via Optical Emission Spectroscopy (OES) and was found to be consistent with the requirement of AMS steel 6415 with a slightly elevated carbon percentage.

Figure 42 - 500X original magnification of the case microstructure of Cheek number 2 after being etched with nital. The case microstructure consists of tempered martensite and dispersed nitrides. The white layer averaged a thickness of 0.00053 inches.

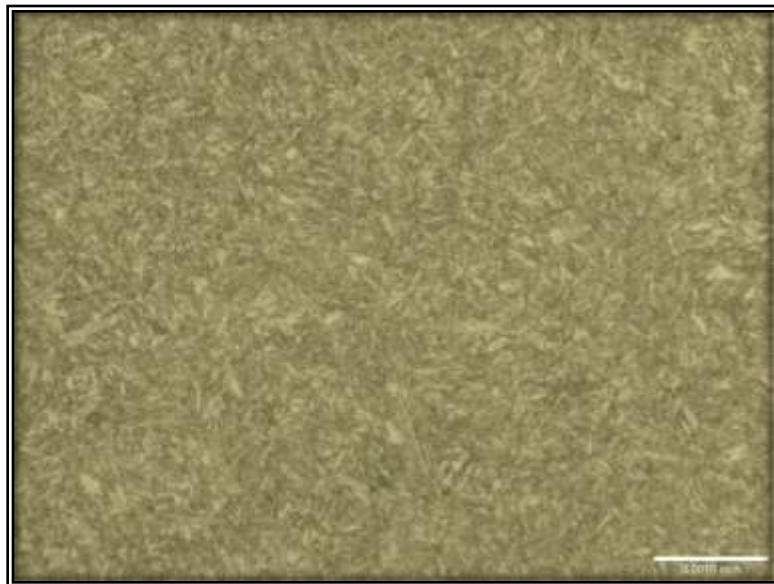
Figure 43 - 500X original magnification of the core microstructure of Cheek number 2 after being etched with nital. The core microstructure consists of tempered martensite, which is conforming.

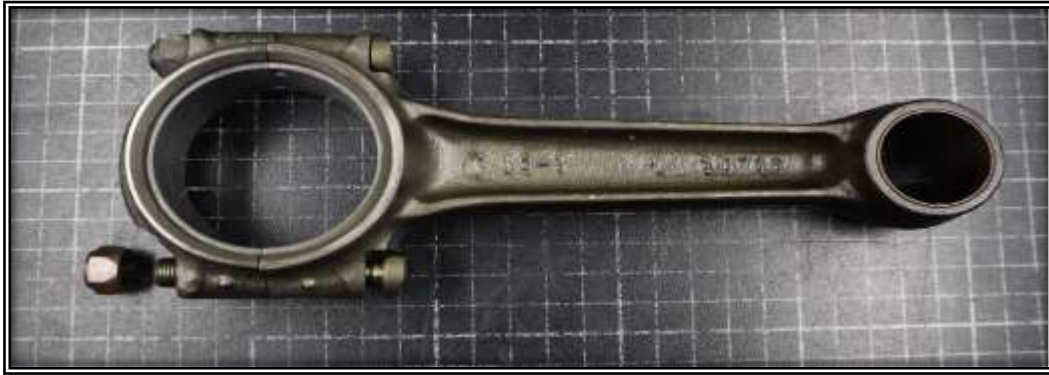
The number 4 connecting rod assembly is shown in figure 59 in the as-received condition. Some damage likely from debris from the fracture was sustained by the I-beam section of the connecting rod, is shown in figure 60. Signs of material smearing and heat tinting are present near the connecting rod bolts is shown in figure 61.

Figure 59 - The number 4 connecting rod in the as-received condition.
