AIRCRAFT ACCIDENT INVESTIGATION AND INQUIRY BOARD

FINAL REPORT

RP-C2673
Cessna 152

TITLE: A serious incident involving a Cessna 152 type of aircraft with Registry Number RP-C2673 owned and operated by Fliteline Aviation School, Inc that made a forced landing following a loss of power at Barangay Barihan, Malolos, Bulacan Philippines on February 10, 2024/1415H.

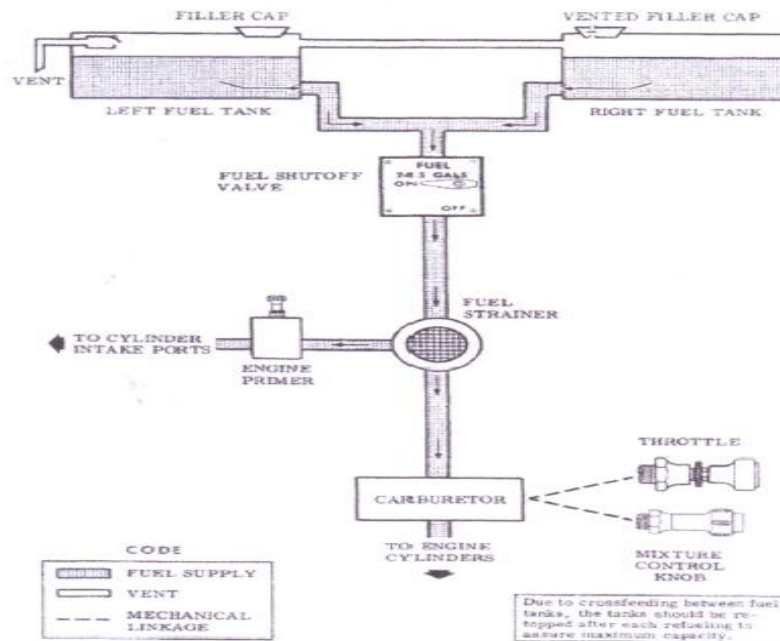
Figure 8 - Aircraft fuel system.

The Cessna 152 aircraft have vented fuel tank in each wing. (Figure 8). Fuel flows by gravity from the two wing tanks to a fuel shutoff valve. With the valve in the on position, fuel flows through a strainer to the carburetor. From the carburetor, mixed fuel and air flow to the cylinders through intake manifold tubes. The manual primer takes fuel from the fuel strainer and injects it into the cylinder intake ports.
