FINAL REPORT

<u>RP-C4202</u> AVION DE TRANSPORT REGIONAL <u>ATR 42-500</u>

TITLE: An incident involving an ATR 42-500 type of aircraft with Registry Number RP-C4202 operated by AirSWIFT Transport, Inc., that had encountered a damaged aircraft main landing gear tires and wheel hubs during landing roll at Lio Airport, Runway 15, El Nido, Palawan, Philippines, on January 09, 2023, at around 1248H.

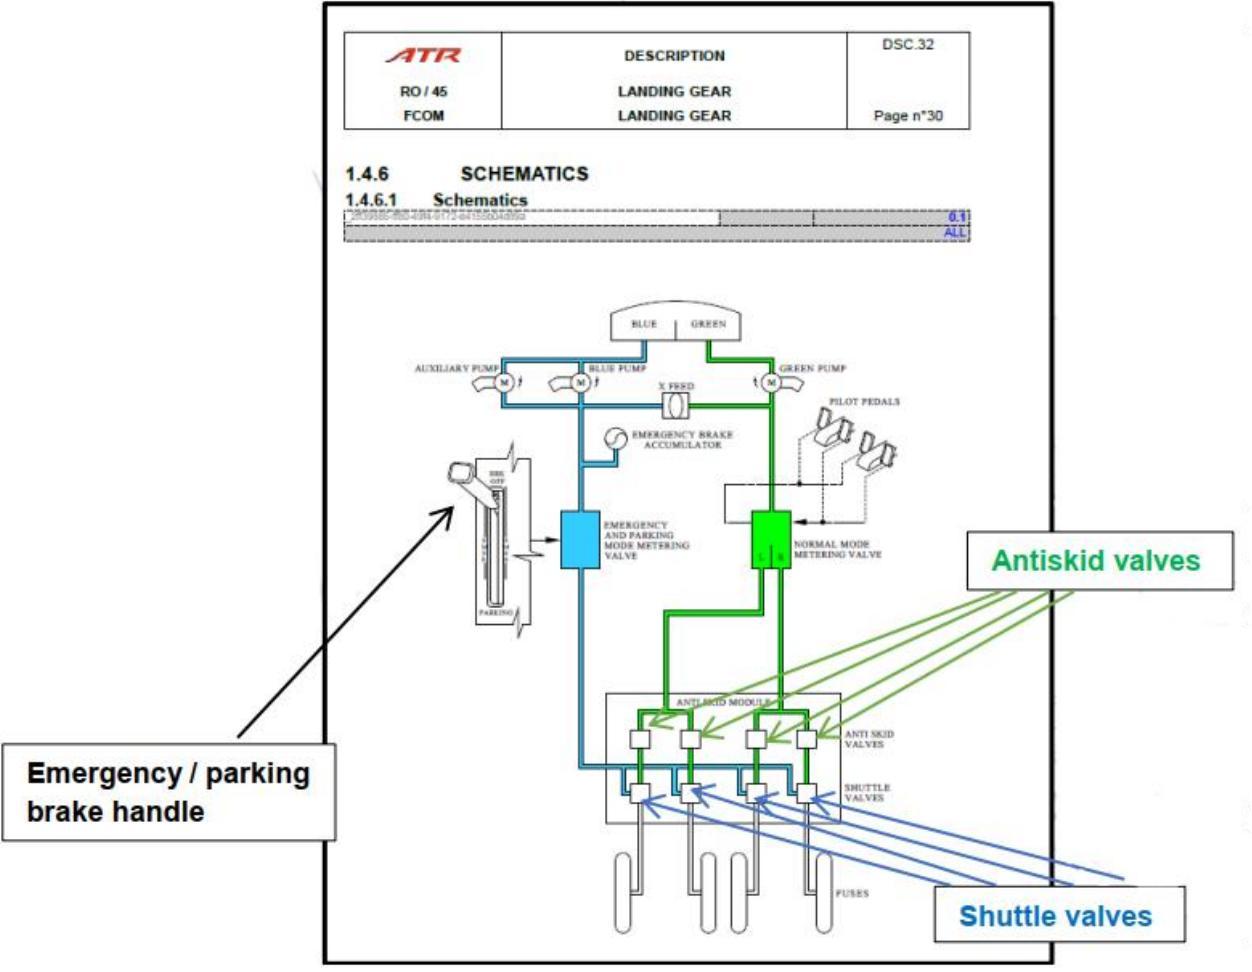
Further, the ATR 42-500/600 aircraft is equipped with two independent hydraulic circuits namely the "green" circuit and the "blue" circuit. The "green" circuit provides landing gear operation (extension and retraction) and also ensures the (usual) normal braking of the four (4) wheels of the main landing gears. On the other hand, the "blue" circuit provides emergency braking and parking braking through a specific hydraulic accumulator (see Figure 10).
