## AIRCRAFT ACCIDENT INVESTIGATION AND INQUIRY BOARD

### **FINAL REPORT**

**RP-C5911**  
**DHC-8-402 (Q400)**

**TITLE:** A serious incident involving a DHC-8-402 type of aircraft with Registry Number RP-C5911 owned and operated by PAL Express Corporation that had a runway excursion at Runway 06, Basco Airport, Basco, Batanes, Philippines on April 16, 2023/0800H.

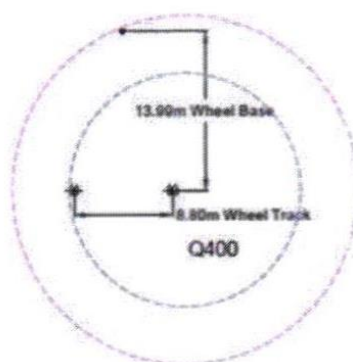
NLG Path

NOTE: Although Q400 can execute a turn using this turning procedure, it must be observed that the clearance between the Outer MLG and runway edge is only 1.2m.
