AIRCRAFT ACCIDENT INVESTIGATION AND INQUIRY BOARD

FINAL REPORT

RP-C1762
CESSNA 152

TITLE: A serious incident involving a Textron Aviation Inc., Cessna 152 type of aircraft with Registry Number RP-C1762 operated by All Asia Aviation Academy, that resulted to a runway excursion during landing roll at Iba Community Airport, Iba, Zambales, Philippines on September 9, 2020 at about 1230H/0430UTC.

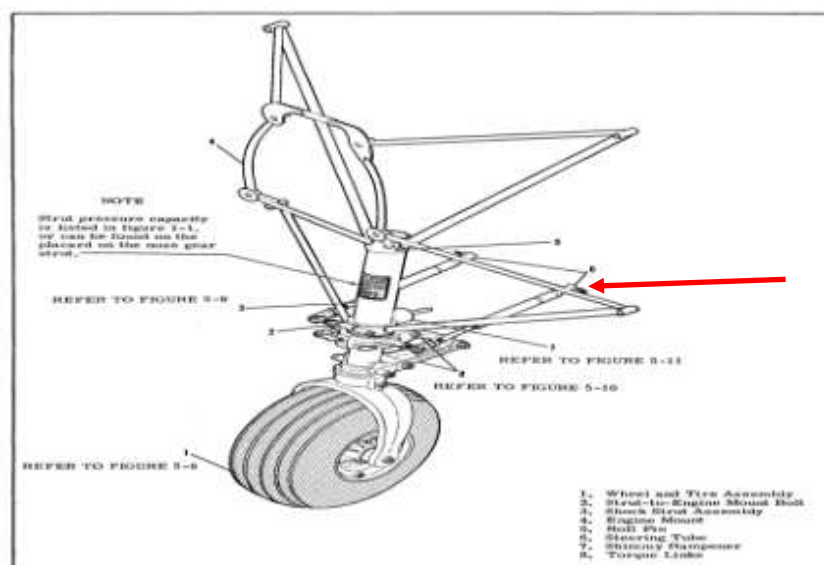
On the final leg of the flight to RPUI, the aircraft executed a full-stop landing. It was during this landing that the left-hand steering tube suffered complete failure, likely at a weakened point due to accumulated fatigue damage. With the left-side tube

fractured, only the right-hand steering tube remained intact, resulting in a loss of balanced steering input. Consequently, the steering assembly was no longer centered, causing the aircraft to involuntarily veer to the right during the landing rollout. This deviation ultimately led to the aircraft exiting the runway surface.

Figure 5 - The damaged NLG left steering tube.

- a. The failure of the left nose landing gear steering tube assembly.

Therefore, during every 100-hour inspection, maintenance personnel should not only conduct a visual examination but also perform a detailed mechanical and structural assessment of the nose wheel steering tube. This includes checking for proper lubrication, alignment with adjacent components, and ensuring all fasteners and linkages are secure and serviceable.

Given its vital role and the consequences of failure, it is recommended that inspection protocols for the nose wheel steering tube be explicitly documented and emphasized in the aircraft's maintenance schedule. Doing so ensures the continued safe operation of the aircraft and prevents avoidable ground handling issues stemming from overlooked component fatigue or damage.
