AIRCRAFT ACCIDENT INVESTIGATION AND INQUIRY BOARD

FINAL REPORT

<u>RP-C5911</u> BOMBARDIER, DHC 8-402 (Q400)

TITLE: A serious incident involving a Bombardier, DHC 8-402 (Q400) type of aircraft with Registry Number RP-C5911 owned and operated by Air Philippines Corporation (PAL Express), that had a gear-up landing resulting to runway excursion at Mactan-Cebu International Airport (RPVM), Philippines on December 10, 2021, 1140H(Local).

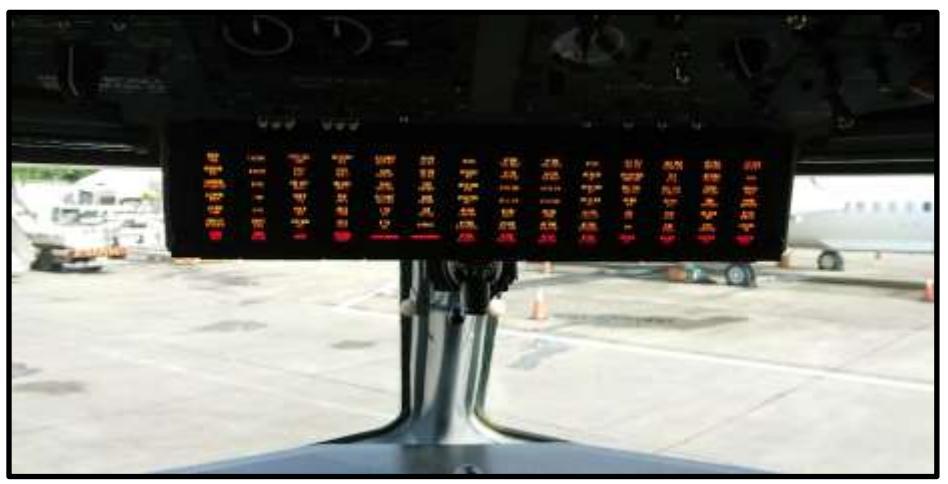
Figure 7: The aircraft annunciator panel.

- **a.** The runway condition was wet at the time of the occurrence.
- **b.** The flight crew became distracted in maintaining situational awareness when the nose wheel steering indicator illuminated at the annunciator panel.
